Annual Environmental Management Report 1 January – 31 December 2014

Mine: Tomingley Gold Operations

Mining Leases: ML1684

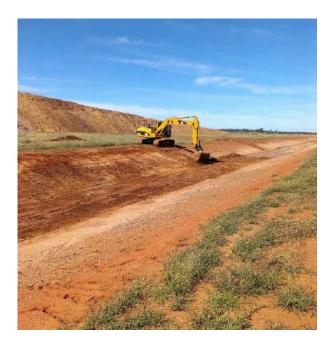
Figure 13: Earthworks trim of Caloma Drain

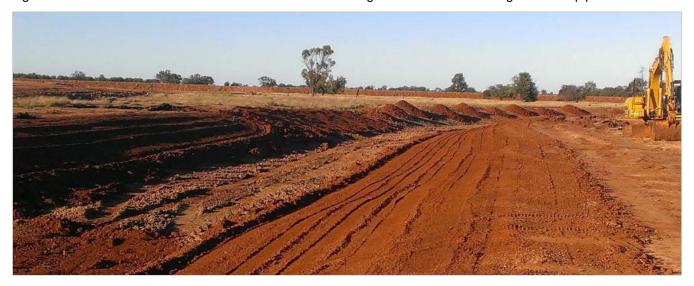
Figure 15: Topsoil placement and spreading in Caloma Drain

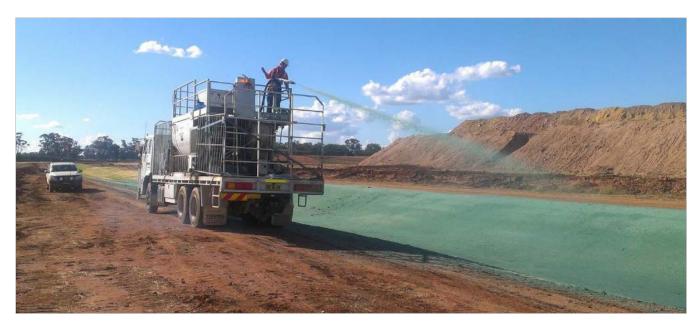
Figure 16: Hydroseeding of Caloma Drain

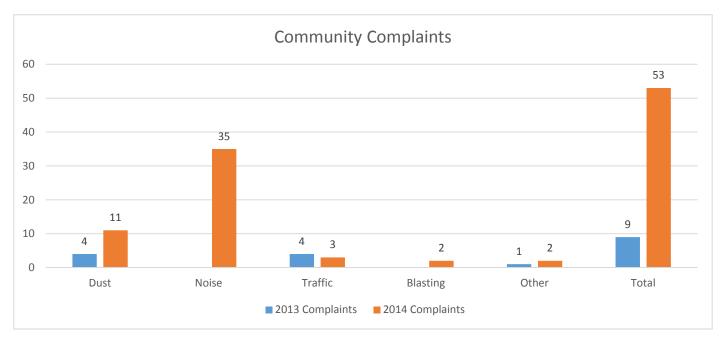
Figure 18: Summary of community complaints by type received in 2014 and previous reporting periods.

The increase in complaints from last reporting period is largely due to the 35 noise complaints received since the transition to operations in early 2014. Figure 18 shows the number and type of complaints received during the reporting period, compared to the previous period.
