Tomingley Gold Operations Annual Review 1 January – 31 December 2015

This Annual Review reports on operational and environmental management activities undertaken at Tomingley Gold Operations Pty Ltd (TGO) during the calendar year 2015, and provides details on activities proposed for 2016. The report has been produced in accordance with the *Post-approval requirements for State significant mining developments. Annual Review Guideline* (DP&E, October 2015) to meet the annual reporting requirements conditioned in the TGO Mining Lease (ML 1684) and Project Approval (PA09_0155).

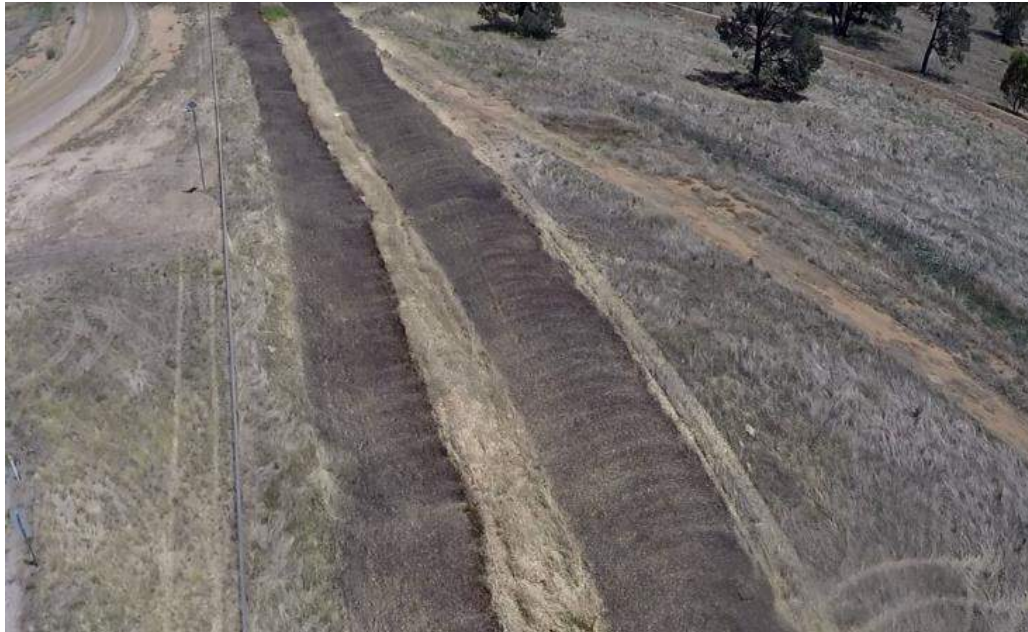
Plate 1: Dirty Water Drain immediately post rehabilitation (December 2015)

Soil dumps modified during rehabilitation works were regraded and re-vegetated with a pasture seedmix to reduce erosion and sedimentation of adjacent drains. Plates 1 to 3 show the remedial works in progress.

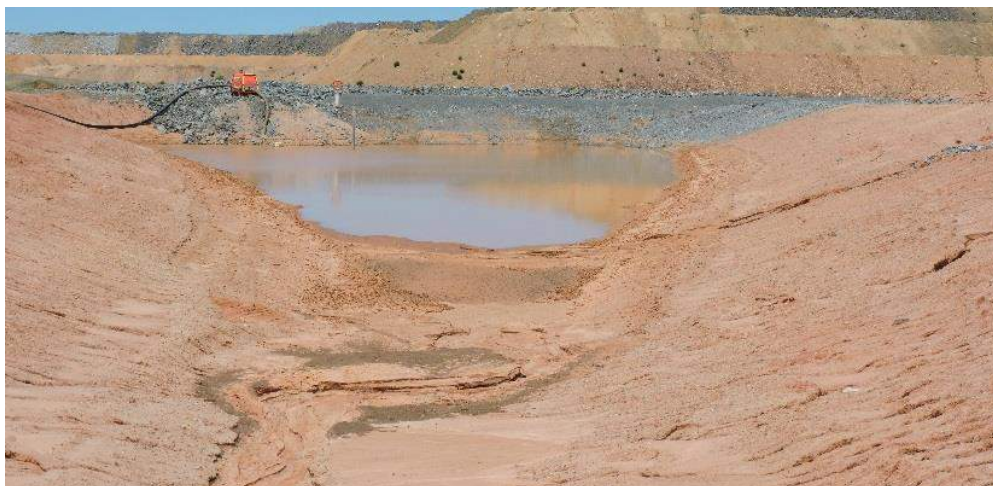
Plate 3: Enlargement of Sediment Basin 5

Staggered inspections of site sediment basins were conducted monthly, with all site sediment basins being inspected once per quarter. Sediment basins were also inspected following heavy rain and/or dewatering. When sufficient water was being held in sediment basins, samples were collected on an approximately fortnightly basis for internal management purposes. No offsite discharges from sediment basins occurred during the reporting period.

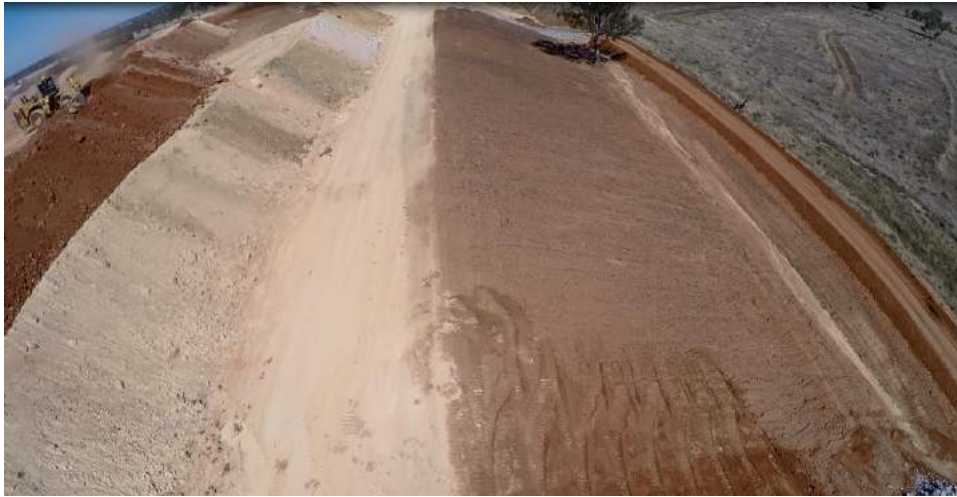
Plate 4: Reshaping works at WRE 2.

Due to the more exacting requirements of the revised design, rehabilitation that had originally been scheduled for completion during the reporting period has been delayed. However, substantial reshaping works have been completed during the reporting period to achieve the the revised design. Construction to achieve the revised water management design (rock armoured drop structures every 200m) have also been commenced. Plates 4 to 6 show reshaping works progress during the reporting period.

TGO has sought input from two specialist consultancies (PSM for geotechnical advice and SLR for rehabilitation design) to produce a suitable revised landform final design. The revised design incorporates detailed bench/berm and drainage specifications, as well as comprehensive rehabilitation treatment to achieve a final landform that sheds and safely conveys water to ground level. The revised bench/berm design is shown in Figure 5 and a full copy of the most recent design specifications is included as Appendix G.

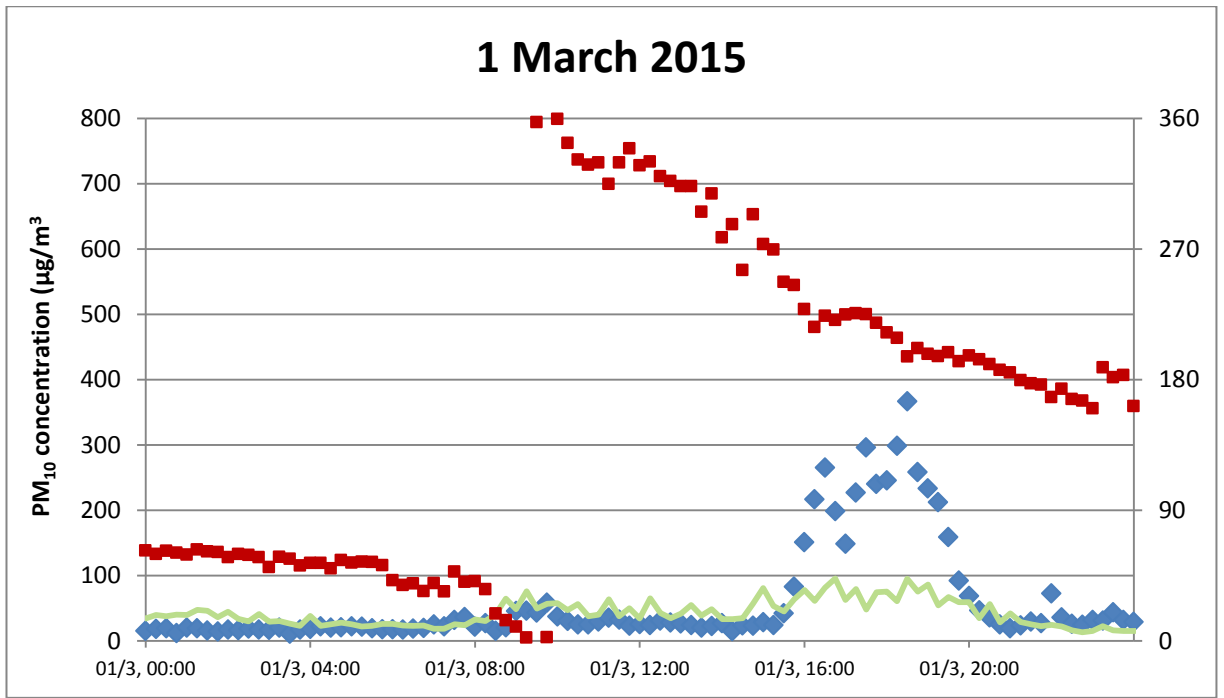
Figure 6 Dust impacts for 1 March 2015 (15 minute averages, µg/m³)

Daily (15 minute average) analysis of PM₁₀ as well as wind speed and direction on 01 March is graphed in Figure 6. The highest recorded 15 minute concentration of PM₁₀ occurred in the evening when winds swung around from the west to the south and PM₁₀ levels reached 367 µg/m³. An increase in wind speed is also evident during this period, where wind speeds reached up to 43 km/h. During this time, the township was downwind of the mine and dust impacts were thus likely due to mine operations.
