Tomingley Gold Project

Soils and Land Capability Assessment

September 2011

Sustainable Soils Management Pty Ltd

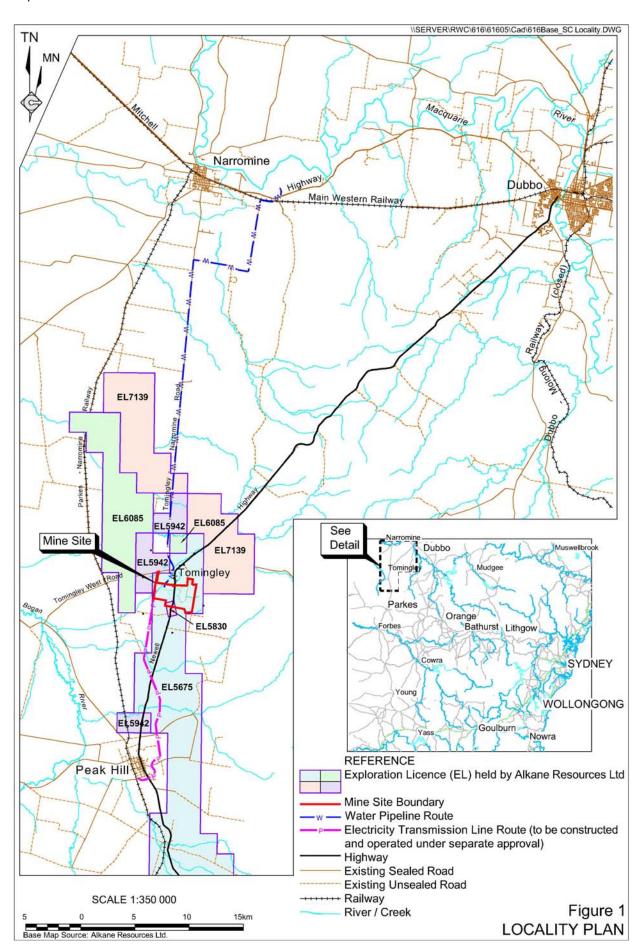
The Project is located approximately 51km to the southwest of Dubbo and approximately 1.5km south of the village of Tomingley (**Figure 1**). All areas of Project-related disturbance would be confined to the Project Site, which is bisected by the Newell highway (**Figure 2**).

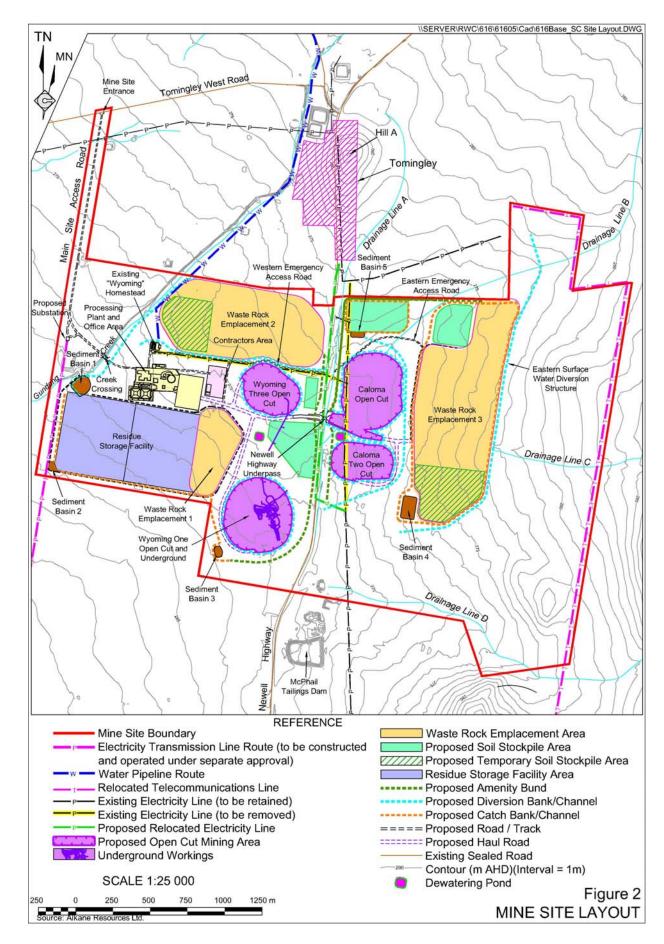
The Project would include the following components (Figure 2).

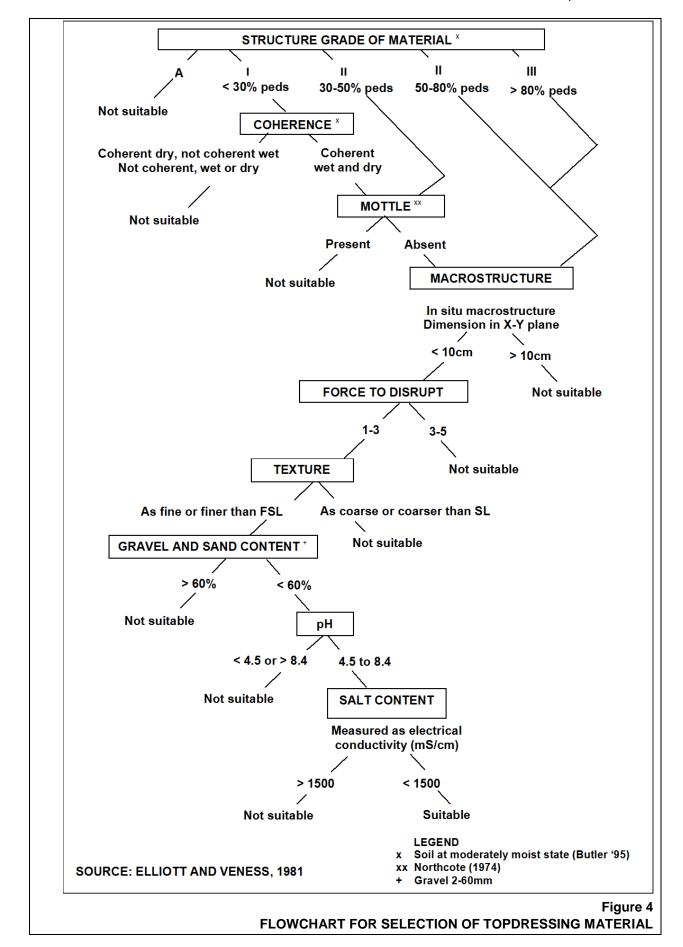
The suitability of soil for use during rehabilitation was determined while assessing soil pits using the physical assessment method of Elliott and Veness (1981) as presented in NSW Minerals Council (2007) and shown in **Figure 4**.

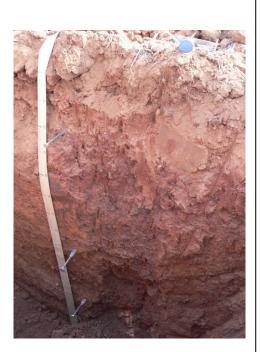
Box 1 Red Dermosol - Test Pit MW904

Pit MW904, typical of the Red Dermosol, is described in Box 1.

Brown light medium clay with strong grade of angular blocky structure and ped size of 3cm breaking to 0.5 cm. Soil is slightly dispersive, completely slakes, has a moderate to good SOILpak score and has no roots present.

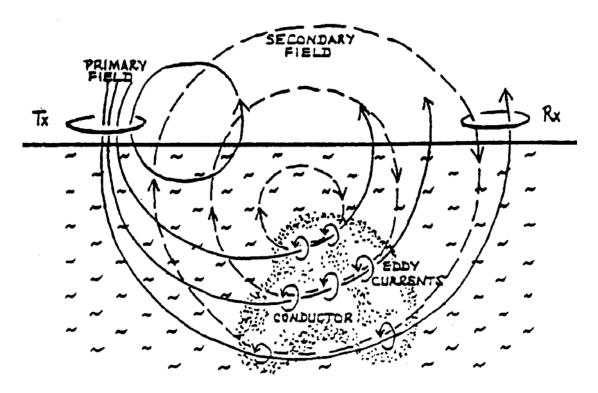
Figure A1. Electromagnetic induction in the earth

These electromagnetic fields are induced as a result of electromagnetic fields that are generated by the EM 31. The EM 31 instrument generates a primary magnetic field (**Figure A1**). This field induces an electric current to flow through the soil. The current produced in the soil as a result of the EM 31 primary field creates secondary magnetic field. The intensity of the secondary field is proportional to the strength of the induced soil current. Because the primary field is of constant intensity the strength of the induced current will fluctuate only as a result of varying conductivity of the soil profile.

In summary the EM 31 instrument produces the primary field, detects the secondary field and then assigns a value to the strength of this secondary field. This value has been calibrated to reflect the conductivity of the soil profile.
