# **TOMINGLEY GOLD PROJECT**

# Monthly Environmental Monitoring Report

**June 2019**

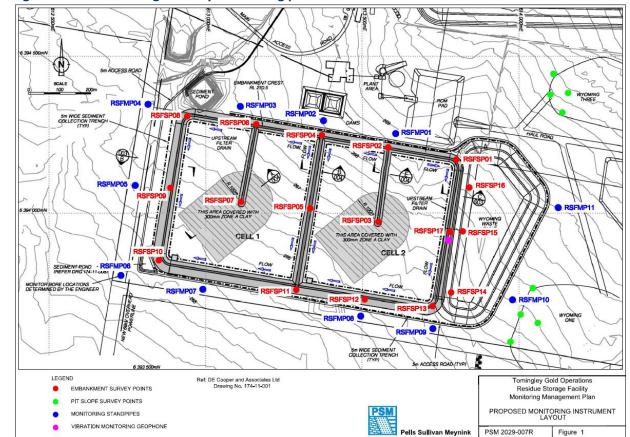
Figure 4. Residue Storage Facility monitoring points

Figure 4 indicates the location of environmental and survey monitoring points on and around the Residue Storage Facility.

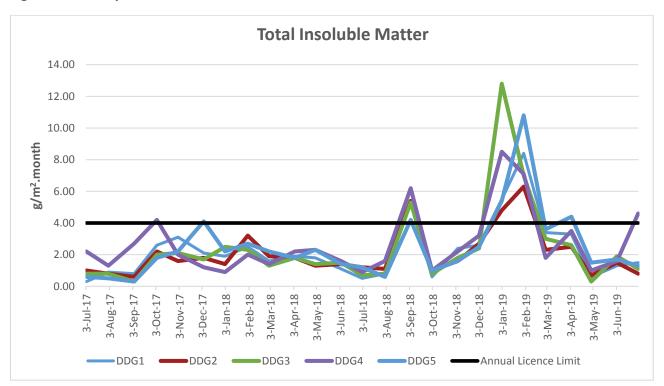
Figure 6. Dust Deposition Results 2017 - 2019

Depositional Dust monitoring undertaken during this month returned the results indicated in the table below. The above average January results coincided with the increase of regional dust and dust storms due to ongoing drought conditions and were not generated by the project. Monitoring location DDG4 recorded an elevated result for the month. An internal investigation determined that the elevated result was most likely generated by the truck parking bays within the Tomingley Village. The performance criteria for deposited dust is averaged over 12 months with a maximum total average of 4g/m2/month.

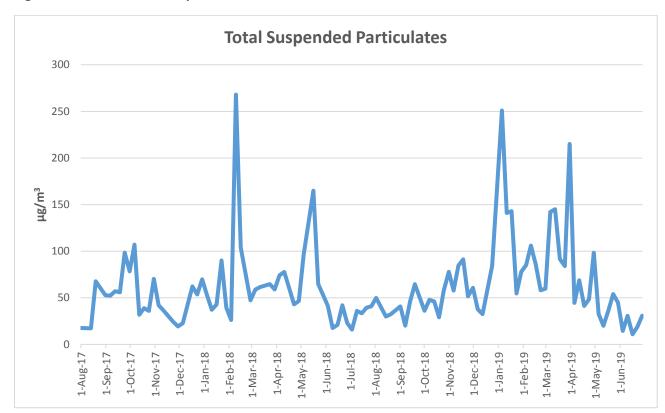
Figure 7. Hi-Volume Air Sampler Data 2017 - 2019

High Volume Air Sampling (HVAS) for Total Suspended Particulates (TSP) was undertaken this month. Figure 7 below provides the results. The above average January results coincided with the increase of regional dust and dust storms due to ongoing drought conditions and were not generated by the project.

The performance criteria for TSP is averaged over 12 months.
