# AUSTRALIAN STRATEGIC MATERIALS LTD

## **Annual Review & Annual Rehabilitation Report**

**1 July 2018 – 30 June 2019**

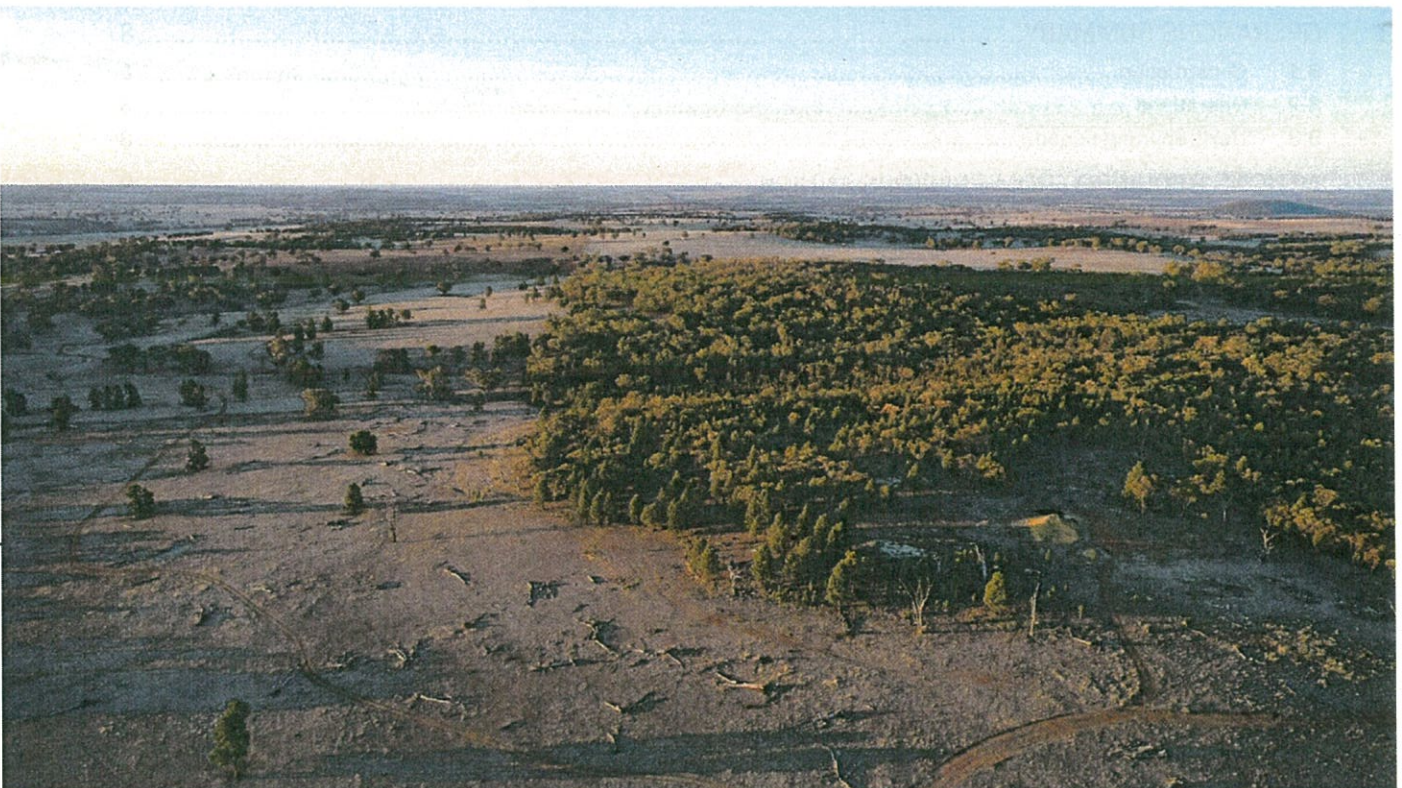
Drone view looking northeast across the Toongi trachyte. A ray of sunlight shines on the test pit ore stockpile. Photo taken 20 August 2018

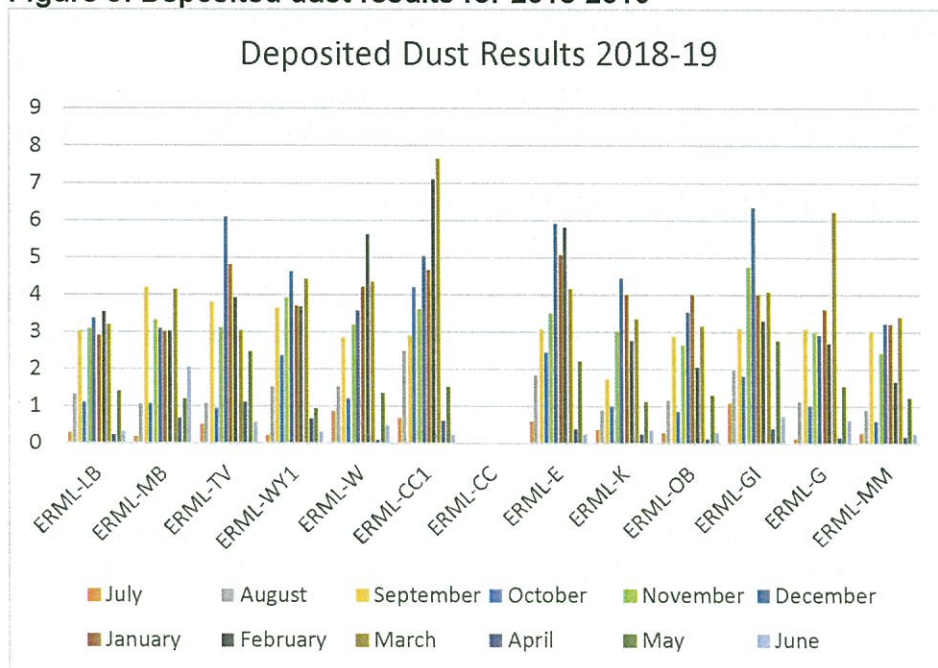
**Figure 5: Deposited dust results for 2018-2019**

2018-2019 has seen numerous raised dust events due to statewide drought conditions. HVS sampling at Alkane's Tomingley Gold Operations provide supporting evidence of raised dust events.

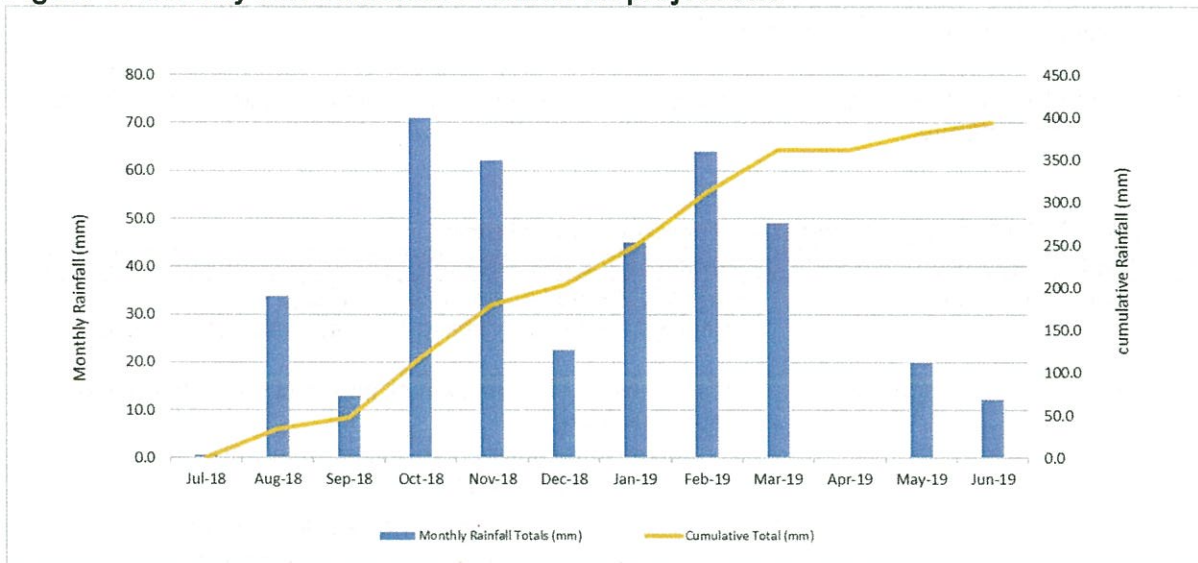
**Figure 6: Monthly and cumulative rainfall on project site**

**Figure 6.** Wychitella monthly and cumulative rainfall to 30 June 2019. A total 393.4mm of rain fell over the reporting period which has seen prolonged drought conditions persist after 294.6mm fell in the preceeding period.

In March 2017 ASM converted the weather station at Wychitella to a cloud based data storage system with real time access to data. There is a break in weather data for this reporting period though rainfall data is continuous from the Met Station or Grandale Homestead rain gauge.

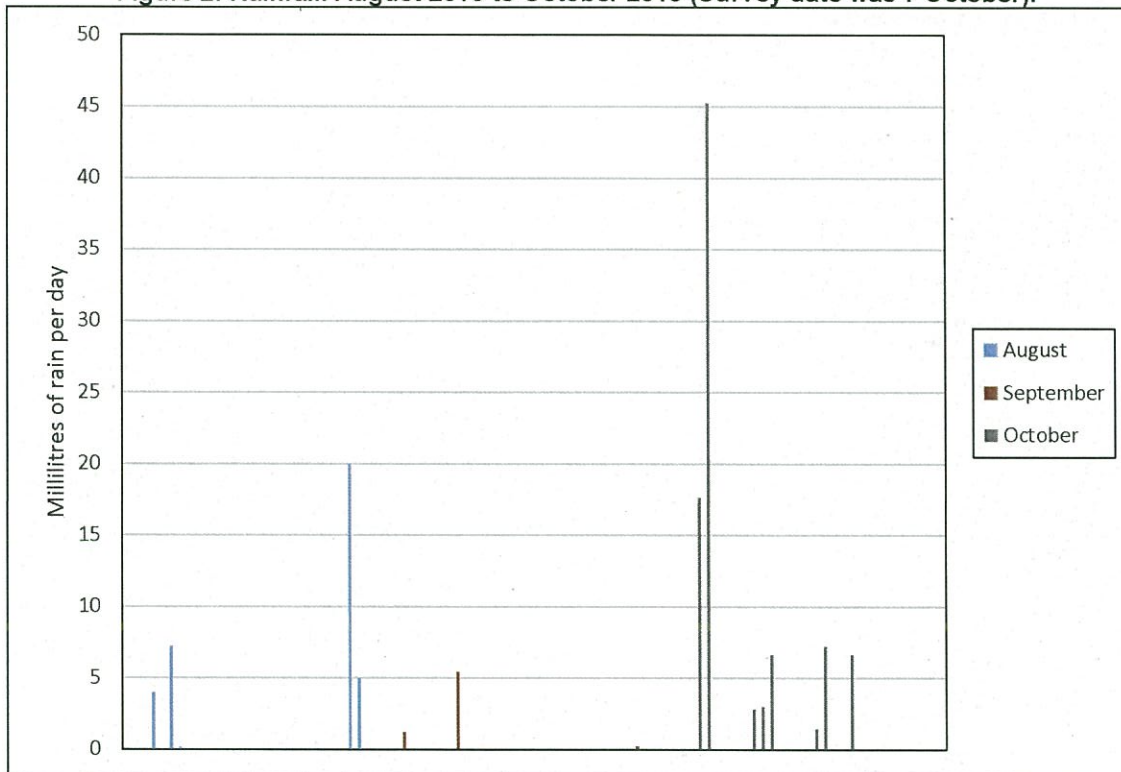
Figure 2: Rainfall. August 2018 to October 2018 (Survey date was 7 October).

Rainfall has been low for 2018; 2016 was the wettest year since 1994 (at Dubbo Airport) with a total of 916.4mm and the year to date rainfall for Dubbo (at Dubbo Airport) as 22 November 2018 is only 253.4mm. In the two and a half months leading up to the monitoring event it continued to be low, however several falls of rain in the first half of October (Figure 2).

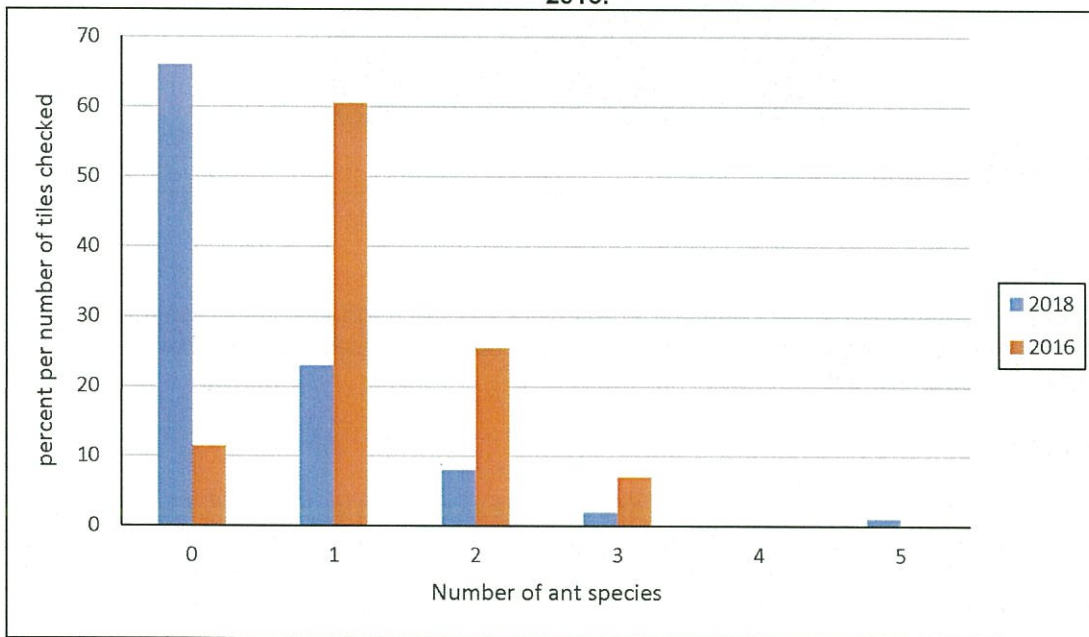
Figure 8: Percentage of times each ant species count occurred, October 2018 versus October 2016.

During this survey effort ants were not collected nor were any species identified, however a count was taken of the number of different species seen under each tile set. The number of times each number of ant species counts for 2018 was compared to the same count for October 2016 (Figure 8). In 2016, most tiles (61%) revealed one species of ant, in 2018, most tiles (69%) revealed no ants. In 2018, 100 tile sets were checked and in 2016 114 tile sets were checked. This may be a result of the drought that has recently been gripping NSW.

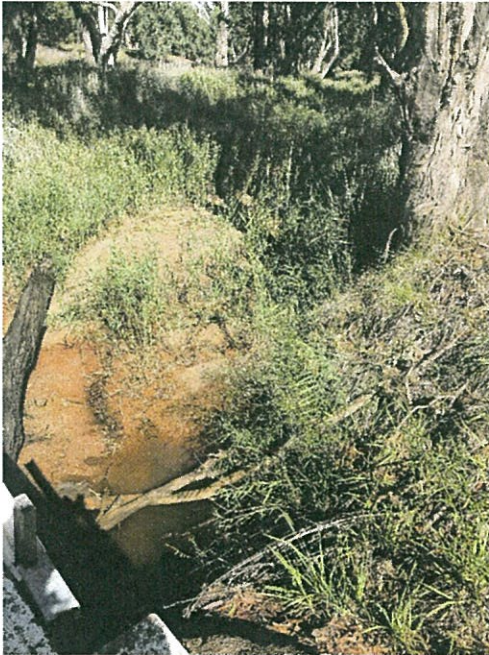
**Dubbo Project Surface Water Sampling 26 March 2019 after 25mm of rainfall overnight.**

SW007-Wambangalang Creek sampled 26 March 2019.

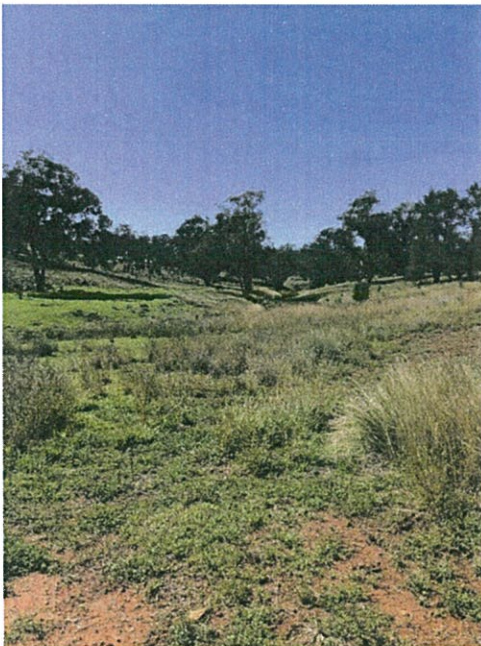
Watercourse B - 1000m upstream of SW003 looking southeast. Photo taken 26 March 2019.

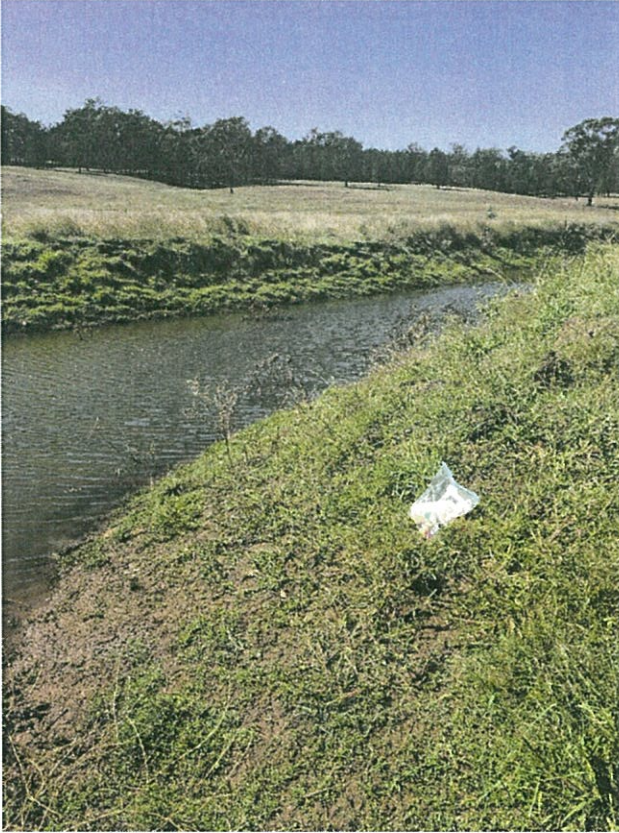
SW003-Watercourse B Toongi Valley sampled 26 March 2019.

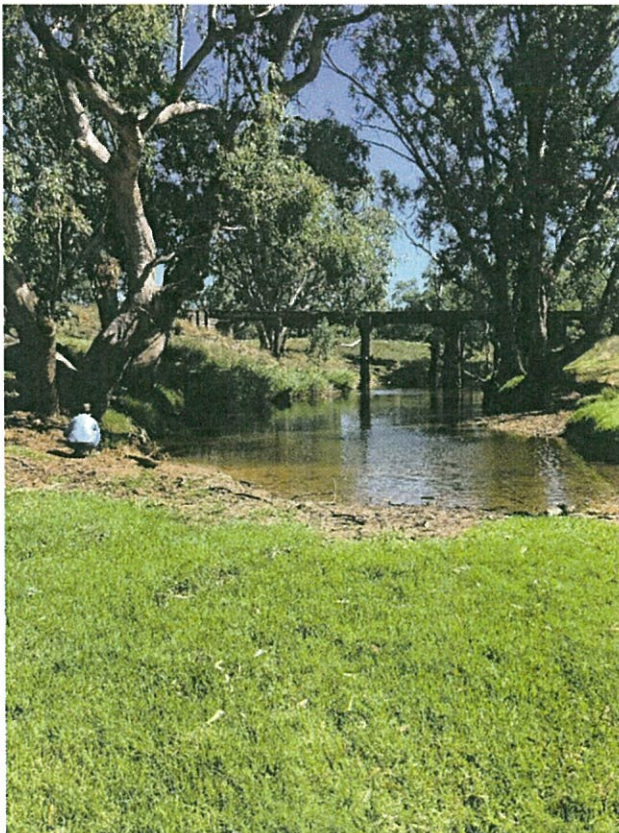
SW005- Wambangalang Creek under sand flow. Sampled 26 March 2019.

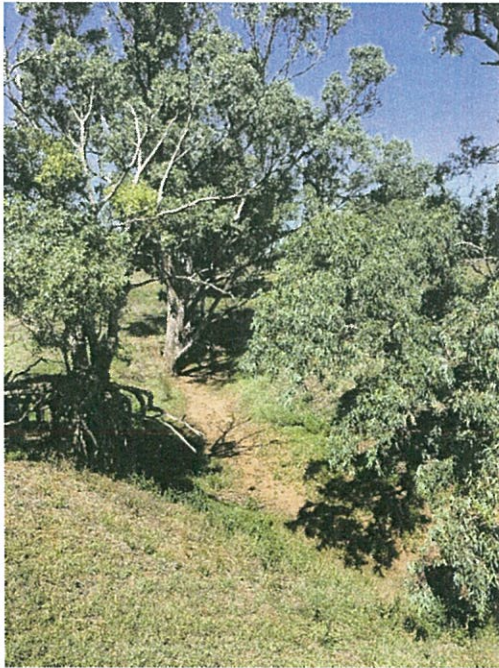
SW004-Paddy's Creek, Wychitella. Normal sample site dry but flowing under sand 26 March 2019.

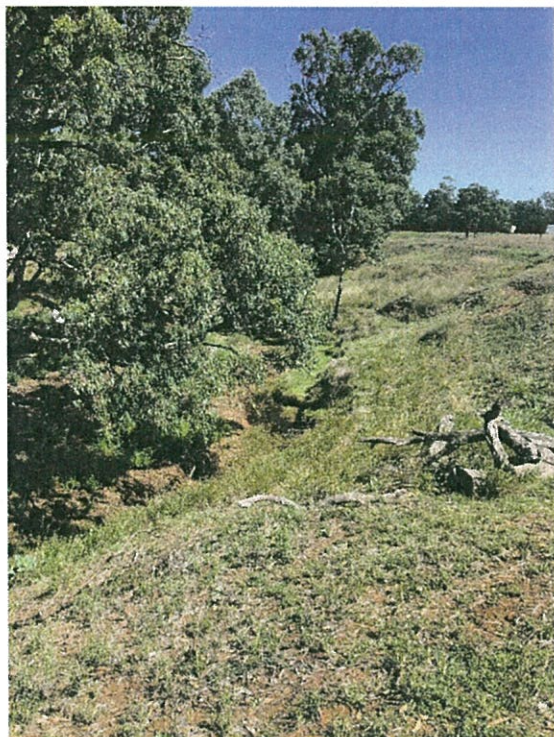
SW004b - Paddy's Creek sampled 25m downstream of usual location. Flowing under sand 26 March 2019. (results reported by ALS as SW004).
