ANNUAL ENVIRONMENTAL MANAGEMENT REPORT

PEAK HILL GOLD MINE 2019

Annual Environmental Management Report 1 January to 31 December 2019

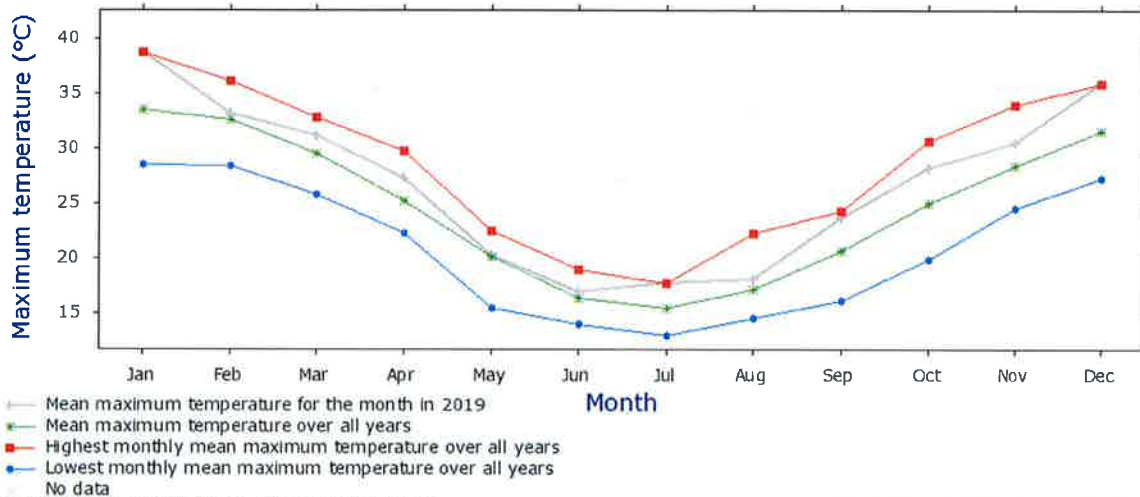
Peak Hill Post Office (050031) 2019 maximum temperature

The charts below contain maximum and minimum temperatures for 2019 versus the long term mean and daily rainfall data for 2019.

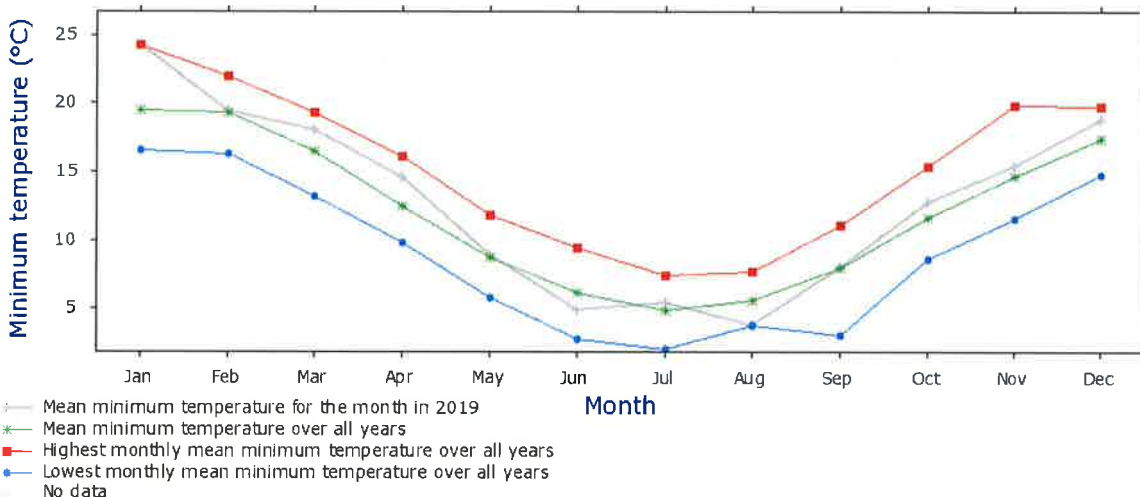
Peak Hill Post Office (050031) 2019 minimum temperature

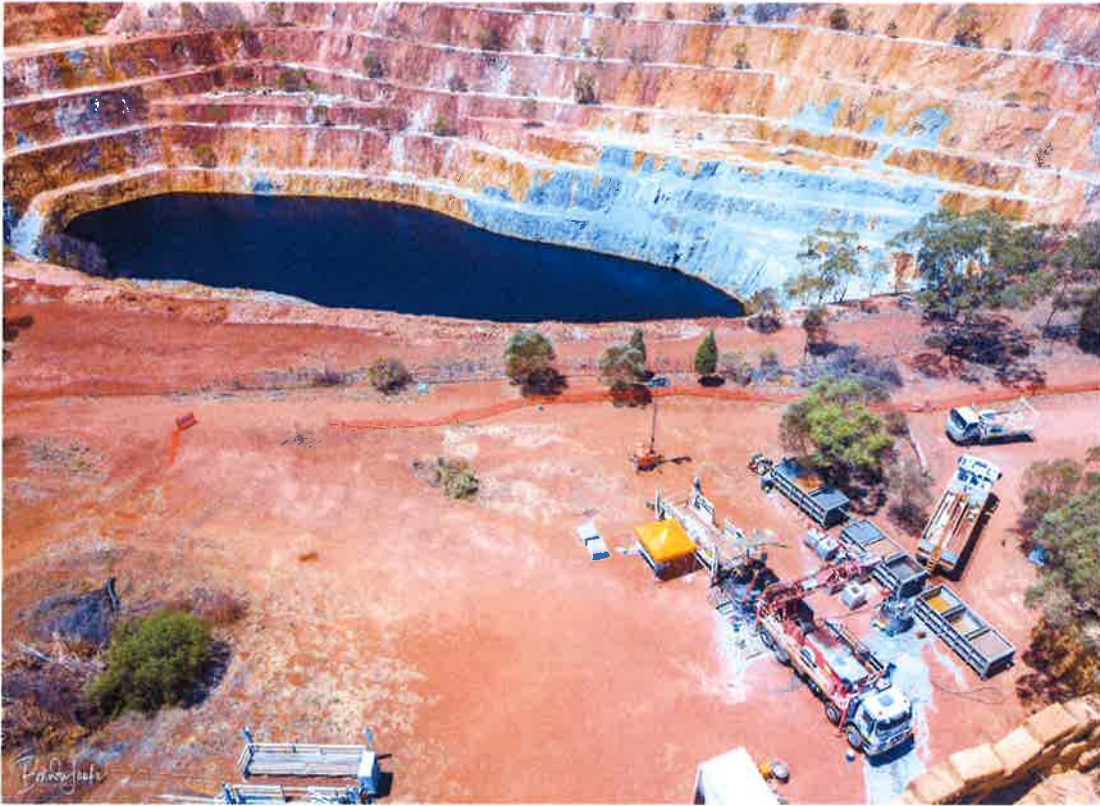
Diamond drilling program 2018-2019 testing gold resources below the Proprietary pit. Photo courtesy of Mitchell taken 13 Feb 2019.

A ten-hole diamond drilling exploration program was commenced immediately west of the Proprietary Pit in December 2018. The aim of the program was to establish whether sulphide resources below the current open cuts would be economically viable to mine from underground. The initial concept would be to truck ore to Tomingley Gold Mine for processing.

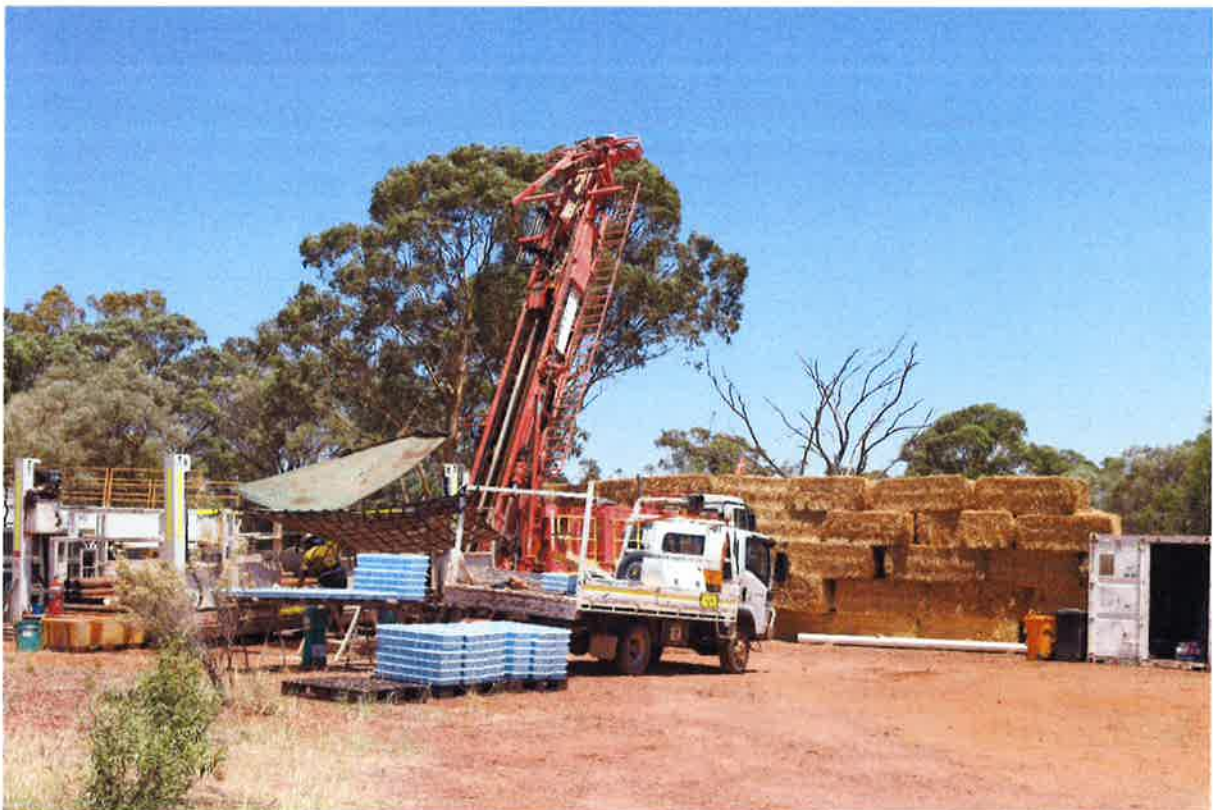
Diamond drilling behind a sound wall of hay bales. Photo taken 8 February 2019.

This three-month long program was conducted 24/7 outside of the Christmas period. A sound barrier constructed of large hay bales was effective in mitigating noise. Some of the drill holes were within 200m of houses but were within the mining lease.

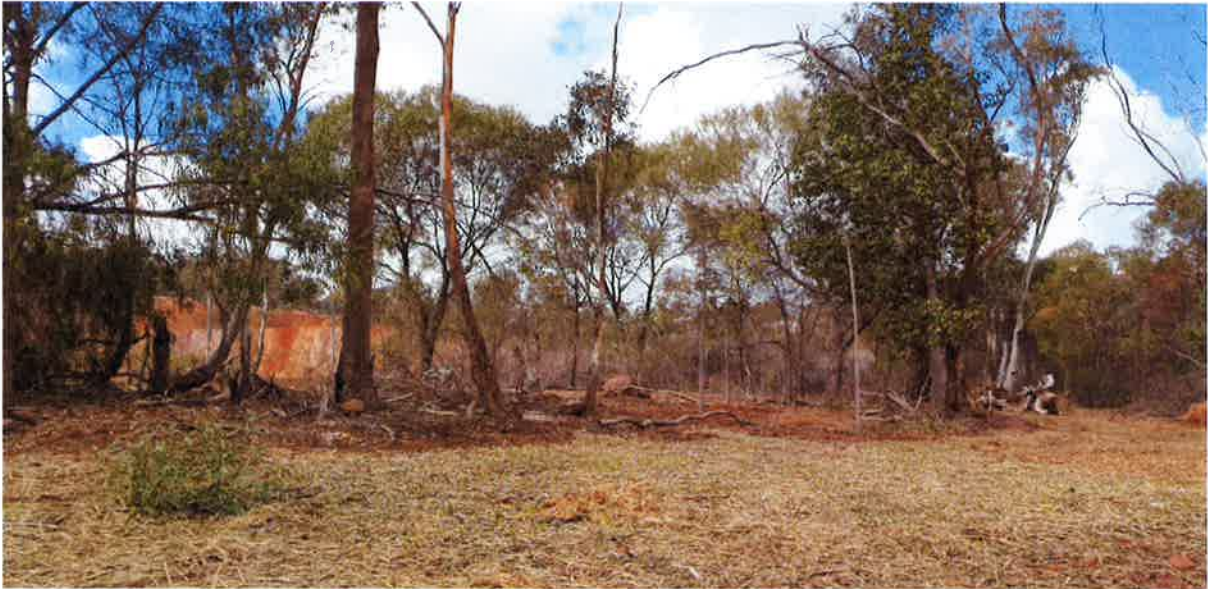
Diamond drill pad rehabilitation. Currajongs were transplanted. *E. dealbata* suckering on left of photo taken 10 July 2019.

There has been no land clearing (other than minor tree clearing for three diamond drill pads west of the Proprietary Open Cut), construction activity, ore extraction nor mineral processing during 2019 (none since 2005).

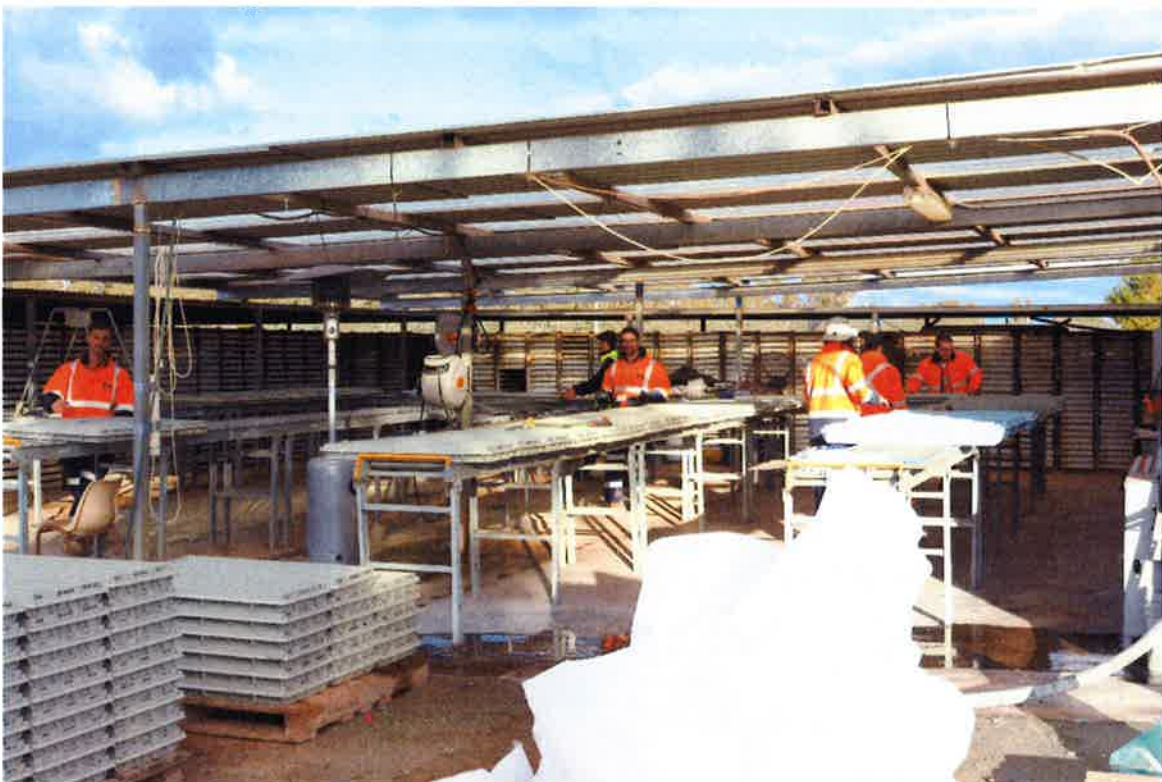
Alkane geologists and contractors in the core yard at PHGM preparing core, logging and cutting for assay. Photo taken 10 July 2019.

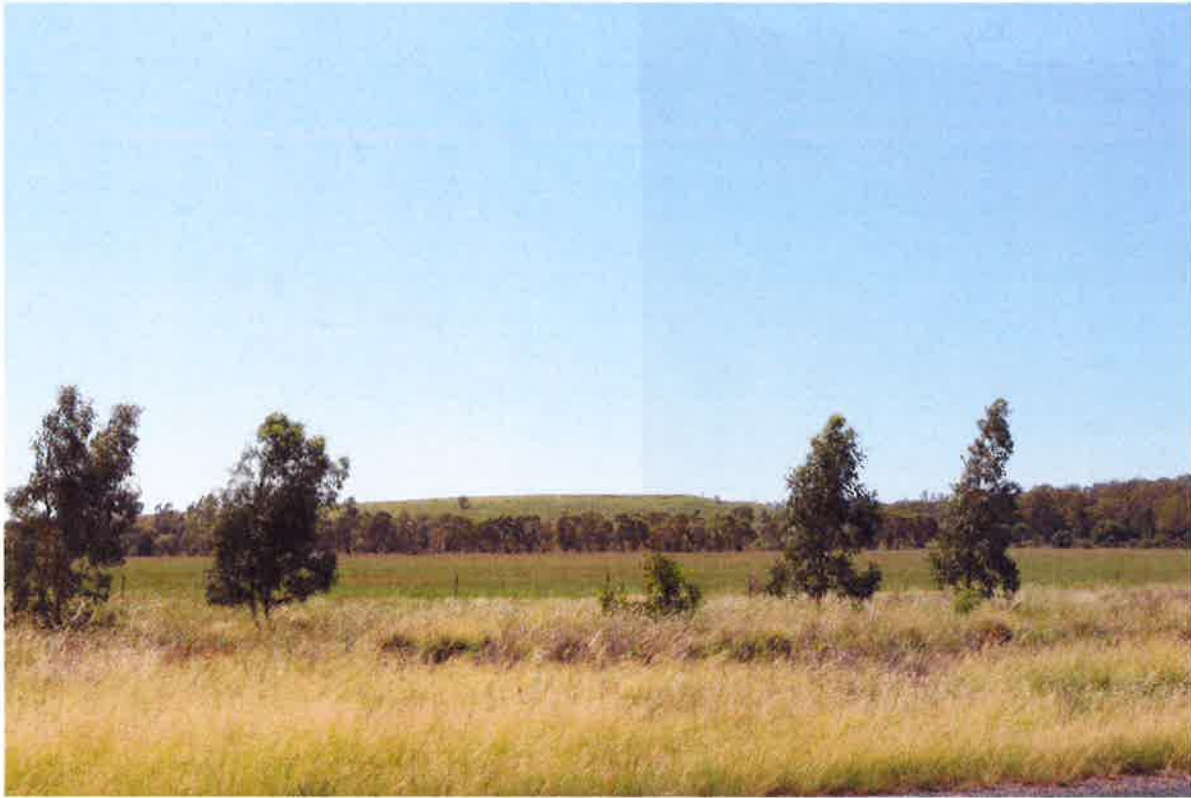
Peak Hill Gold Mine final landform as seen from Newell Highway travelling south. Photo taken 14 January 2019

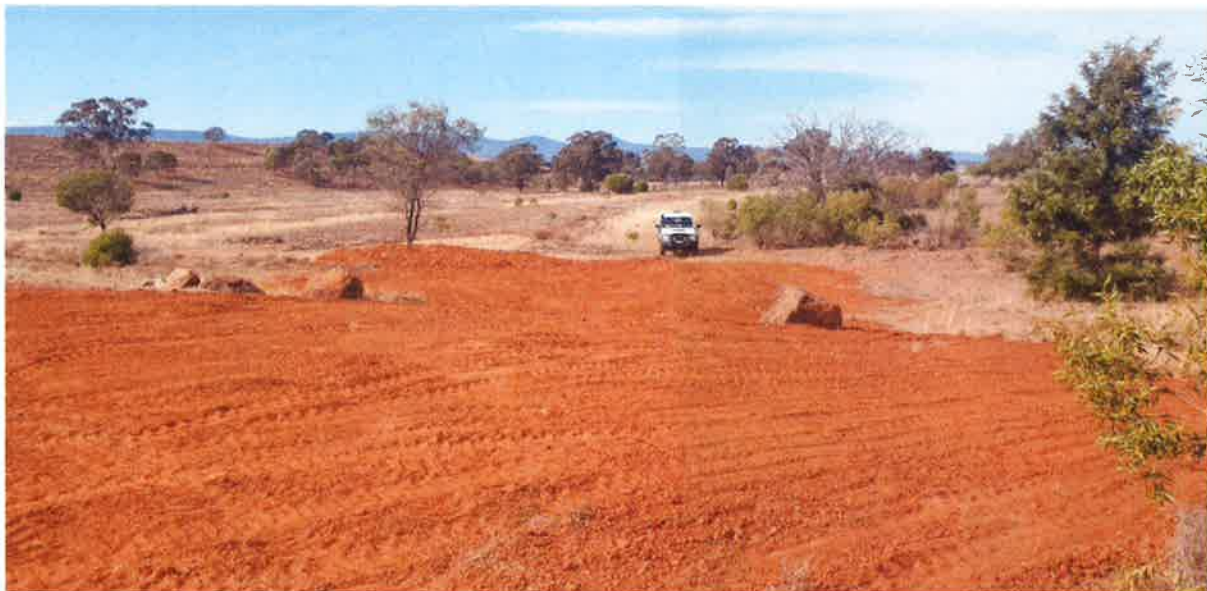
ROM pad re-topsoiling of an area that once held a stockpile of sulphidic material. The sulphides were removed to Parkers Pit (toe of Gilligan's island). Photo taken 29 July 2019.

During this reporting period, approximately 70 tonnes of waste rock containing sulphides was removed from the southern edge of the ROM Pad and placed in Parkers Pit (toe of Gilligan's Island). That area was re-topsoiled in July 2019.

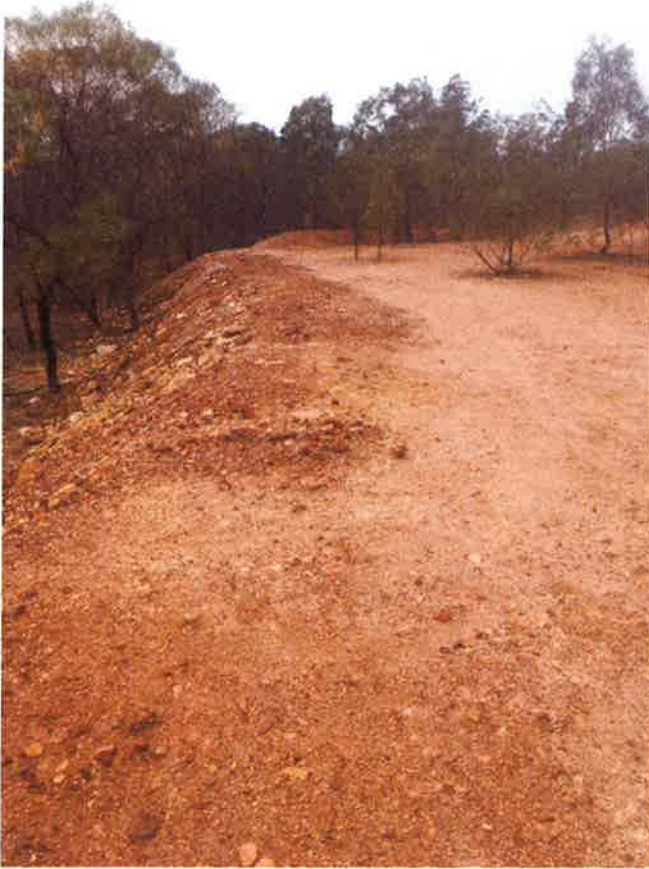
Haul Road to Proprietary pit with sulphide contaminated windrow removed to the toe of Gilligan's Island in July 2019.

A windrow containing sulphides on the haul road to the Proprietary pit was removed to Parkers pit (toe of Gilligan's Island).

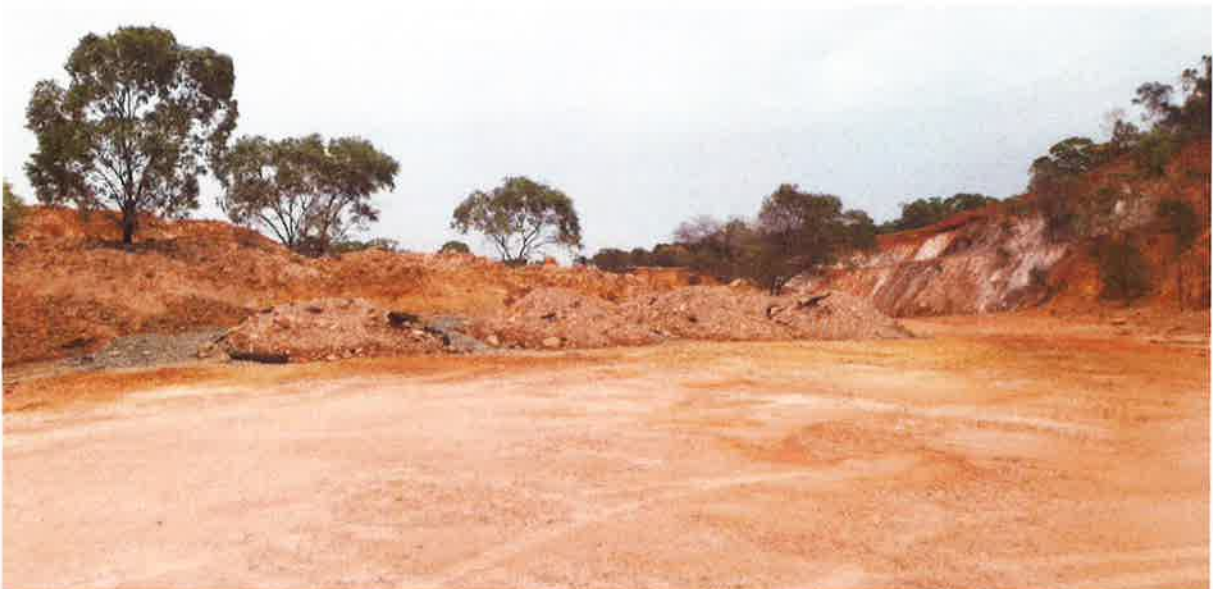
Sulphides from ROM Pad at the toe of Gilligan's Island. Photo taken 5 March 2019.
