ANNUAL ENVIRONMENTAL MANAGEMENT REPORT

PEAK HILL GOLD MINE 2021

Annual Environmental Management Report 1 January to 31 December 2021

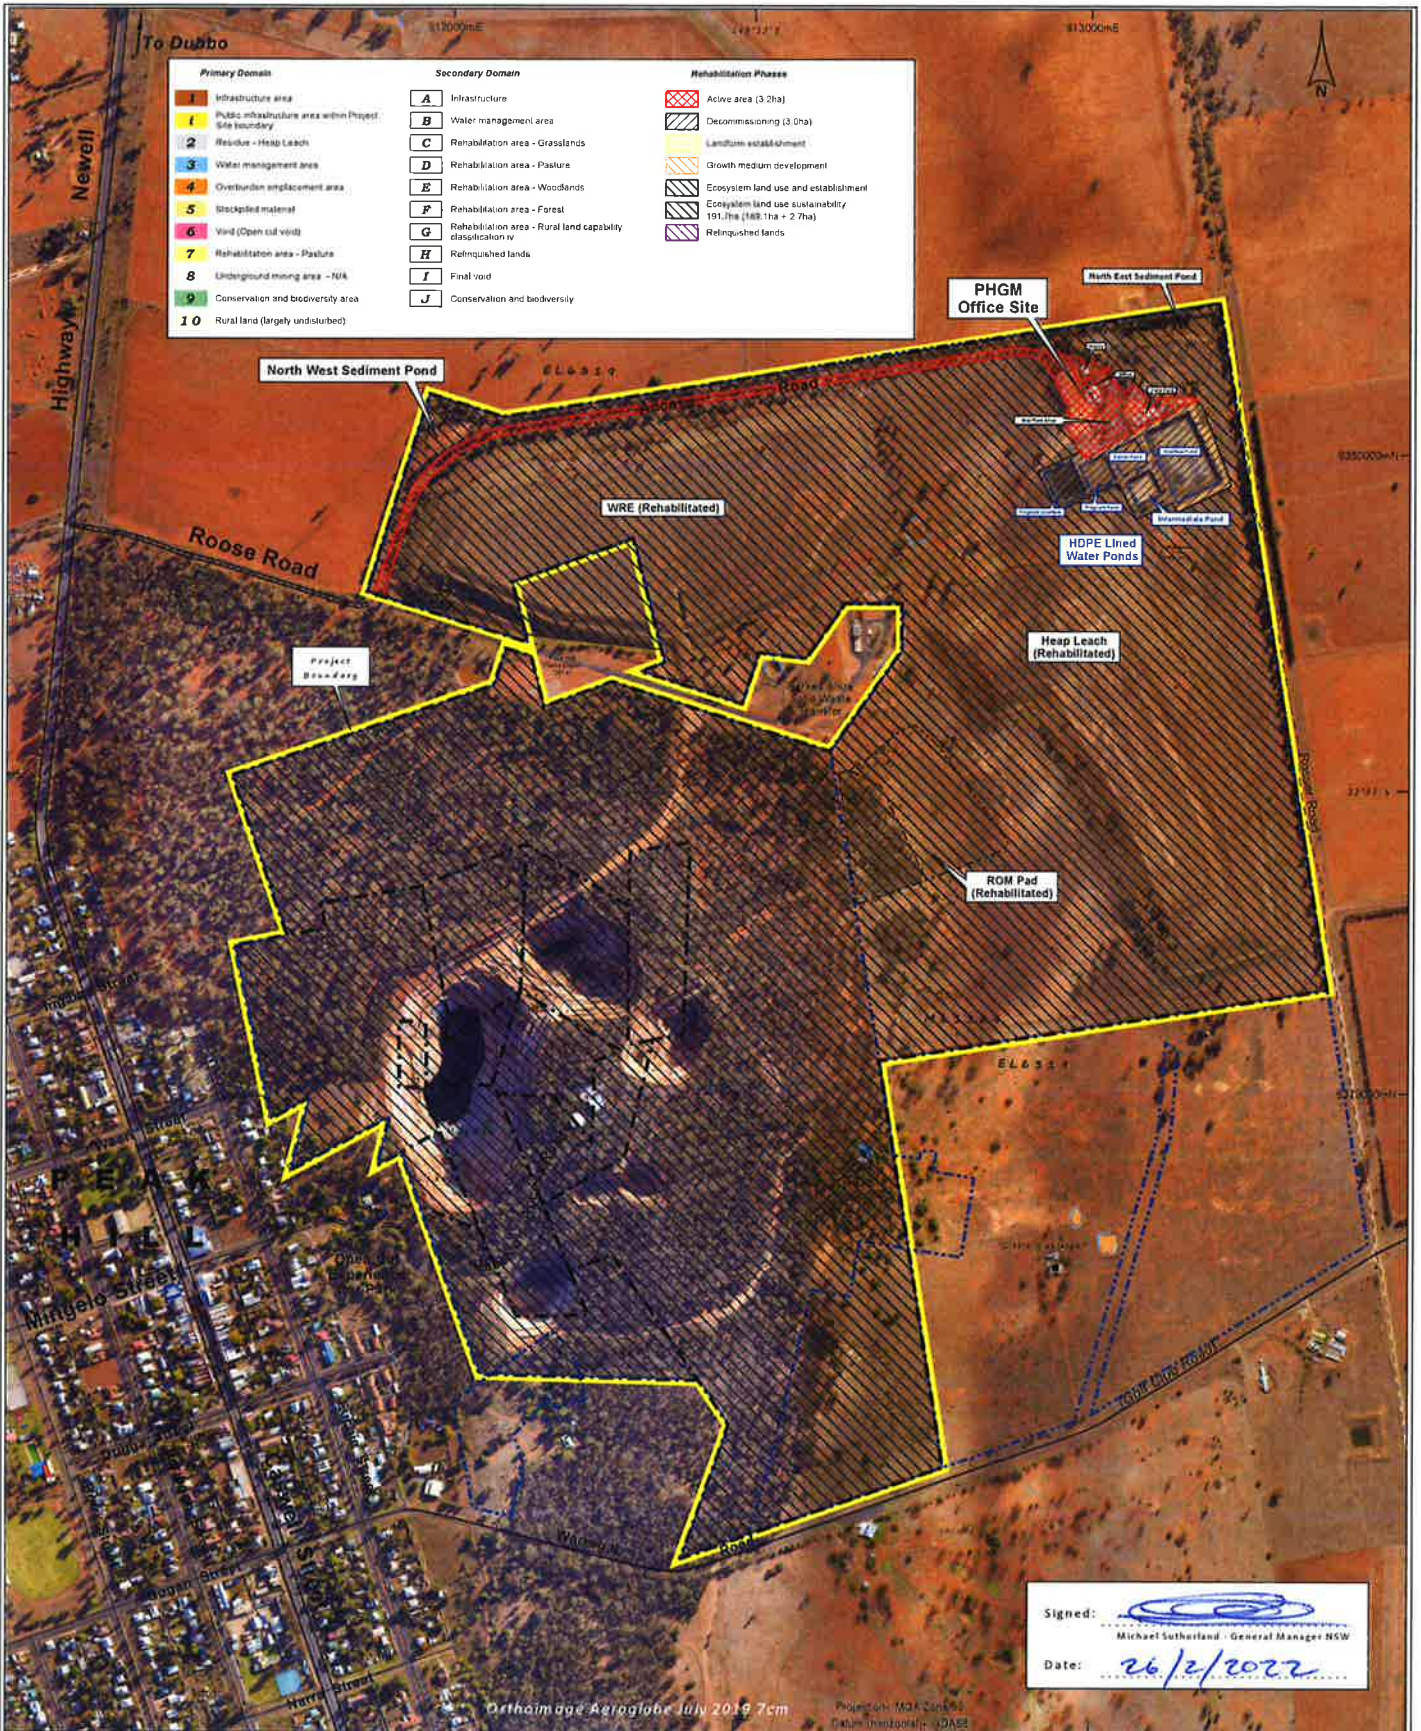
**ALKANE RESOURCES LTD**
PEAK HILL GOLD MINE
Mine Domains at
31 December 2021
 (AEMR 2021 - Plan 2)

Primary Domain		Secondary Domain		Rehabilitation Phases	
1	Infrastructure area	A	Infrastructure	[Red cross-hatch]	Active area (3.2ha)
1	Public infrastructure area within Project site boundary	B	Water management area	[Diagonal lines]	Decommissioning (3.0ha)
2	Residue - Heap Leach	C	Rehabilitation area - Grasslands	[Yellow box]	Landform establishment
3	Water management area	D	Rehabilitation area - Pasture	[Green box]	Growth medium development
4	Overburden emplacement area	E	Rehabilitation area - Woodlands	[Diagonal lines]	Ecosystem land use and establishment
5	Stockpiled material	F	Rehabilitation area - Forest	[Diagonal lines]	Ecosystem land use sustainability 191.1ha (149.1ha + 2.7ha)
6	Void (Open cut void)	G	Rehabilitation area - Rural land capability classification iv	[Purple box]	Relinquished lands
7	Rehabilitation area - Pasture	H	Relinquished lands		
8	Underground mining area - N/A	I	Final void

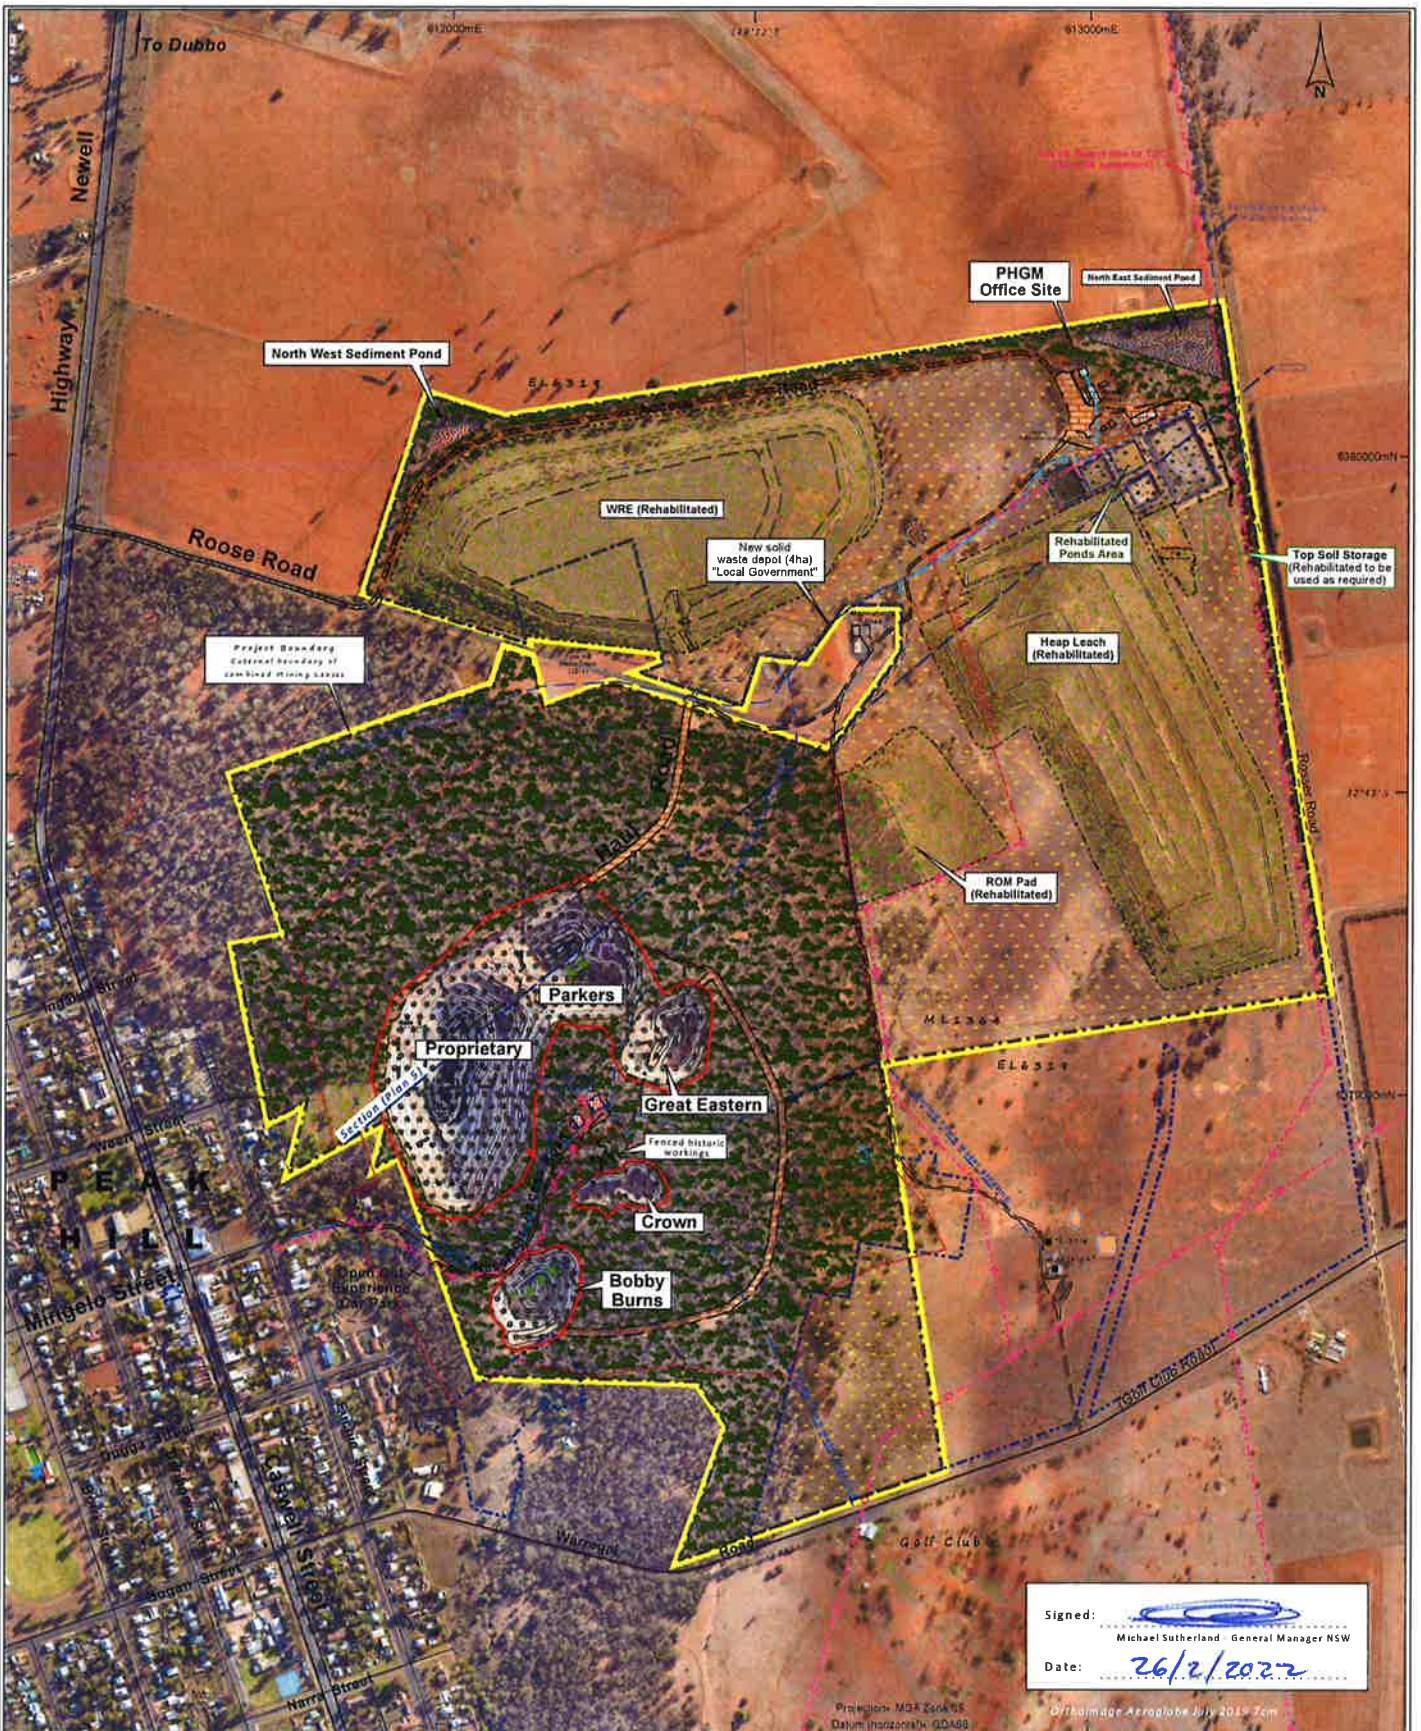
Compiled: ALK Plan No.: ALK PKH 1EV-004b
 Drafted: D Moyses Date: 24 Feb 2022 Figure No.: Plan 4

PEAK HILL GOLD MINE
Final Rehabilitation and Post Mining Land Use - 2022

The final steps in rehabilitation of the site will be described in MOP (Jul 2022). **Plan 4** shows proposed final rehabilitation outcomes.

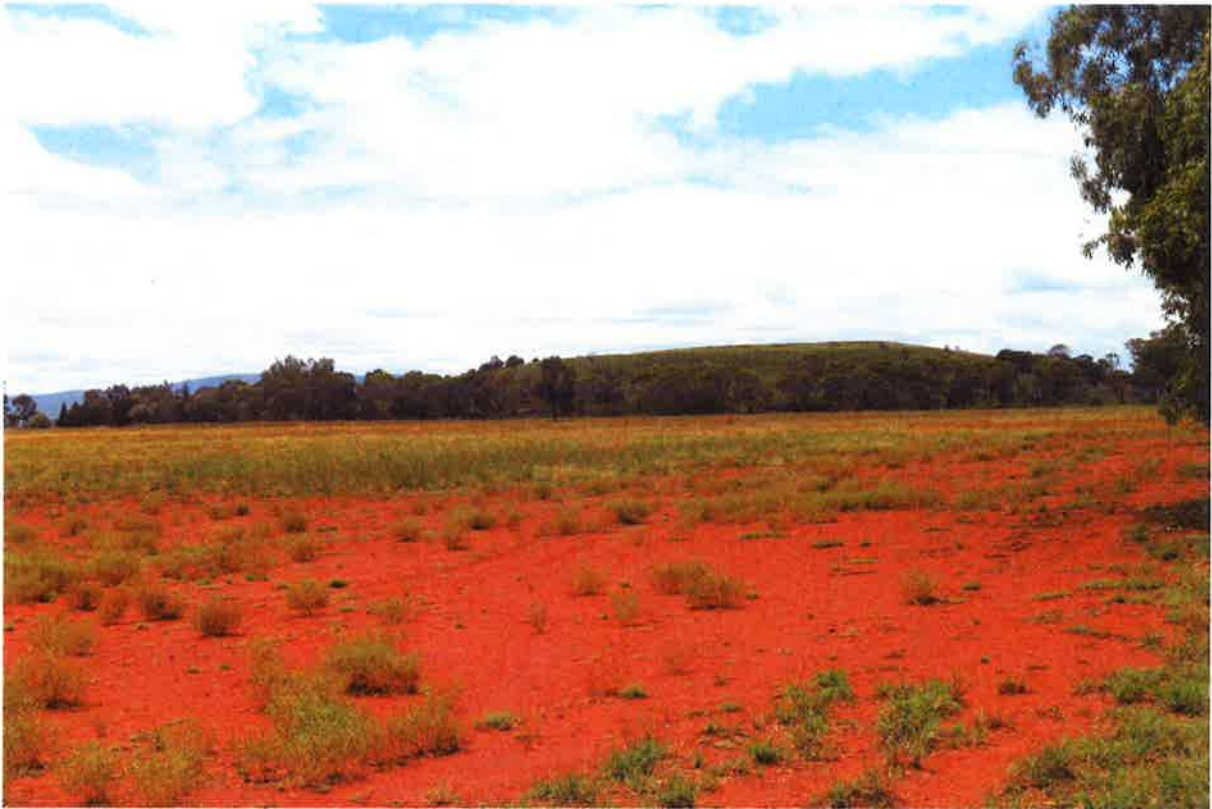
Photo 1: Peak Hill Gold Mine waste rock emplacement and screen plantings looking northeast. All photos unless otherwise labelled were taken by Mike Sutherland on 30 December 2021.

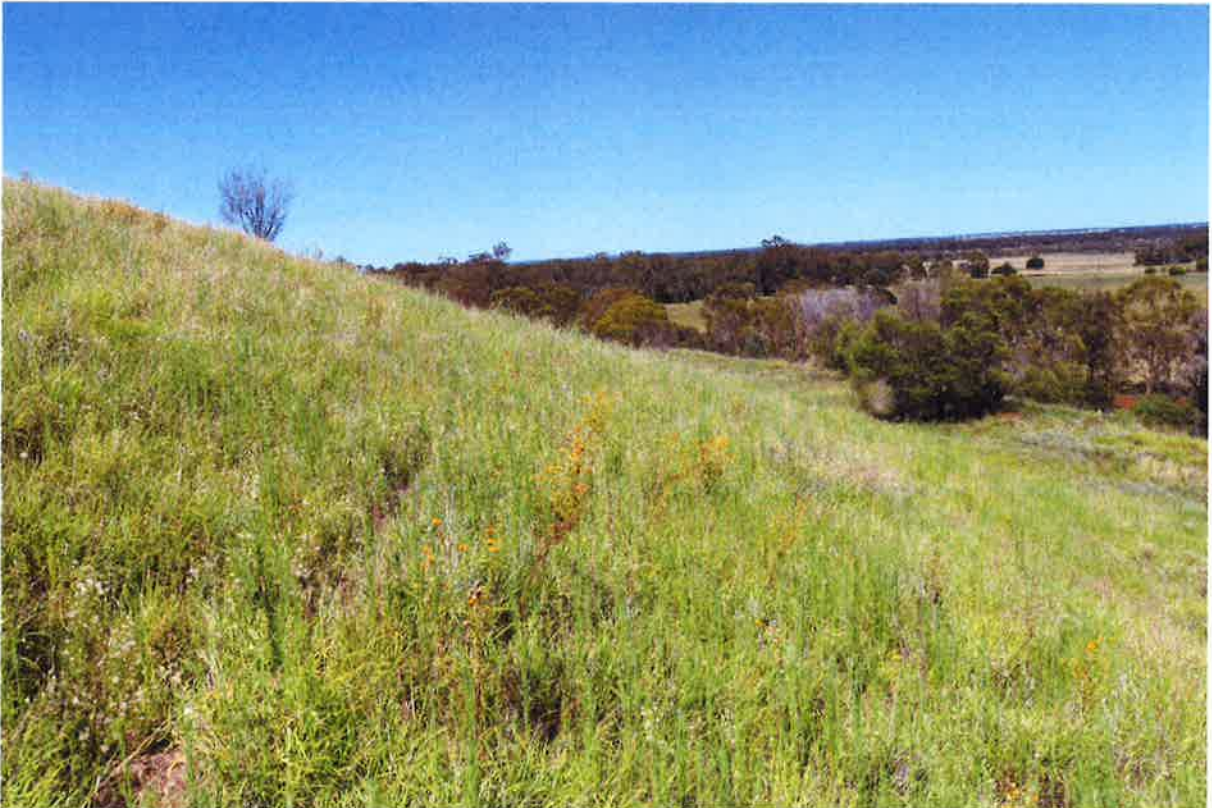
Photo 2: Upper batter of WRE looking west. Self-sown Sticky everlasting daisies (*Helichrysum viscosum*) were abundant across the mine site in 2021.

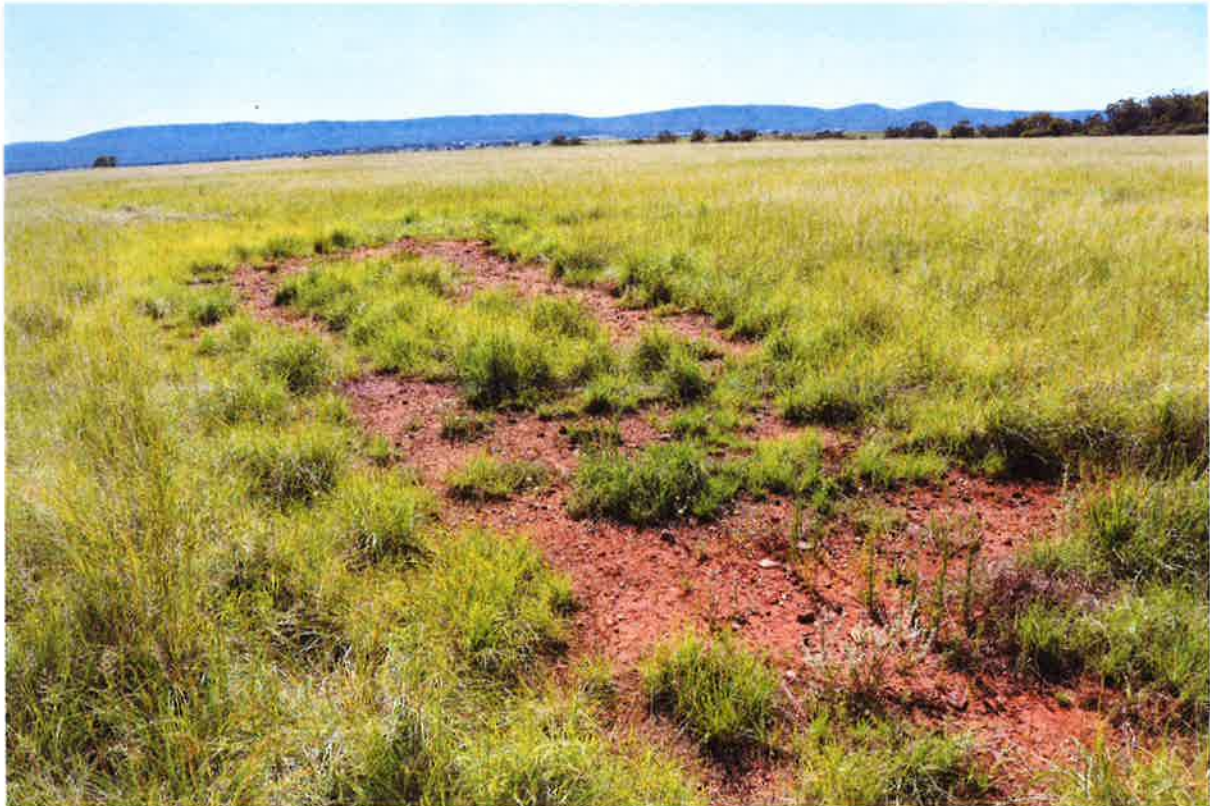
Photo 3: One of the “bare patches” on the WRE. There is evidence that lime treatment (2/t Ha) in April 2021 has assisted in shrinking these patches.

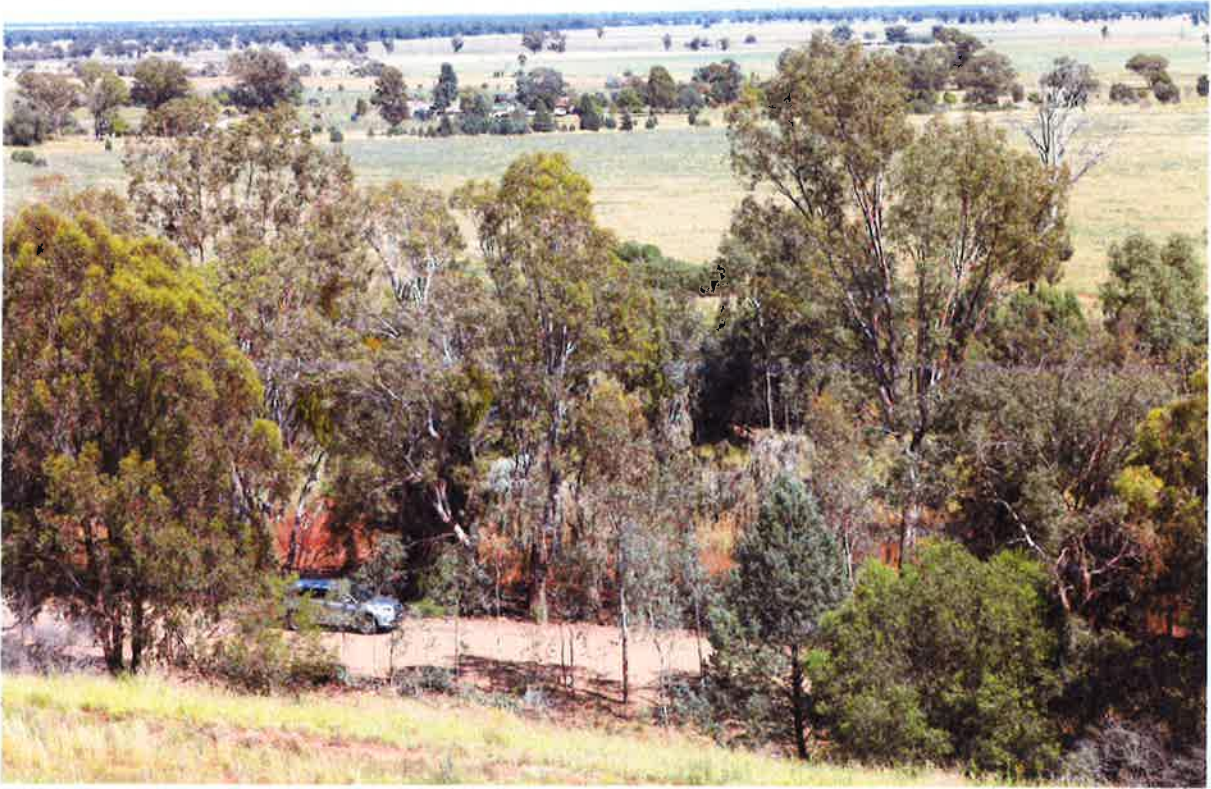
Photo 5: View of vegetation surrounding northwest sediment pond. This pond has never discharged water since construction in 1996.

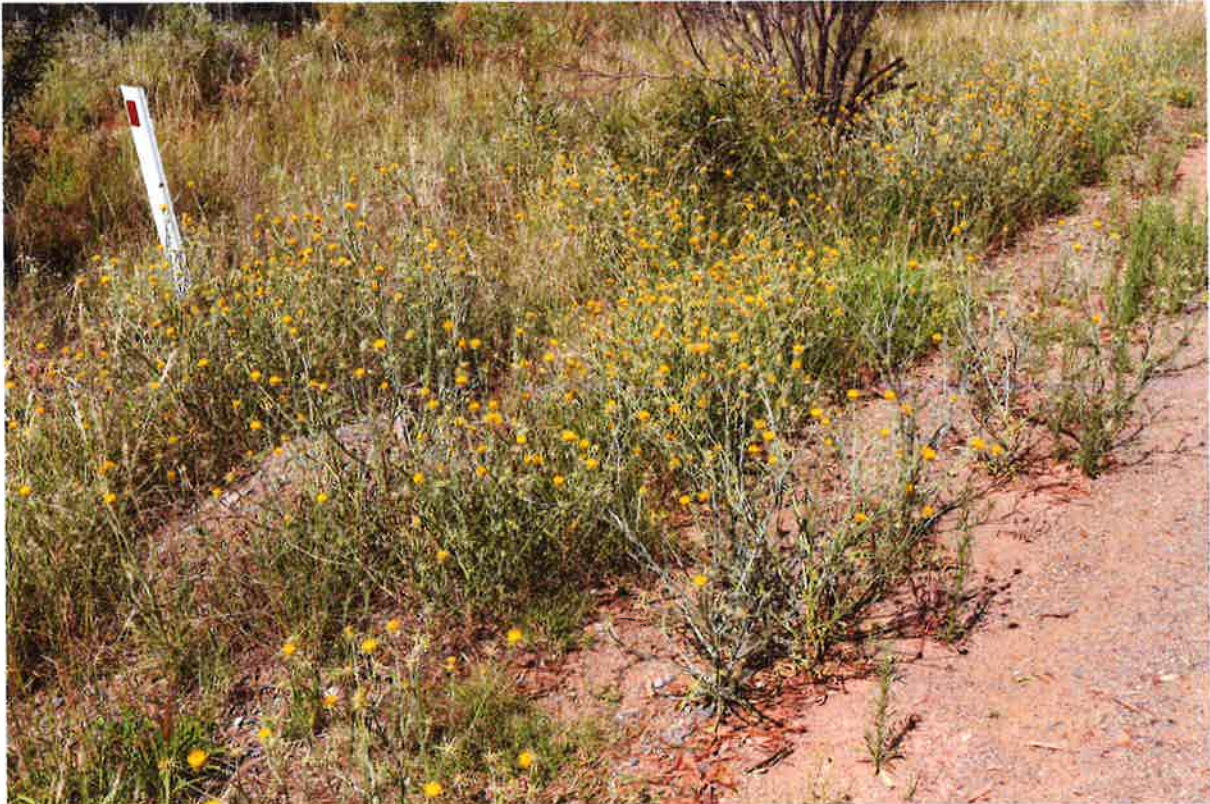
Photo 7: St, Barnaby's Thistle (**Centaurea solstitialis*) growing on the minesite entrance road. This weed species has been introduced to site by exploration vehicles returning from NMPP tenements. The infestation was removed by hand in January 2022.

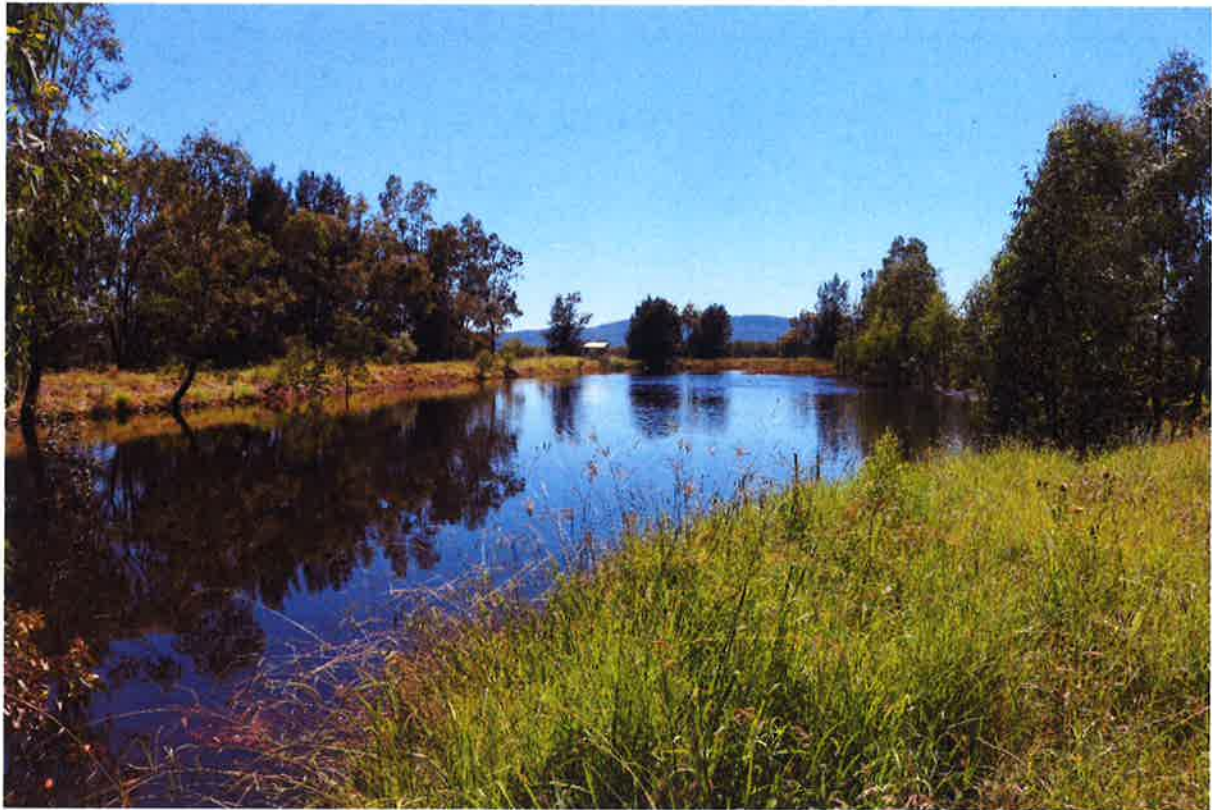
Photo 9: The northeast sediment pond did not discharge during 2021 despite 834mm of rainfall for the year.

The mine site rehabilitation performed as designed and no damage has been observed on any of the final landforms. The northeast sediment pond did not overflow during 2021 and thus there was no surface water monitoring conducted.

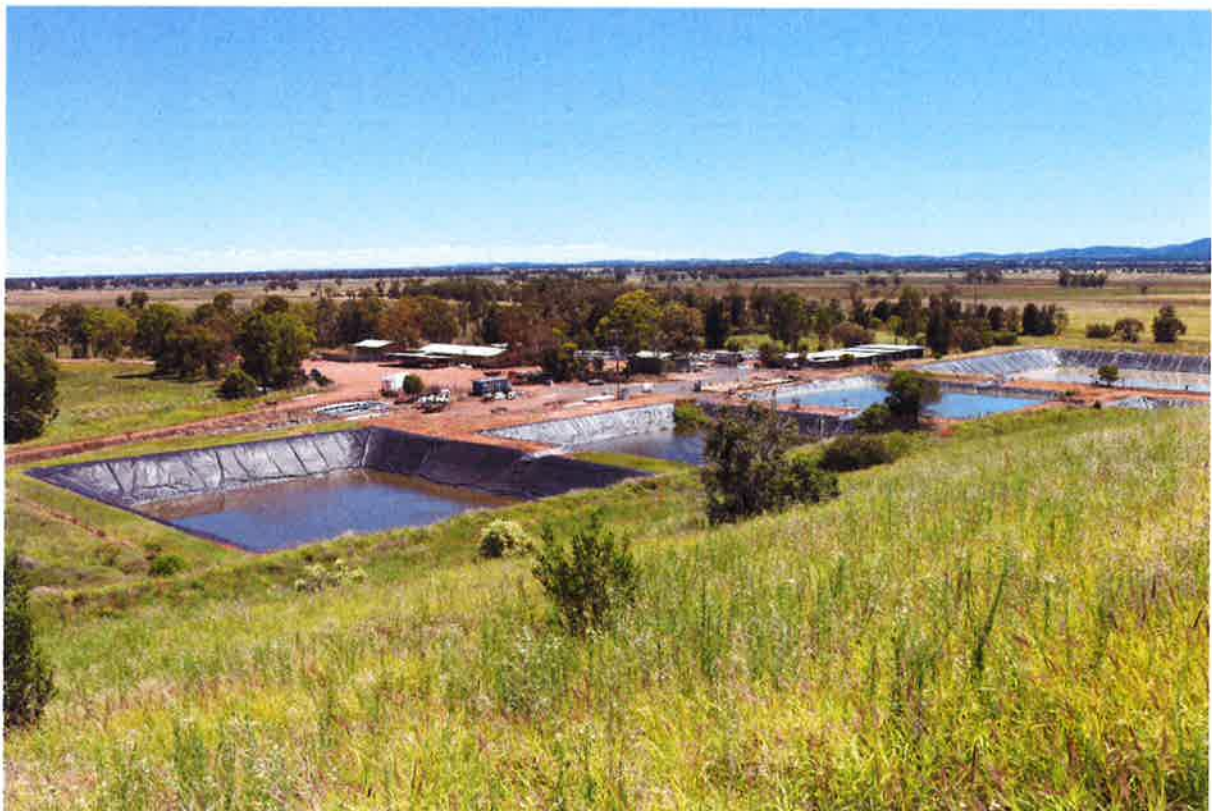
Photo 10: View of HDPE-lined ponds, core yard, office and house at Peak Hill Gold Mine.

Decommissioning the ponds (see photographs in Appendix 1) is a minor task when compared with the work that has preceded.

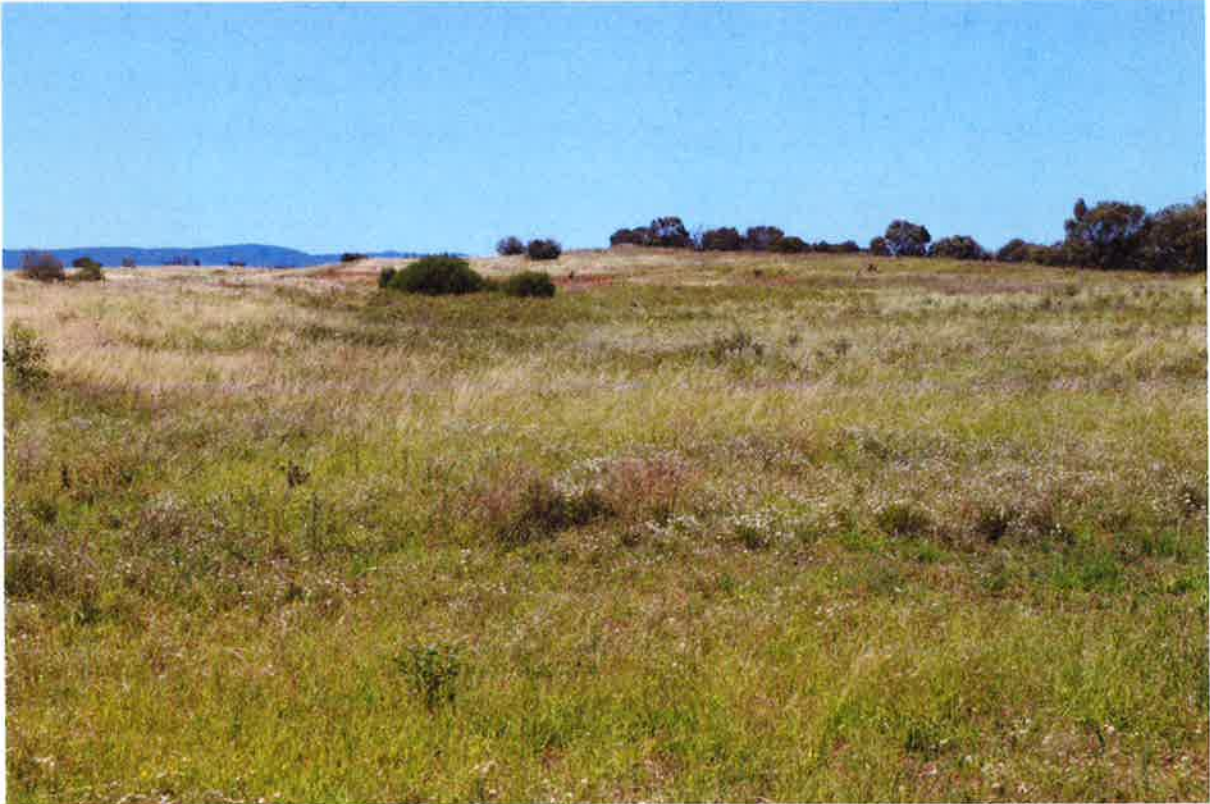
Photo 11: Excellent groundcover on top of the heap leach final landform looking south.

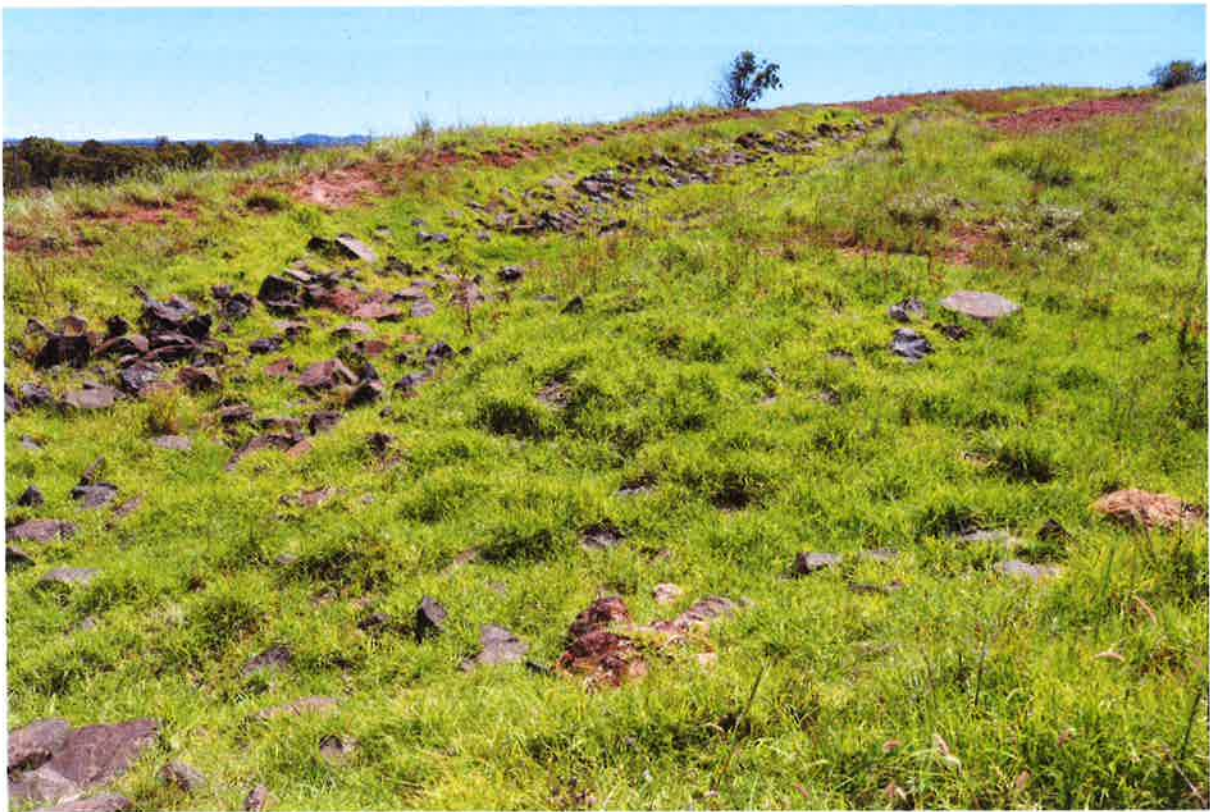
Photo 12: Rock-lined flume designed and built by Soil Con in 2005. Kikuyu grass thrives between basalt rock/blocks. This single flume sheds water from the heap leach landform.

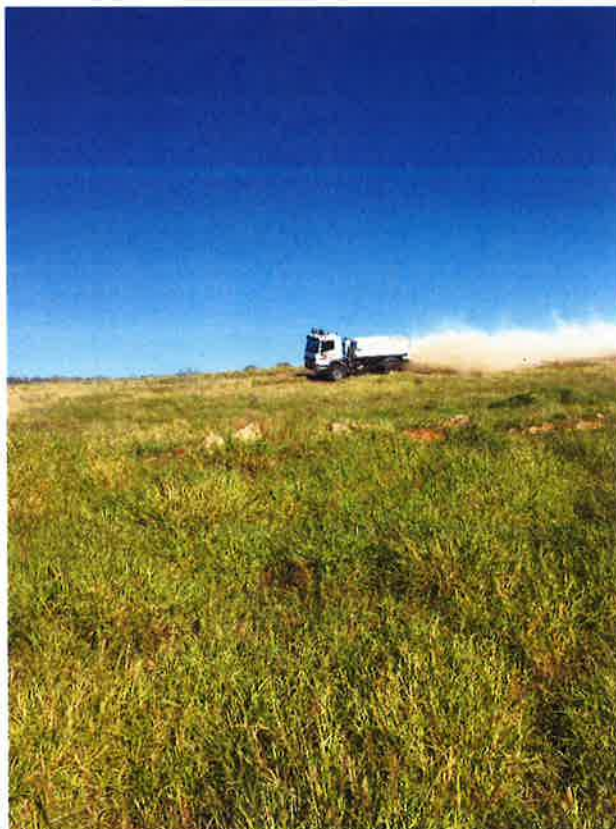
Photo 20: Agricultural lime being spread at a rate of 2t/Ha on the top of heap leach final landform in April 2021.
