2021 Annual Review

TOMINGLEY GOLD OPERATIONS
ENVIRONMENTAL PERFORMANCE

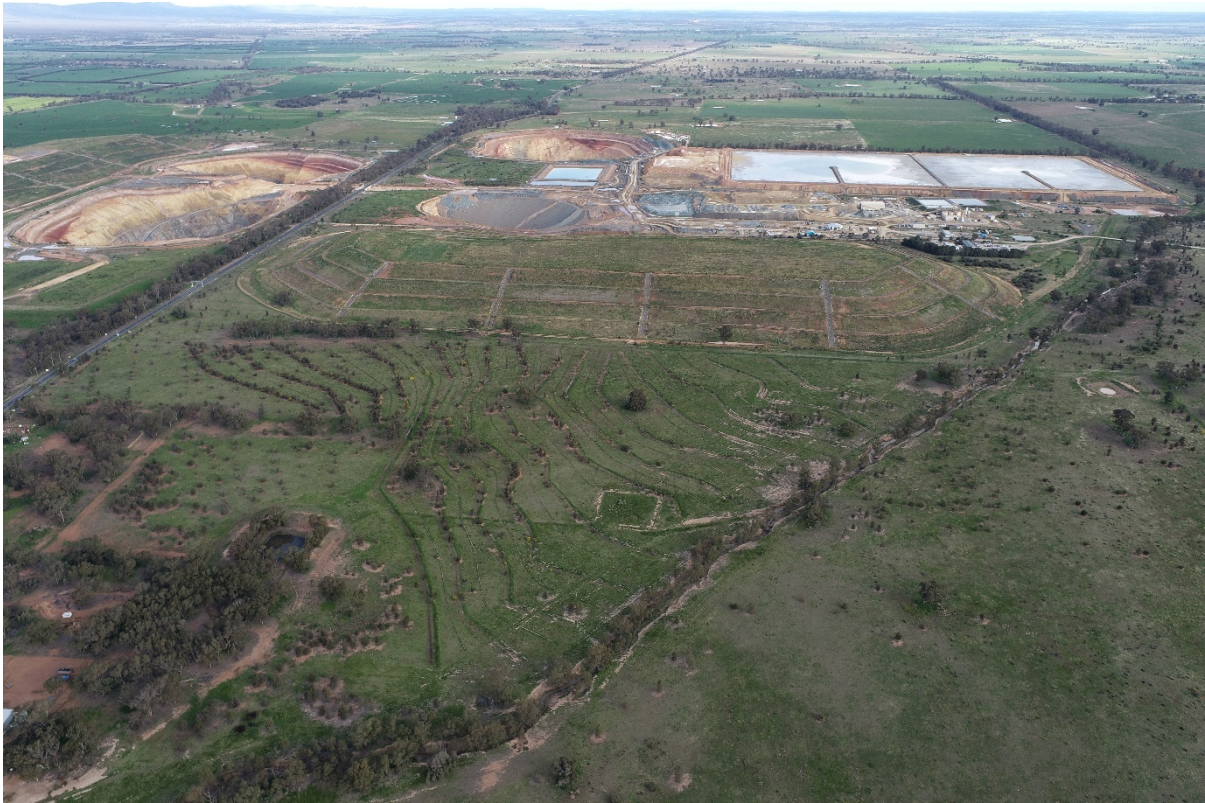
Plate 3: Vegetation establishment on WRE 2

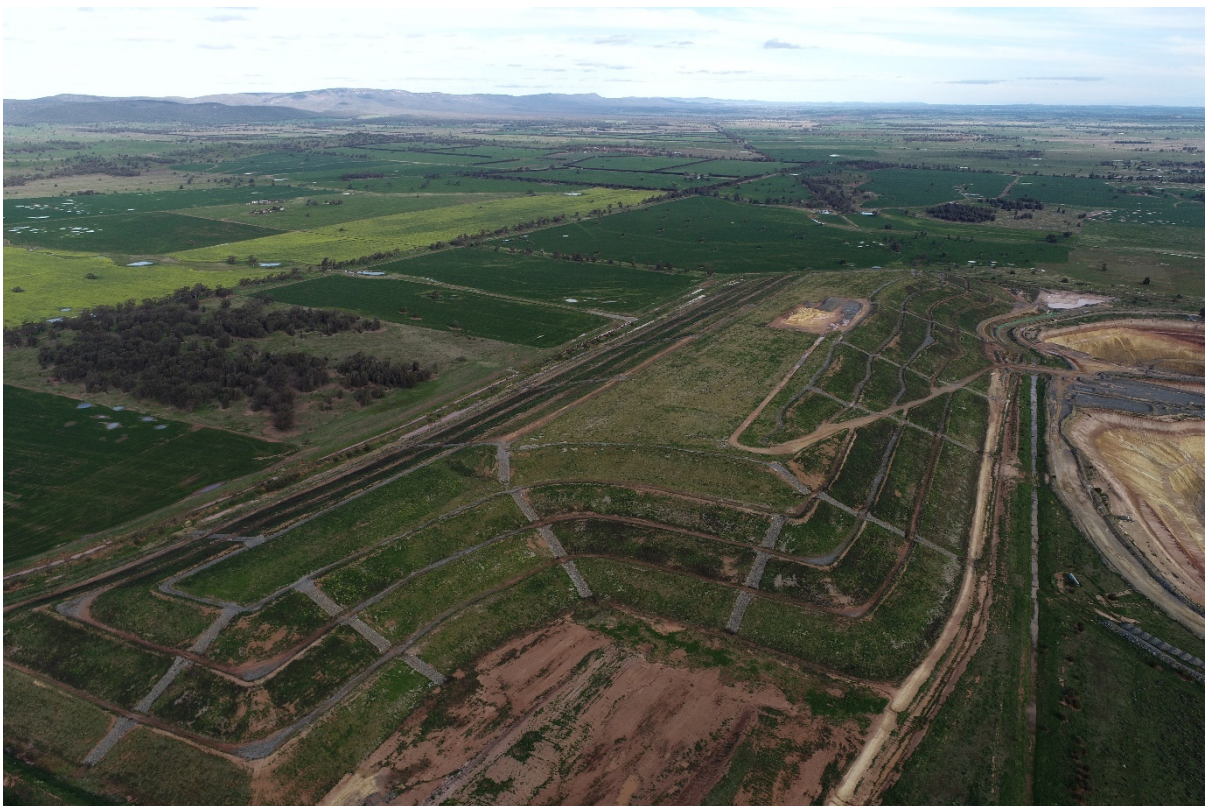
Plate 4: Vegetation establishment on WRE 3

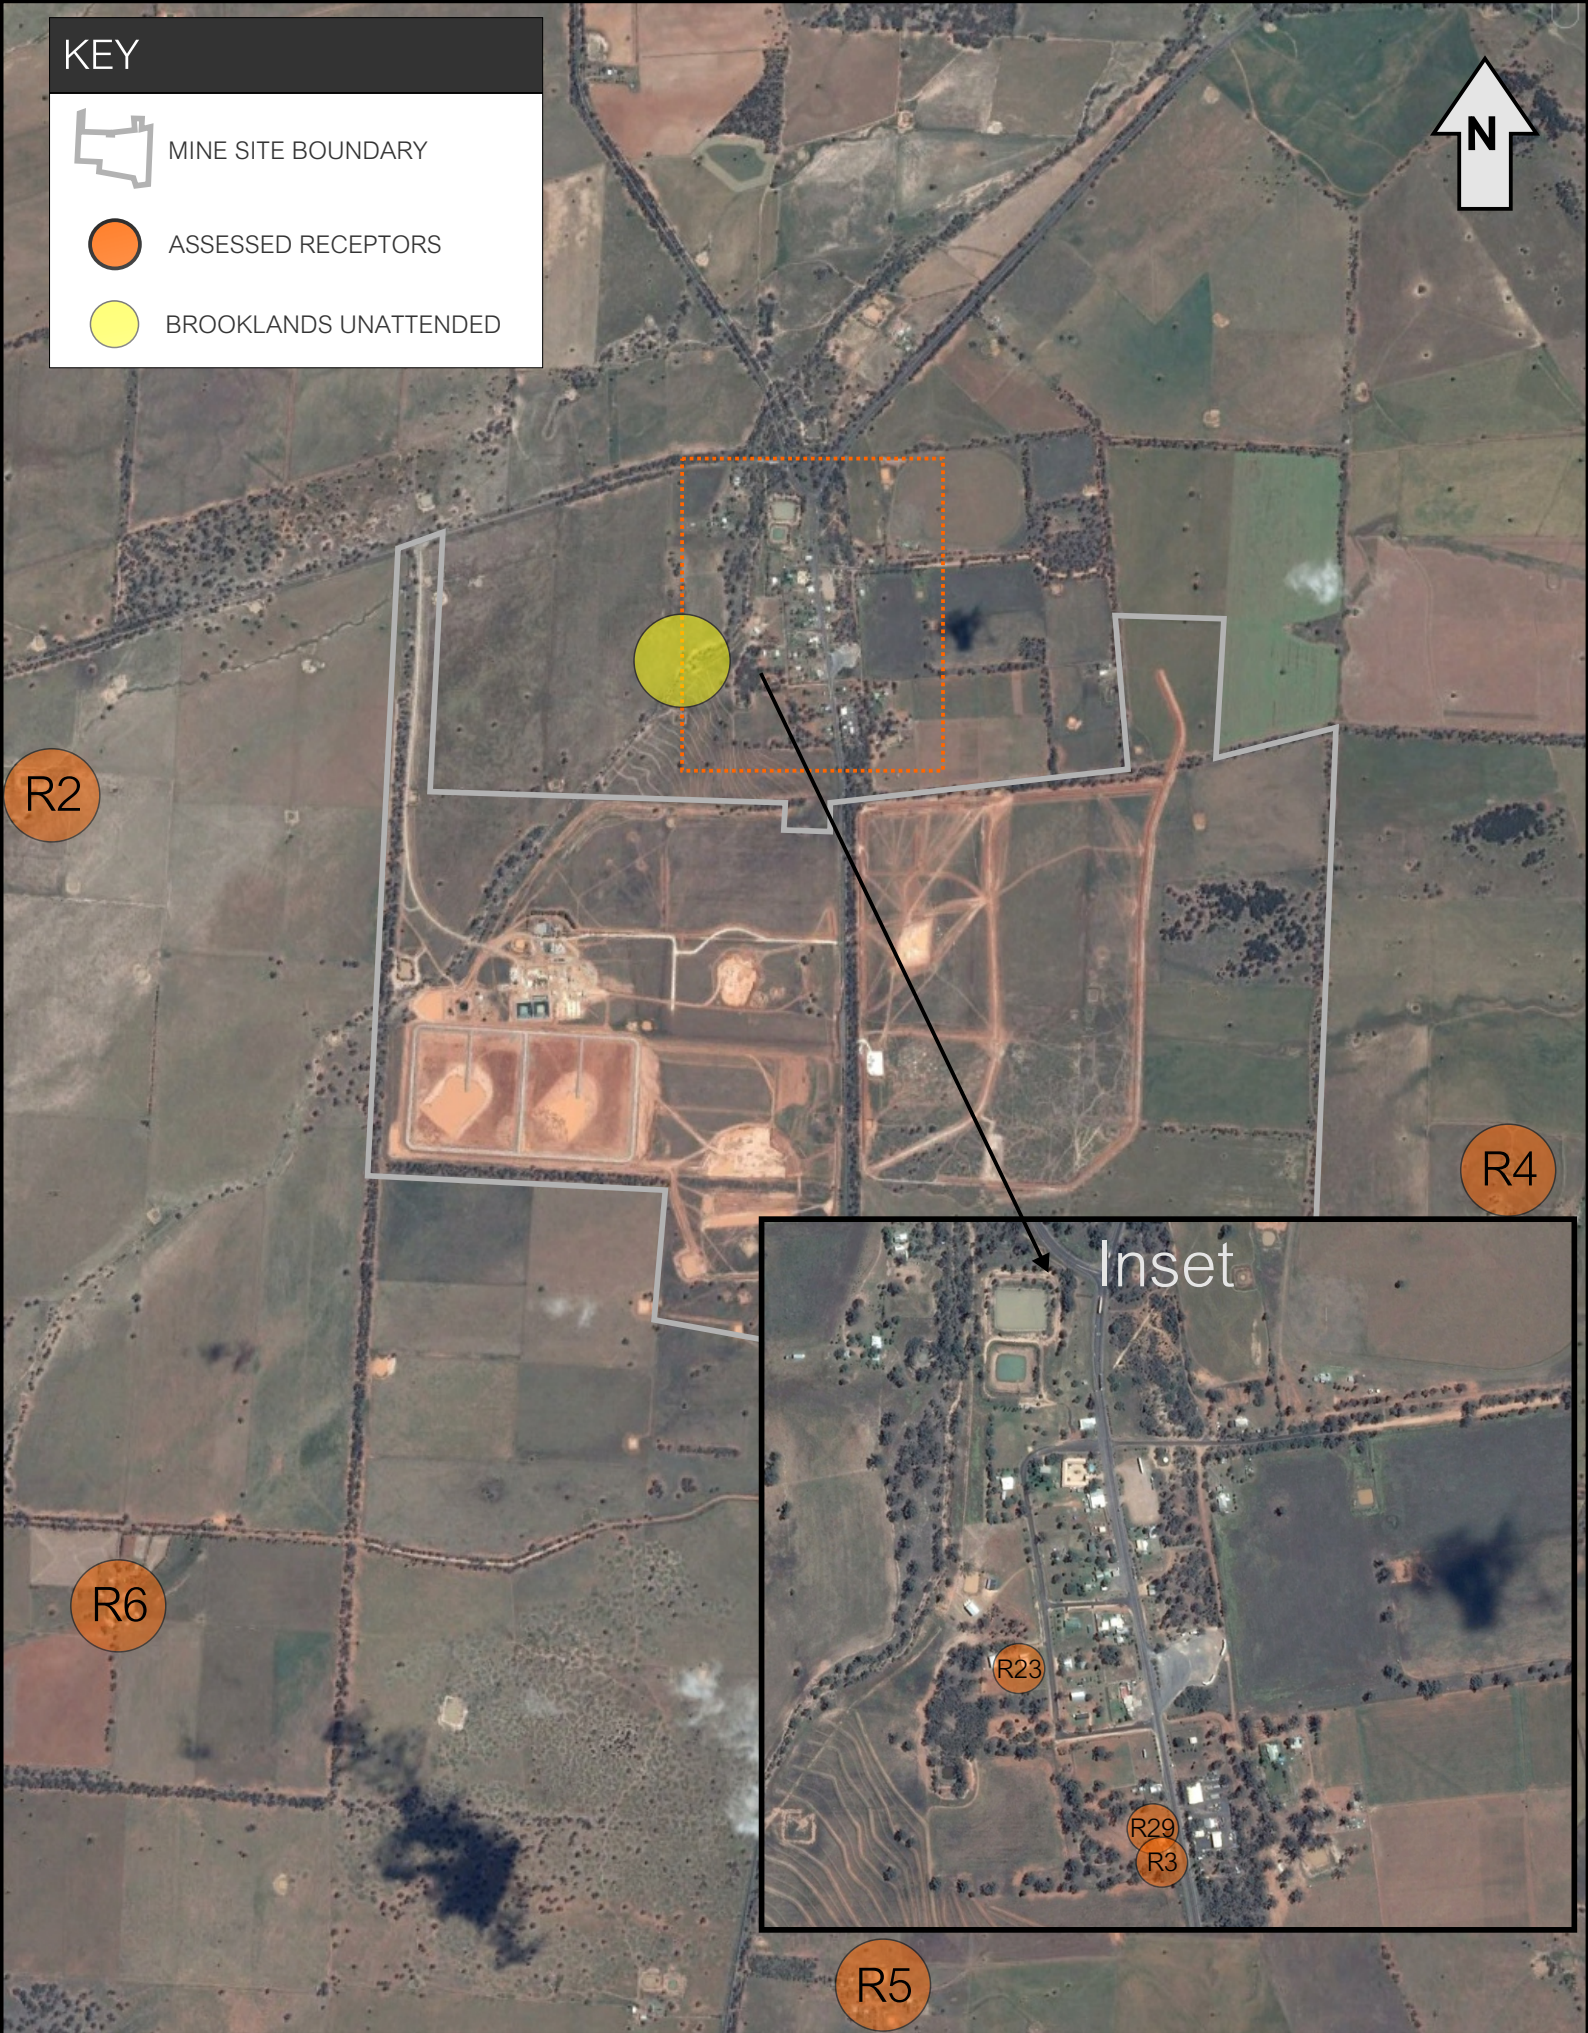
FIGURE 1 - LOCALITY PLAN AND ASSESSMENT LOCATIONS
TOMINGLEY GOLD MINE EPL NOISE MONITORING

The mine is located to the south of the village of Tomingley, NSW. Receivers in the locality surrounding the mine are primarily rural/residential and for consistency the naming convention for each receiver has been retained from historic noise assessments. The monitoring locations with respect to the mine are presented in the locality plan shown in **Figure 1**.

The validation compares monthly attended monitoring results against the closest assessed unattended monitoring location. Currently, TGO has one unattended real-time monitoring terminal installed at the Brooklands property (nearest to R23). **Figure 1** identifies the location of the monitor with respect to the attended monitoring locations. It is noted that the Brooklands unattended monitor is situated 600m west of the attended noise monitoring location R23, therefore, background (LA90) noise levels are significantly lower due to offset distance to highway traffic.

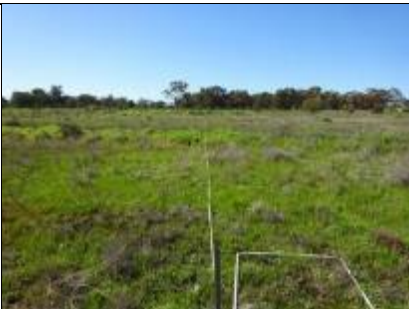
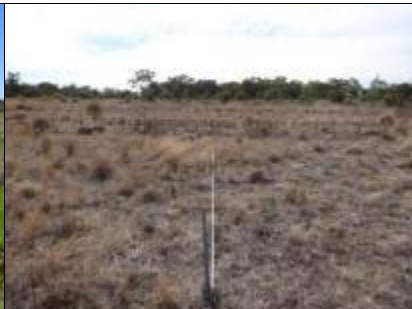
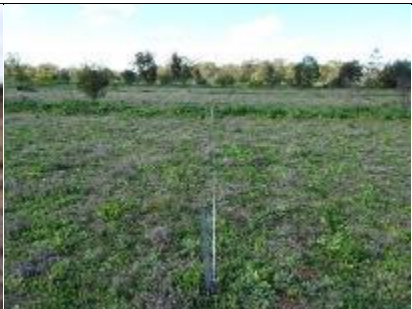
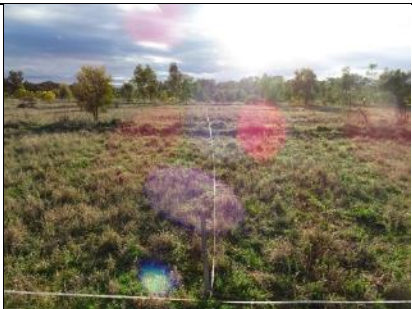
<div data-bbox="96 885 264 941" style="border: 1px solid black; padding: 2px;">Reveg 1</div>

2014 Photo	2016 Photo	2018 Photo	2020 Photo	2021 Photo
<p>Reveg 1: <i>LFA transect = Vegetation transect.</i> This site was situated in an old cropping paddock north of the ML. It had been contour scalped and seeded in 2013 with the intention to re-establish Inland Grey Box woodland EEC.</p>

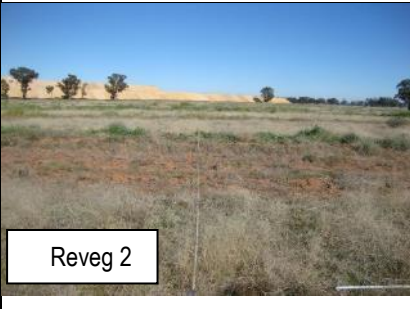
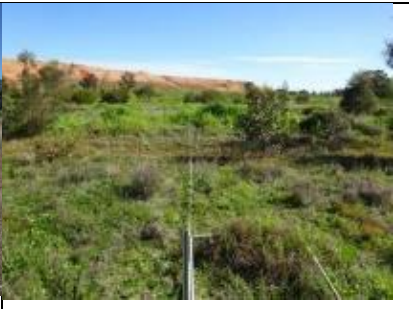
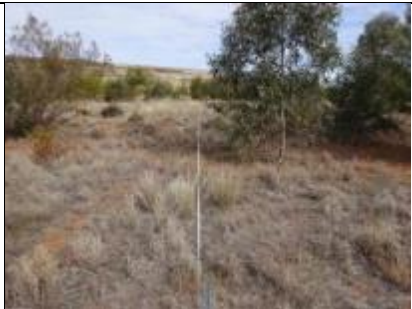
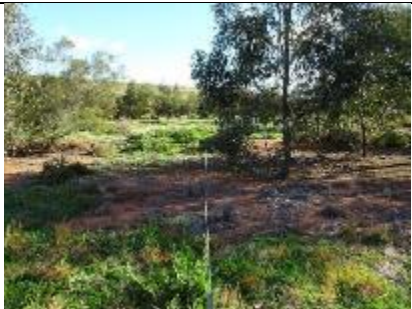
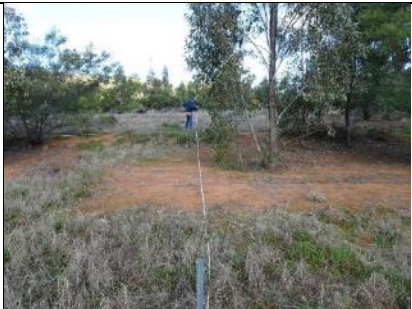
<div data-bbox="96 1268 264 1324" style="border: 1px solid black; padding: 2px;">Reveg 2</div>

<p>Reveg 2: <i>LFA transect = Vegetation transect.</i> This site was situated in an old cropping paddock north of the ML. It had been contour scalped and seeded in 2013 with the intention to re-establish Fuzzy Box woodland EEC.</p>

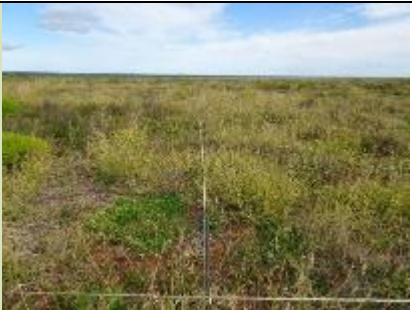
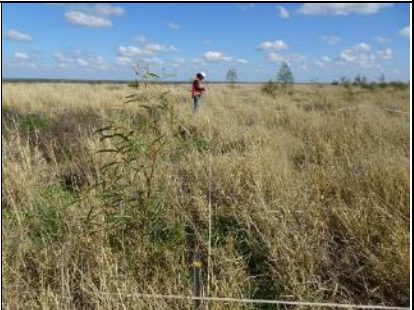
WRE2-2 (Rehabilitation site): This site was rehabilitated in February 2019. It was rehabilitated using 200mm of topsoil, 10t/ha gypsum and hydro-mulched and seeded with a pasture and native tree and shrub mix (see MOP).

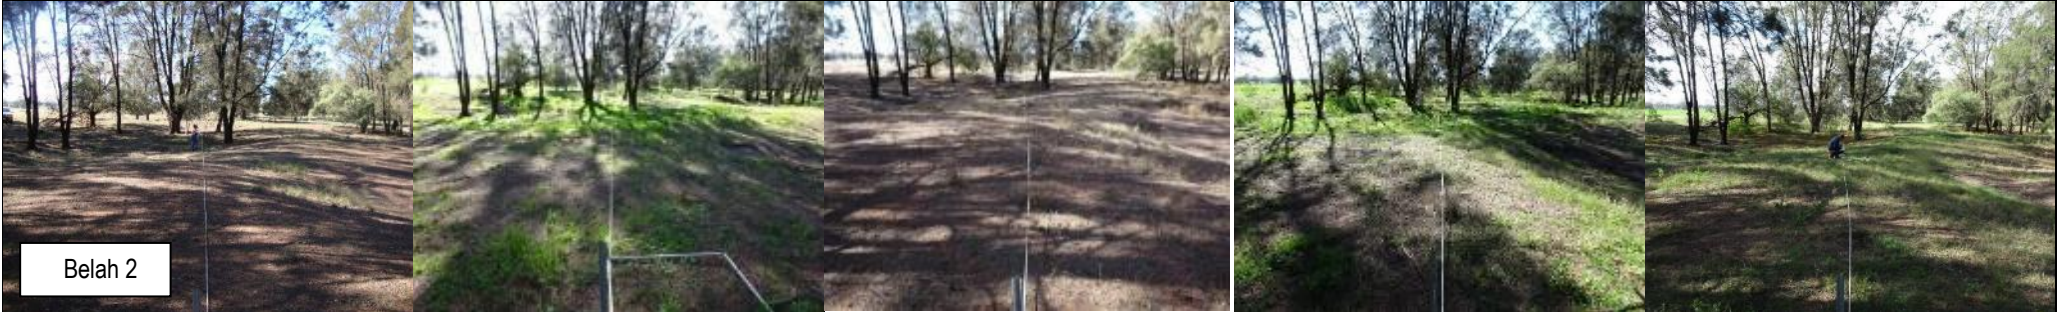
Belah 2: *LFA transect = Vegetation transect.* This site was situated within the larger remnant east of WRE 3 in the eastern half of the ML on an area of gilgais and has subsequently not been cultivated. It was degraded regrowth woodland with some old growth trees and was dominated by *Casuarina cristata* (Belah).

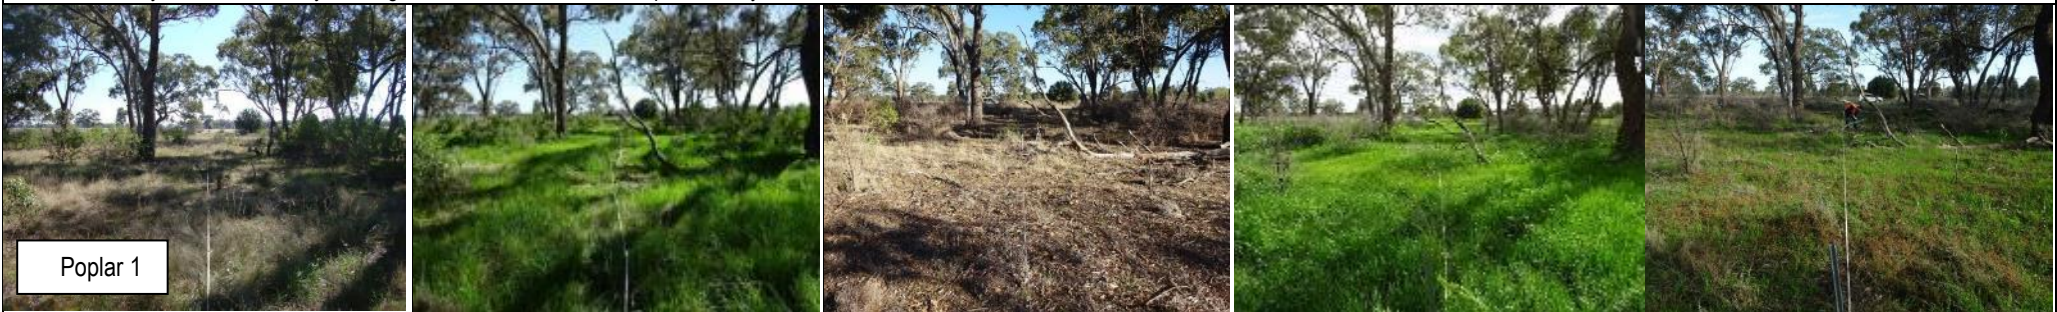
Poplar 1: *LFA transect = Vegetation transect.* This site was situated at the northern end of Gundong Creek. It was open grassy woodland dominated by *E. populnea* with scattered occurrences of *E. conica* and *Myoporum montanum*. The understorey was dominated by native grasses and had a well-developed litter layer.

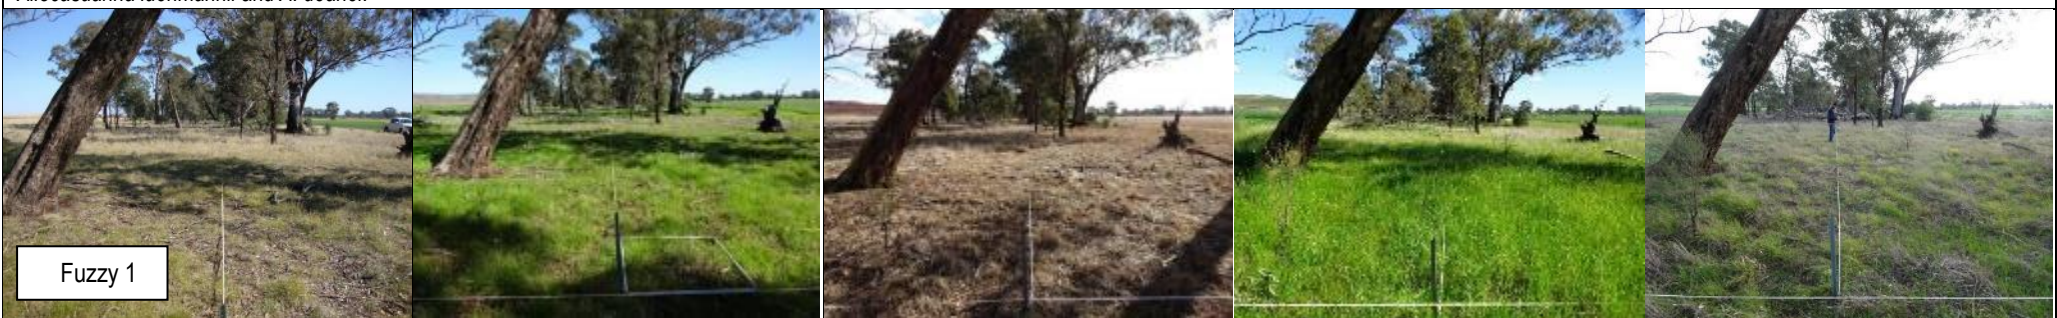
Fuzzy 1 (Reference site): This site was situated east of the ML within a remnant woodland on the northern laneway. It was open woodland dominated by *E. microcarpa* with scattered *E. conica* (Fuzzy Box), *Geijera parviflora*, *Allocasuarina lehmannii* and *A. deanei*.

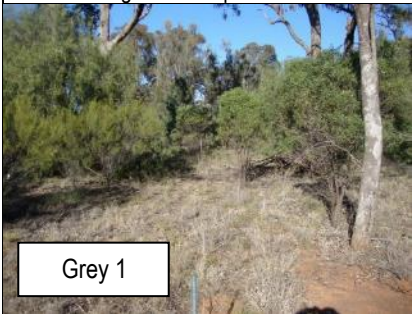
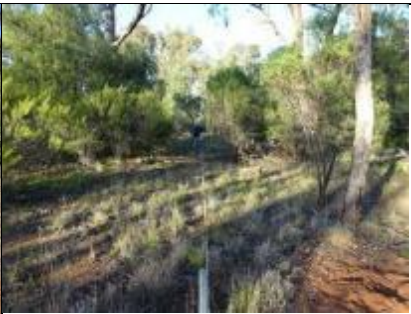
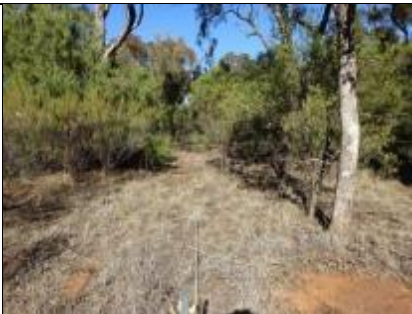
<div data-bbox="114 619 259 671" style="border: 1px solid black; padding: 2px; width: fit-content;">Grey 1</div>

2014 Photo	2016 Photo	2018 Photo	2020 Photo	2021 Photo
<p>Grey 1 (Reference site): Situated on the eastern side of the Newell highway roadside corridor. Shrubby woodland dominated by <i>E. microcarpa</i> (Grey Box) and <i>E. populnea</i> (Poplar Box) scattered individuals of <i>Casuarina glaucophylla</i> (White Cypress Pine), <i>Allocasuarina luehmannii</i> (Bulloak), <i>Brachychiton populneus</i> (Kurrajong) and <i>Geijera parviflora</i> (Wilga) sub dominants. The site contained some large old regrowth trees but was predominantly comprised of scattered regrowth and patches of shrubs.</p>

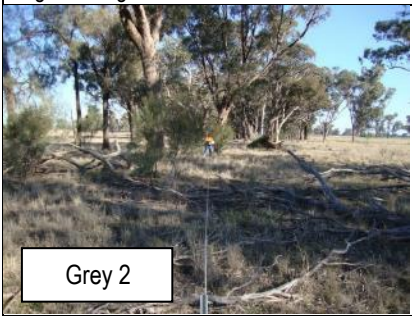
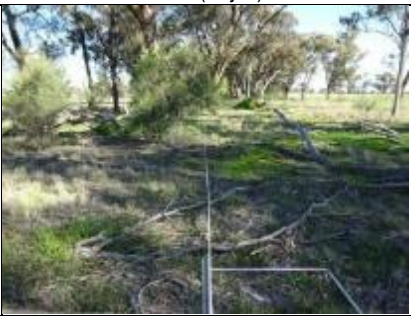
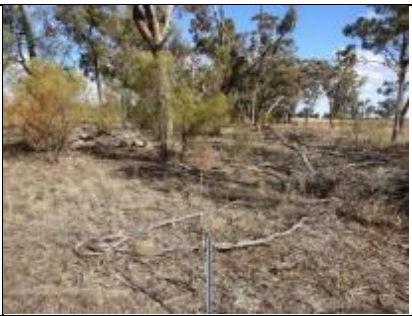
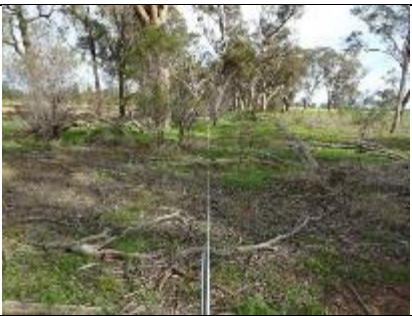
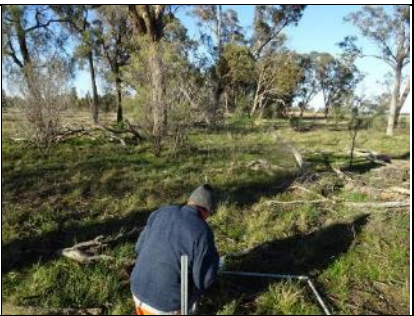
<div data-bbox="114 997 259 1050" style="border: 1px solid black; padding: 2px; width: fit-content;">Grey 2</div>

NA	NA
<p>Grey 2 (Reference site): Situated along the mine access road along the western boundary. Open grassy woodland dominated by <i>E. microcarpa</i> with several mature <i>Allocasuarina luehmannii</i> and scattered <i>A. deanei</i> (Deane's Wattle), regenerating <i>Allocasuarina luehmannii</i> and an individual <i>A. oswaldii</i> (Miljee).</p>

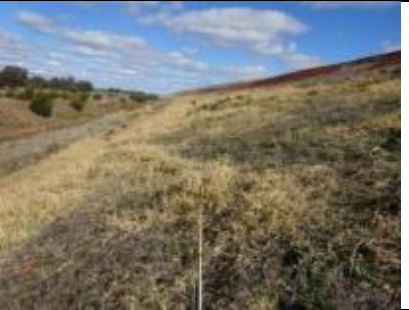
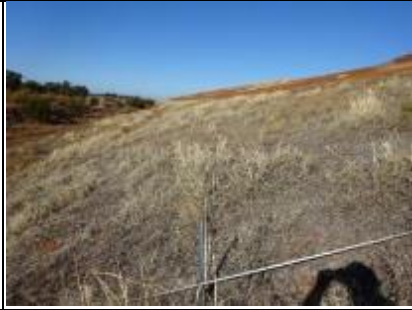
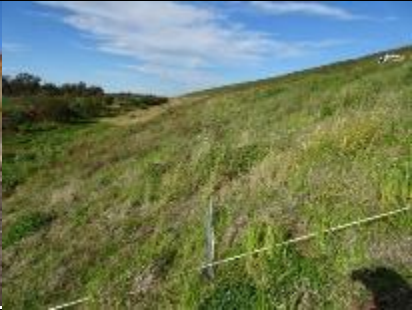
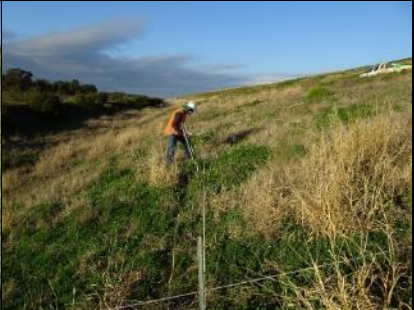
2016 Photo	2017 Photo	2018 Photo	2020 Photo	2021 Photo
<p>WRE3-1 (Rehabilitation site): This site was rehabilitated in February 2017. It was rehabilitated using 200mm of topsoil over rock, 10t/ha gypsum and seeded with a pasture mix (see MOP). Straw mulch was hydro-mulched over the entire area.</p>				
<p>N/A</p> <p>WRE3-1</p>

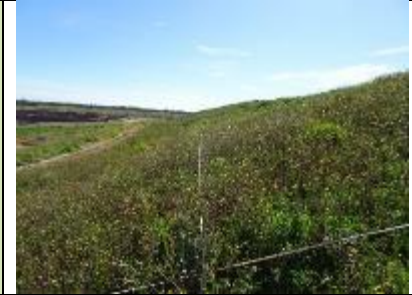
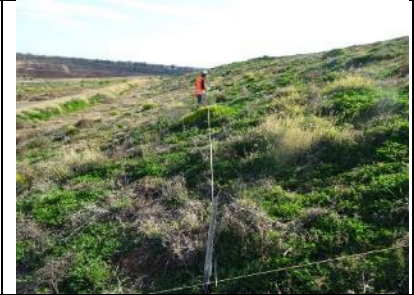
<p>WRE3-2 (Rehabilitation site): This site was rehabilitated in February 2019. It was rehabilitated using 200mm of topsoil over rock, 10t/ha gypsum and seeded with a pasture mix (see MOP). Straw mulch was hydro-mulched over the entire area.</p>				
<p>WRE3-2</p>	<p>NA</p>	<p>NA</p>

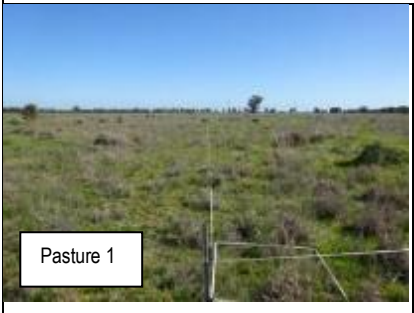
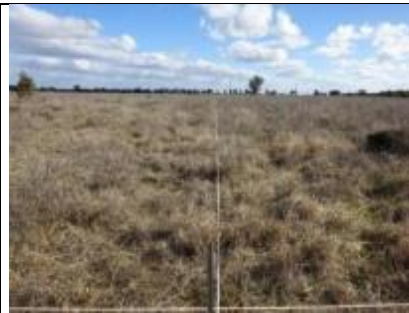
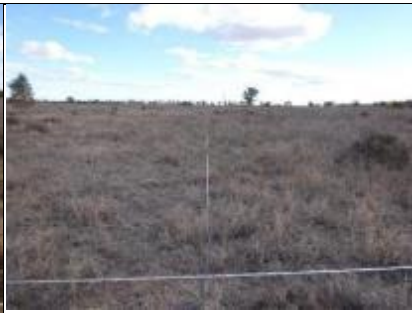
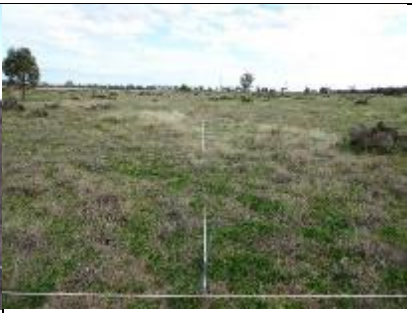
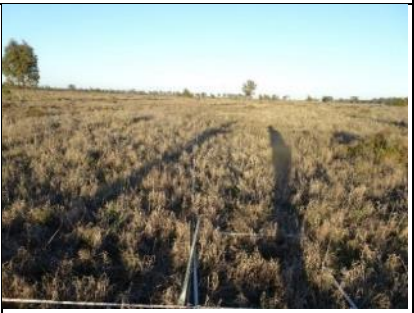
<p>Pasture 1 (Reference site): This was an area of pasture recovering after a long cropping history.</p>				
<p>Pasture 1</p>

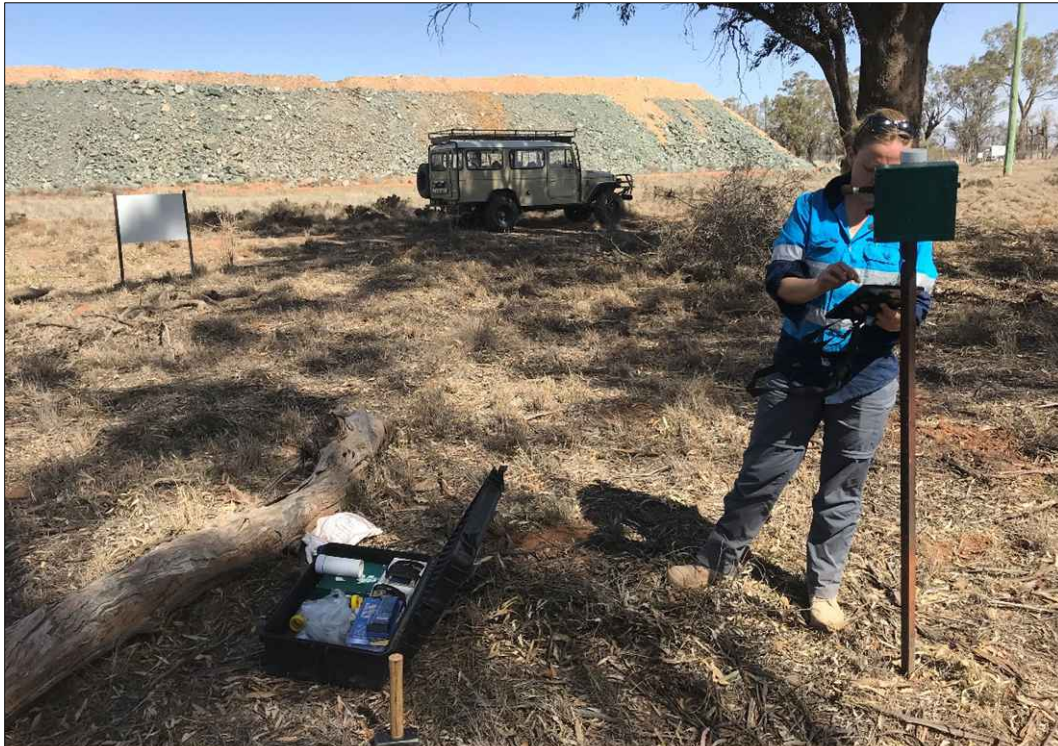
Plate 2-1: Installing bat monitoring equipment at TGO

Two ultrasonic bat call recorders were used to monitor bat activity at TGO (See Figure 2-1):

- In the Biodiversity Offset Strategy Vegetation Community 1, *Inland Grey box, Poplar Box, White Cypress Pine all woodland on red loams* (Figure 1-3), near the TGO residue storage facility (RSF) (Plate 2-1)
- In the Biodiversity Offset Strategy Vegetation Community 5, *Belah / Black Oak, Western Rosewood, Wilga Woodland* (Commonly known as the 'Belah block').

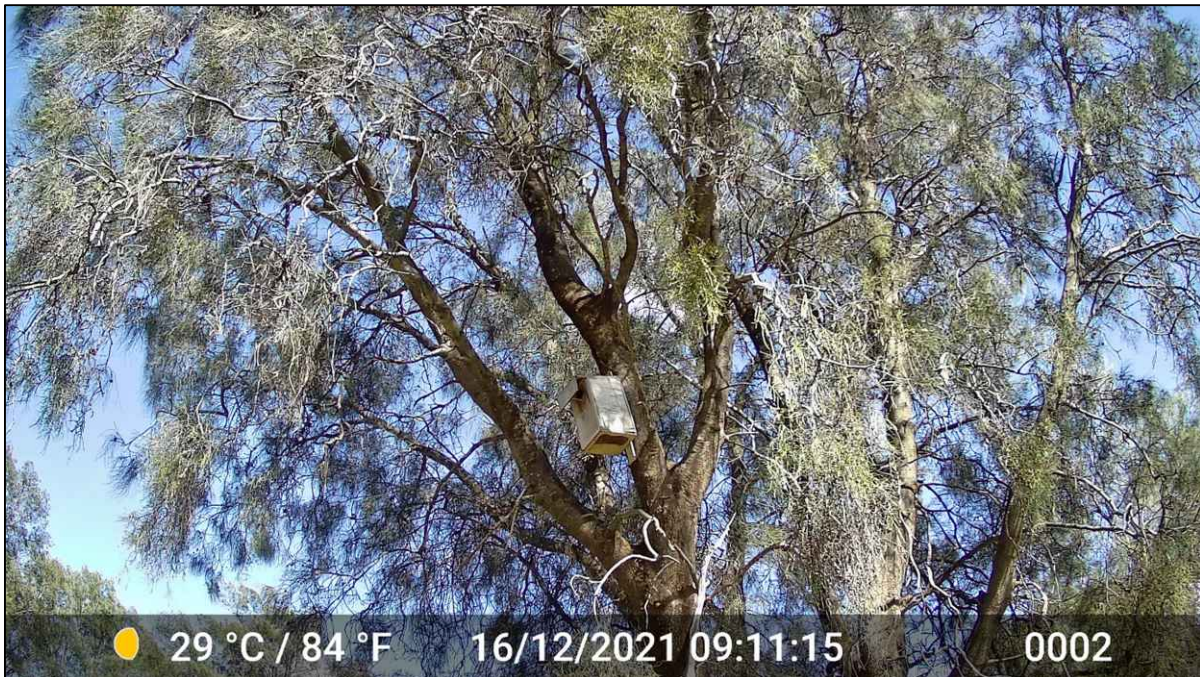
Plate 2-2: Artificial hollow observed via camera trap

A camera trap was also used over three nights to record nocturnal fauna activity and other incidental animals in the 'Belah block' observing an artificial hollow installed by TGO (Plate 2-2).

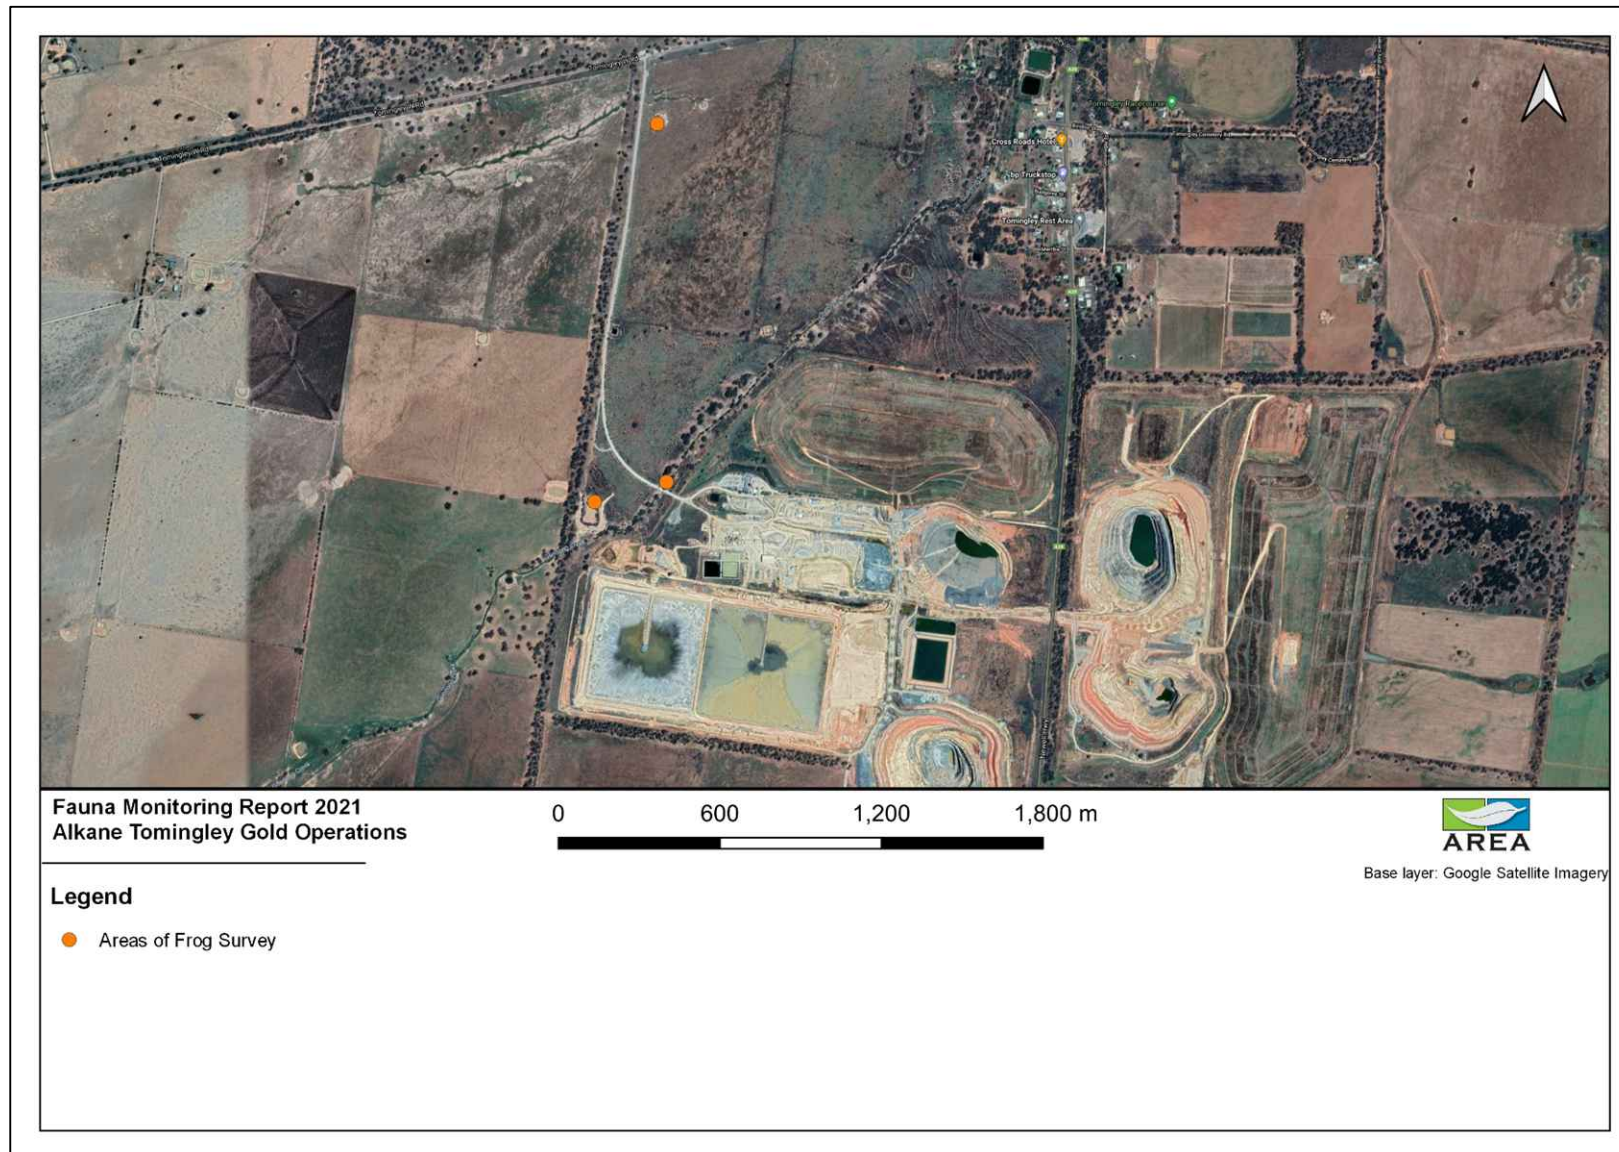
Figure 2-3: Frog monitoring locations

A frog survey was conducted after dusk at three areas within the TGO property see Figure 2-3. The frog survey was conducted in areas where there was a high abundance of aquatic habitat both with an ephemeral water source at Gundong creek or a more constant water source at two dams in close proximity to TGO. The dam to the north and the dam to the west of the TGO mine site were both full of water, and reeds creating optimum frog habitat.

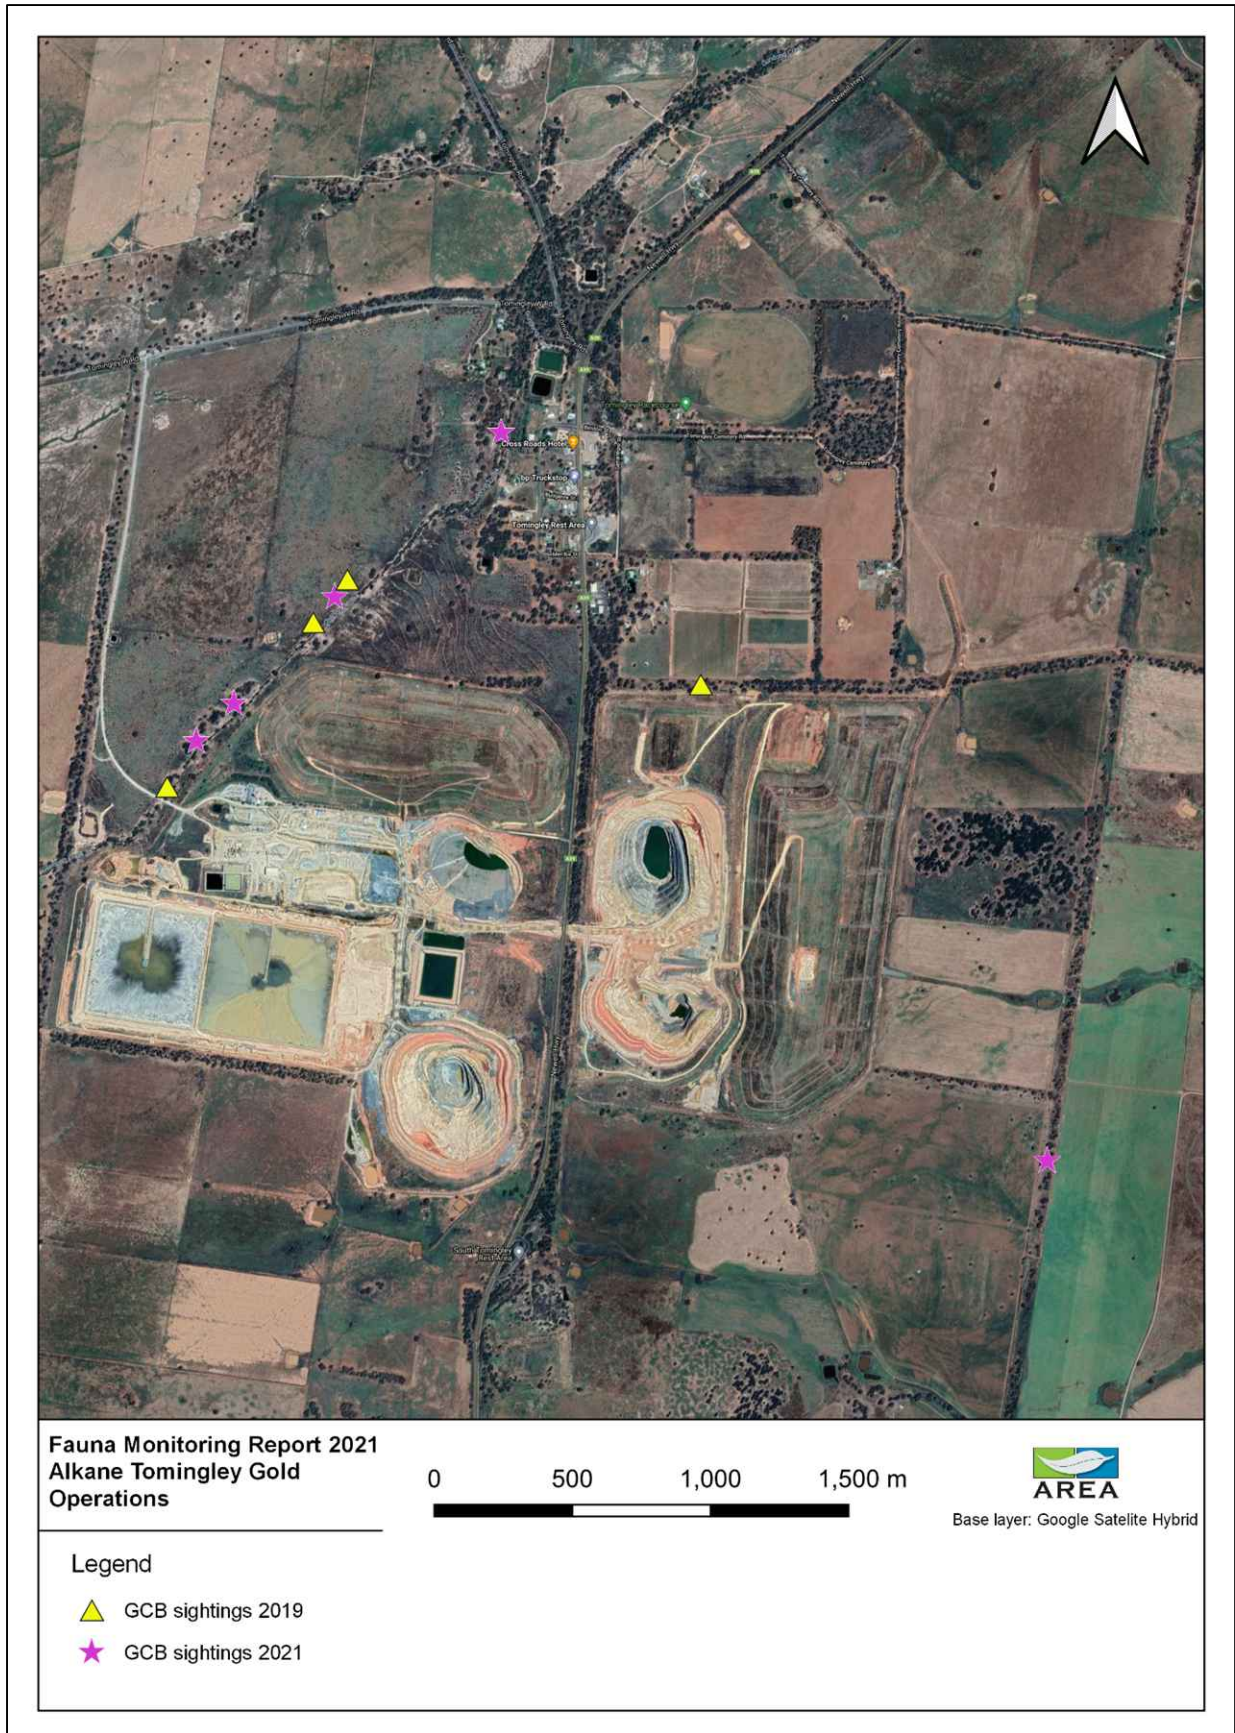
Figure 3-2: Comparison of GCB sightings in 2019 and 2021

GCB survey results for 2021 are shown in Figure 3-1. A comparison of GCB sightings recorded in 2019 and 2021 are shown in Figure 3-2.
