2022 Annual Review

TOMINGLEY GOLD OPERATIONS
ENVIRONMENTAL PERFORMANCE

Table 1: Annual Review Title Block

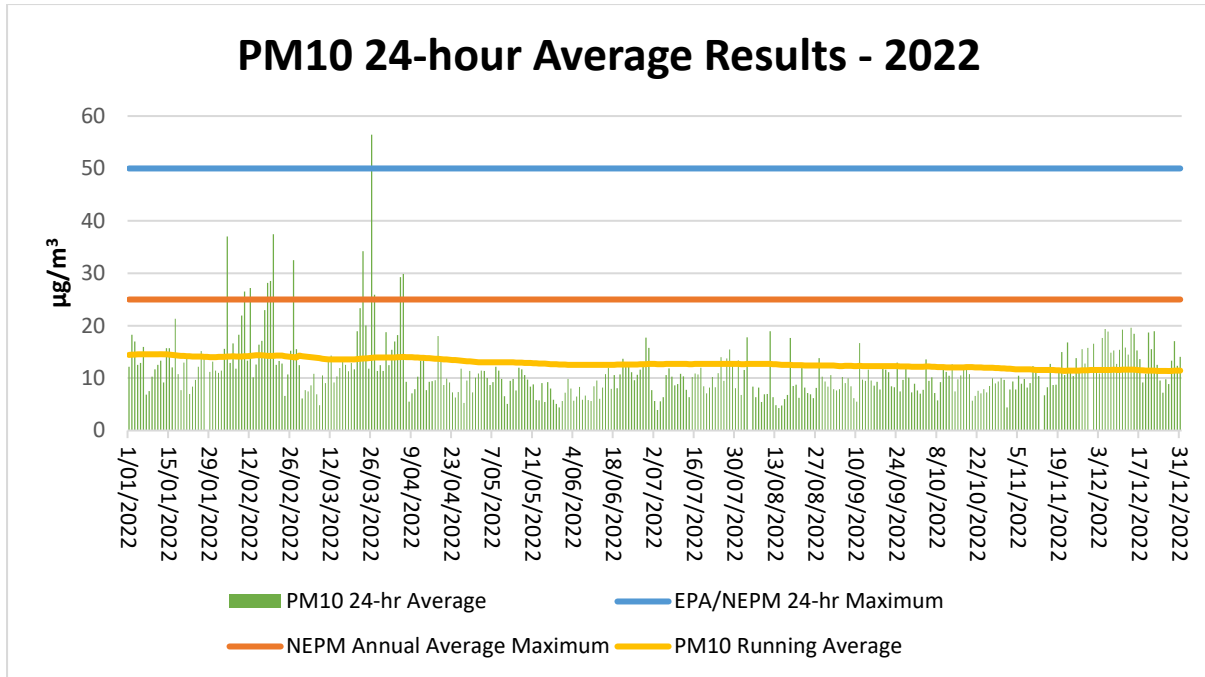
Figure 2 – PM10 RTA1 TEOM 24hr Results Jan-Dec 2022

During the reporting period, 1 result measured at the RTA1 TEOM exceeded the PM₁₀ 24 hour average criteria of 50 ug/m³ (as stipulated in Schedule 3 Condition 17). On the 26th March, PM10 emissions were recorded at 56.5 ug/m³. A review of this event was conducted at the time, and the reasons found were noted with the monthly environmental reports that are produced.

The review found that at the time of the incident, winds were predominately of a northerly and north easterly direction (indicating an approach from Tomingley town relative to the monitor).

Wind speeds were consistent with the previous several days which recorded much lower PM₁₀ values, as such, it is unlikely that the wind speeds were a cause of the exceedance. At the same time, a series of earthworks was being undertaken in town, with two service stations under construction in addition to several residents conducting their own property maintenance.

It is believed that dust created in town as a result of these activities has been blown south towards site, resulting in the exceedance. While technically in breach of the licence condition, it is not considered relevant as it has been caused by factors unrelated to TGOs operation.

PM₁₀ results for January to December 2022 are shown in

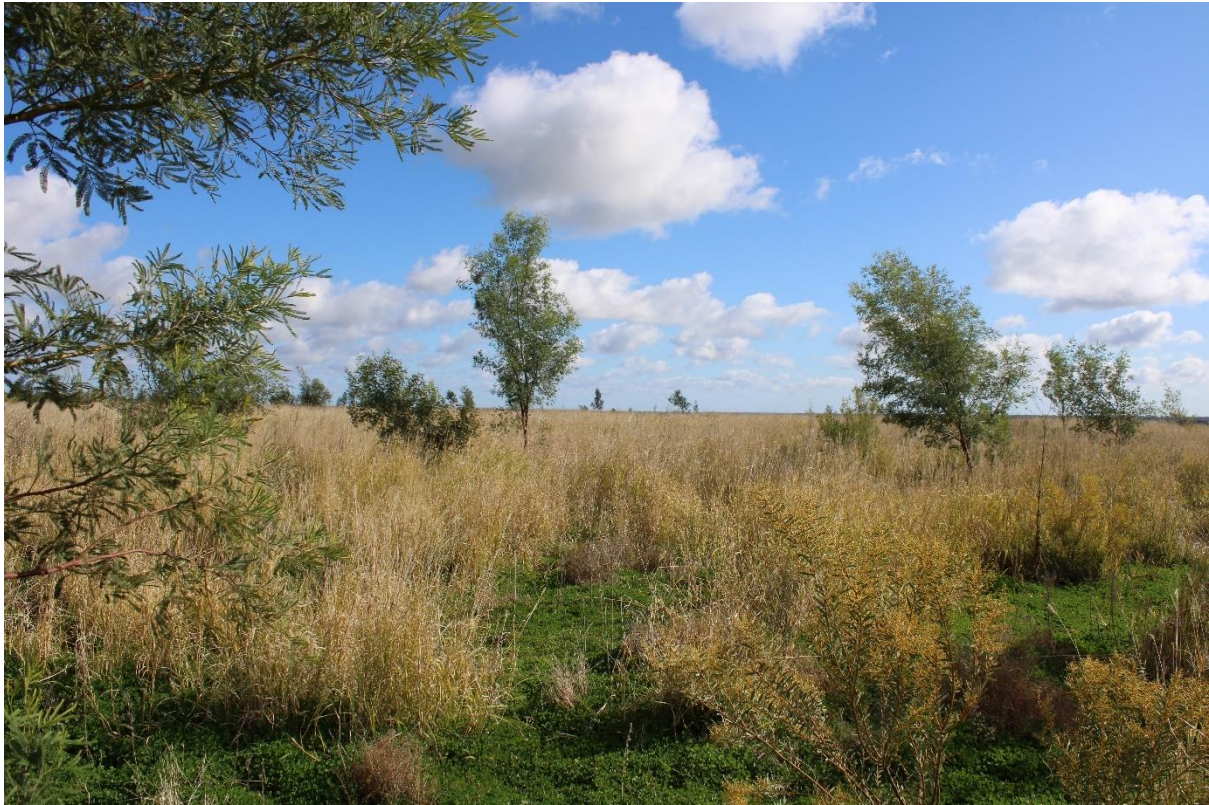
Plate 1: Vegetation establishment on WRE 2
