ALKANE
RESOURCES LTD

Rehabilitation Management Plan

Peak Hill Gold Mine

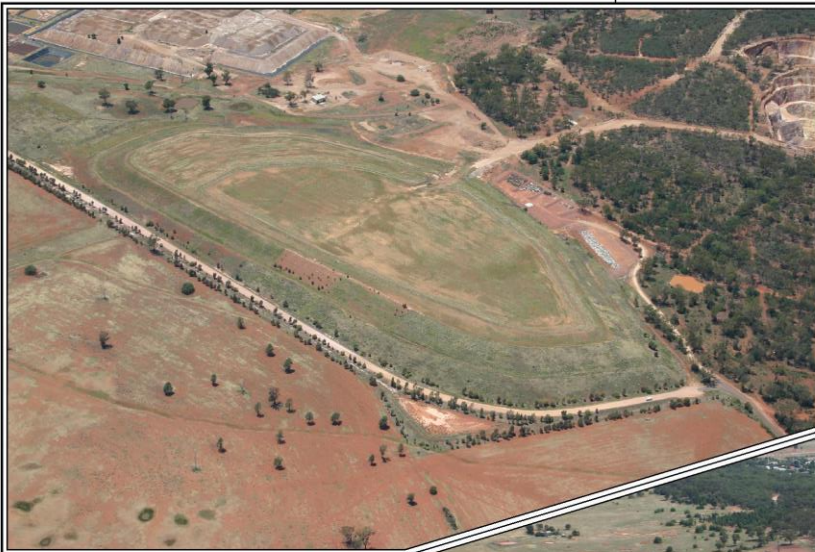
Plate 1: Rehabilitated Waste Rock Emplacement
(Ref: RW Corkery, 9 January 2005)

Plate 1 shows the rehabilitated Waste Rock Emplacement during January 2005 prior to the cessation of processing operations.

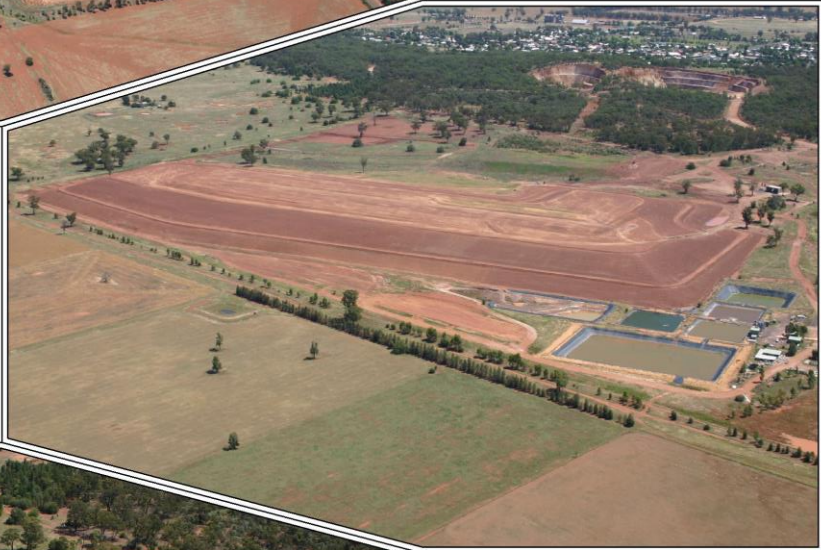
Plate 2: Heap Leach Landform Top
Soiled and Seeded.
(Ref: RW Corkery, 4 December 2005)

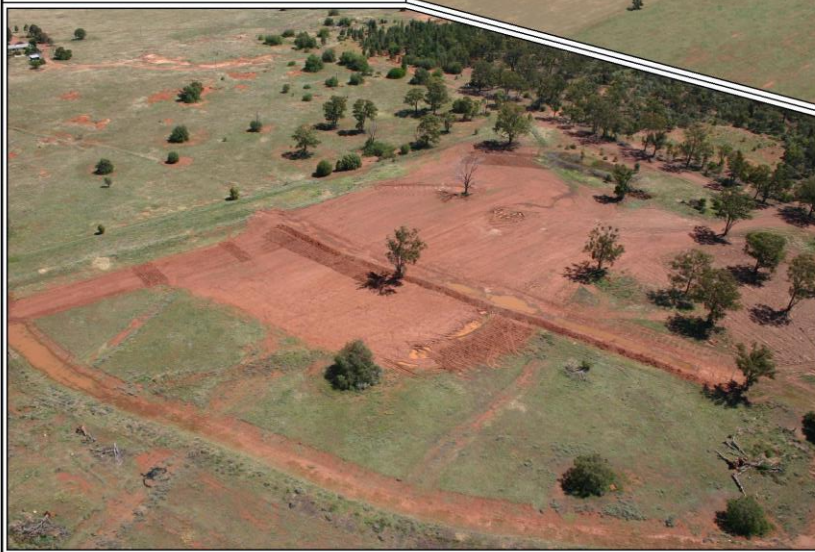
Plate 3: Top Soil Stockpile Area
Recontoured.
(Ref: 4 Dec 2005)

Plate 3 photo taken 4 December 2005 shows the rehabilitation of the topsoil stockpile area located to the south of the ROM Pad, including internal access roads located in the vicinity, during the Landform Development and Growth Medium Development phases of rehabilitation. Note the surface treatment being applied to the rehabilitated areas. The construction of contour bank to replace the original bank located in this area prior to the Mine can be seen in the mid-ground. The rehabilitated topsoil stockpile area can be seen behind a row of remnant vegetation and within the woodland area at the rear of the image. The Magazine area was within the Ecosystem and Land Use Establishment phase of rehabilitation at the image. The progressive and current state of rehabilitation across the Mine Site can be seen in the Annual Environmental Management Reports on the website: www.alkane.com.au/projects/tomingley-gold-project/peak-hill/environmental-reports/

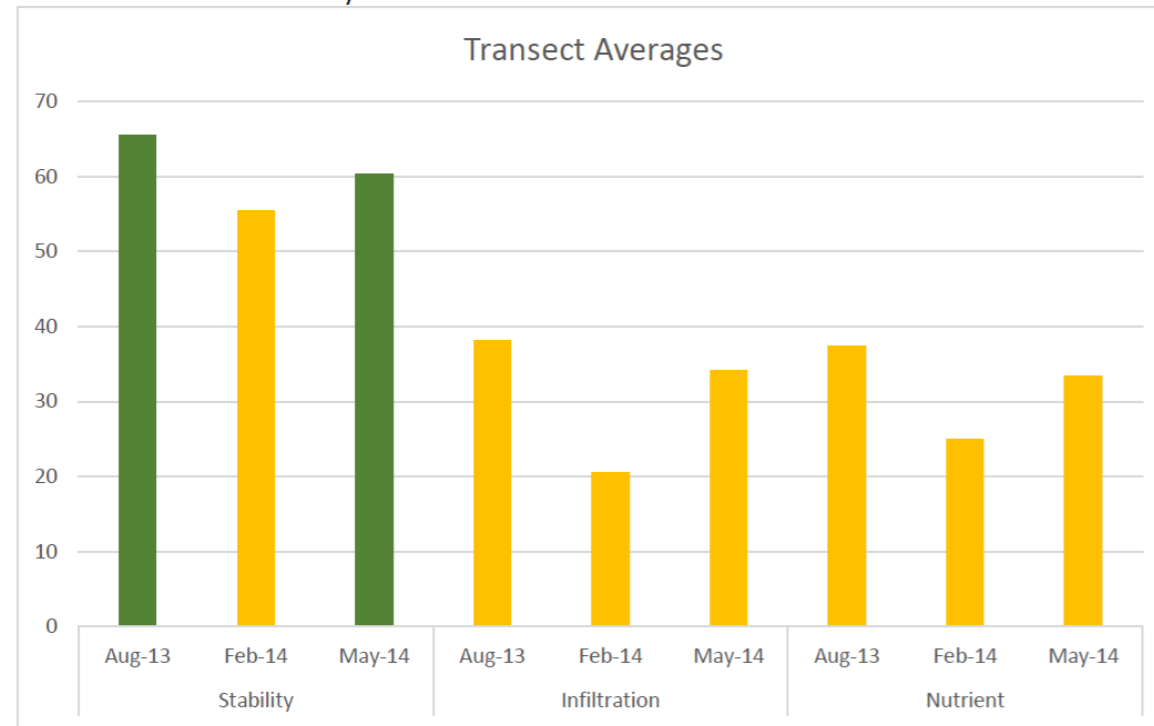
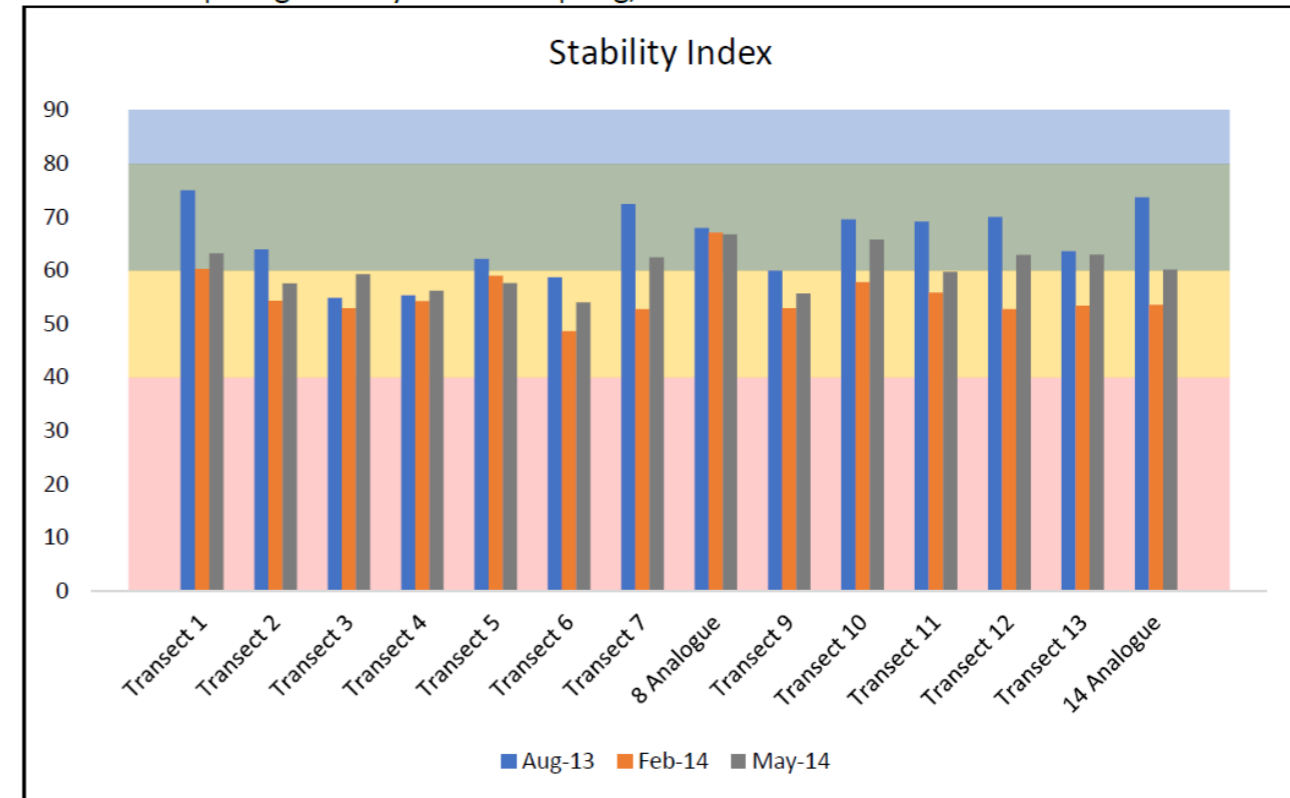
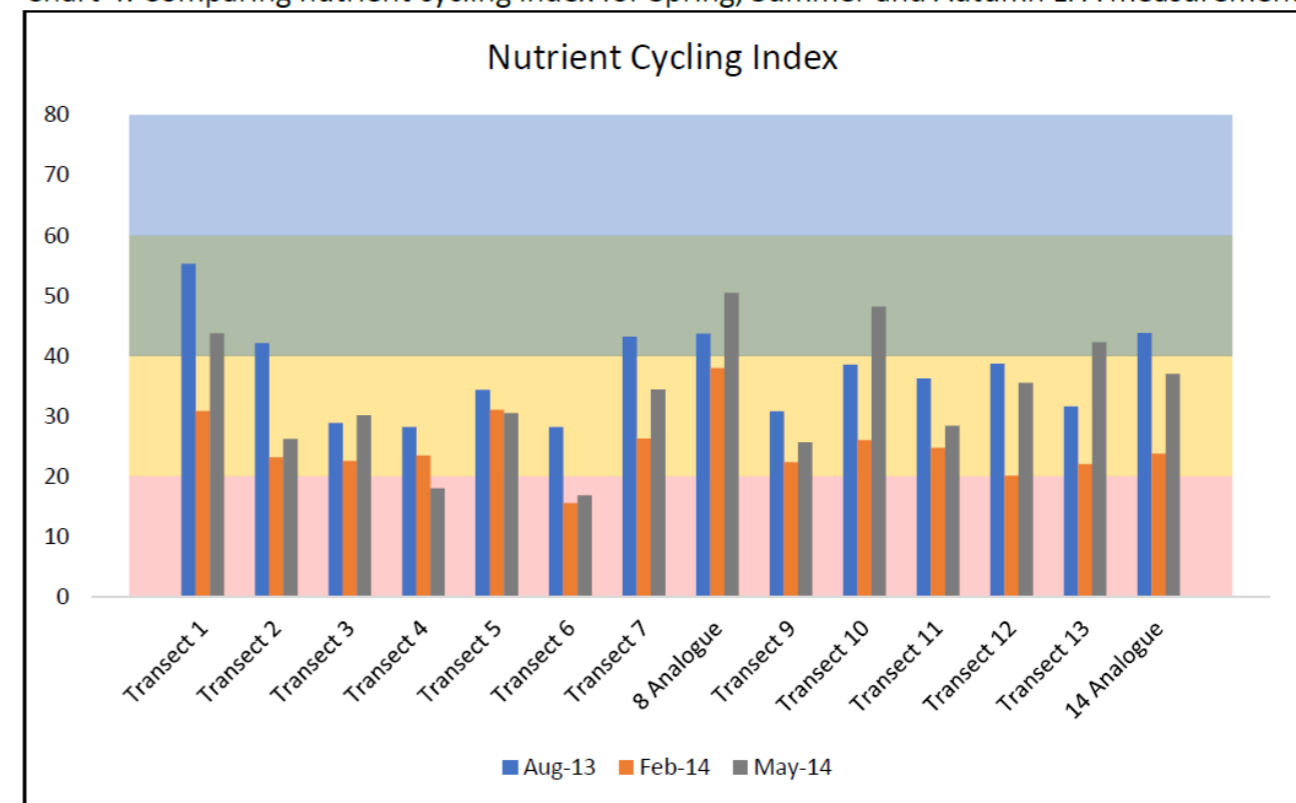
FIGURE 9
LFA RESULTS SUMMARY

Chart 1: Comparing average indices measurements for all transects for: Stability, Infiltration and Nutrient Cycling. Measurements conducted August 2013, February and May 2014. Green represents Good and Gold Satisfactory results.

Chart 2: Comparing stability index for Spring, Summer and Autumn LFA measurements

Chart 3: Comparing infiltration index for Spring, Summer and Autumn LFA measurements

Chart 4: Comparing nutrient cycling index for Spring, Summer and Autumn LFA measurements

Figure 9 presents the summary of the most recent LFA monitoring results. In summary, all locations show typical responses to seasonal variations and all locations were recorded as performing either Good or Satisfactory for Stability, Infiltration and Nutrient Cycling.
