# Tomingley Gold Project Rehabilitation Management Plan

State Significant Development  
MP 09\_0155

**R.W. CORKERY & CO. PTY. LIMITED**

December 2022

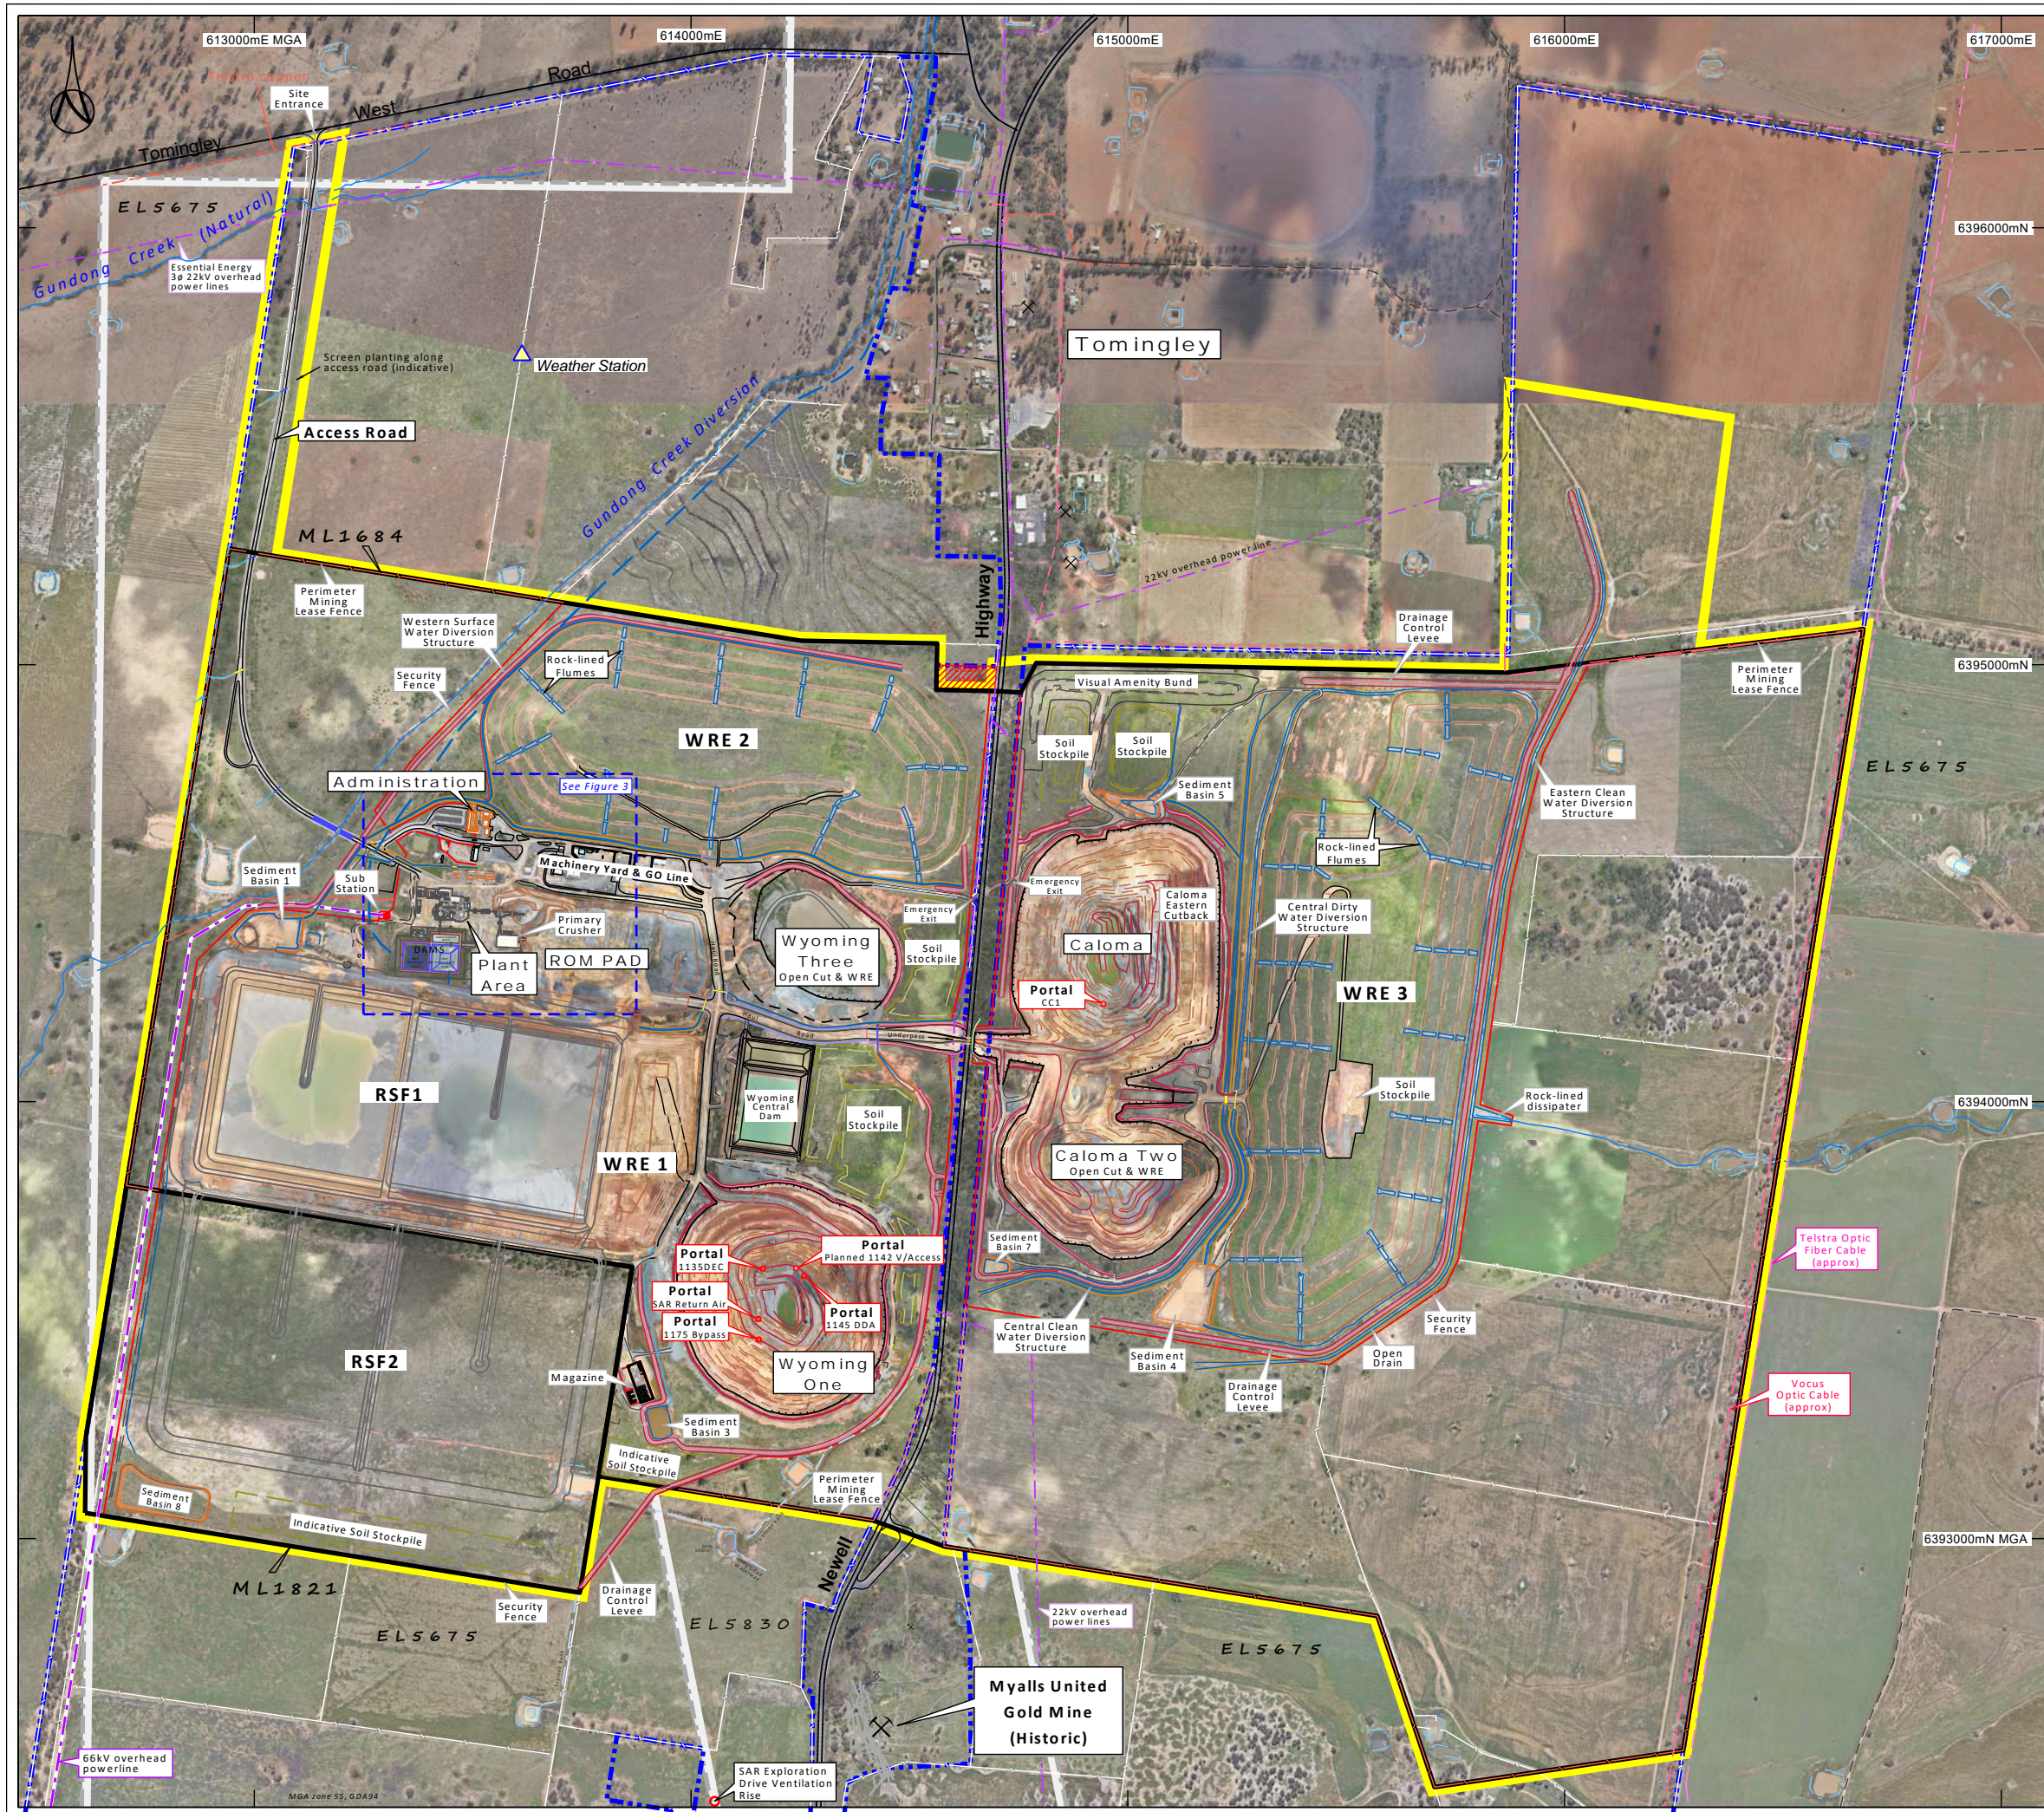
**Current Site Layout**  
 (RMP 2022 - Figure 2)

- Drainage course
- Clean water storage / farm dam
- Internal Water Diversion Structure
- Rock-lined Flumes
- Bund and / or drainage control levee
- Pit surface edge
- Historic mine / workings
- Sediment basin (internal site water)
- Buried fibre optic cable, Telstra, Vocus
- Power - overhead grid power 22kV, with pole
- Power - Transmission line 66kVA to TGO, with pole
- Buried non potable water pipeline to TGO
- Roads TGO internal; site access, light vehicle or haul road, variable widths
- Security fence
- Perimeter Mining Lease fence
- Roads; Newell Highway
- Roads; sealed, and unsealed
- Mining lease boundary (TGO)
- Mining lease - excepts the surface and soil below thereof to a depth of 2 metres
- Exploration lease boundary (Alkane)
- Tomingley Gold Mine - Project site boundary
- Tomingley Gold Operations Pty Ltd - Land ownership boundary

Compiled: TGO (D Pritchard) Plan No.: ALK TGO 1MP-042  
 Date: 19 October 2022 Figure No.: 2

The TGO Mine consists of, but is not limited to, the following (see **Figures 2 and 3**).

The location of current soil stockpiles and stockpiling areas are shown on **Figure 2**. The current volume of stockpiled growth medium is currently unknown; however, is estimated to be approximately 470k m<sup>3</sup>. **Table 9** presents the current estimated volumes of soil for each of the key stockpiles within the TGO Mine Site. The Company does not currently anticipate a significant deficit in growth medium for the rehabilitation of the TGO Mine Site.

Reclaim water is collected at centrally located decant towers within the Residue Storage Facilities and pumped directly to the Process Water Dam near the Processing Plant (see **Figures 2 and 3**).

Water management infrastructure of the TGO Mine Site is shown on **Figure 2** and **Figure 7**. In general, the Company manages surface water within the TGO Mine Site in accordance with the approved *Water Management Plan*. Surface water is classified as follows.

The principal public safety control for the TGO Mine Site is the security fencing that surrounds the core operational mining areas, as shown on **Figure 2**. Entry to the secured areas of the TGO Mine Site is restricted a single entry and is controlled on a 24/7 basis. CCT security monitoring is also undertaken in high-risk areas. Additional locked entry points are also located to allow for emergency access. During decommissioning, access will continue to be controlled during all active rehabilitation operations.

Access and ventilation is provided via a number of portals in the Wyoming 1 Open Cut. A portal has also been established within the southern wall of the Caloma 1 Open Cut, primarily for ventilation and emergency egress (**Figure 2**). Groundwater accumulation within the TGO Underground Mine is pumped to the Wyoming 3 Open Cut.

The management of surface water for the operational Residue Storage Facilities (excluding the internally draining upper surfaces) consists of a progressively developed network of perimeter table drains and Sediment Basins as part of the Dirty water drainage network (see **Figures 2 and 7**). As discussed in Section 6.2.2.3, certain components may be retained as part of the final landform of the Facility.

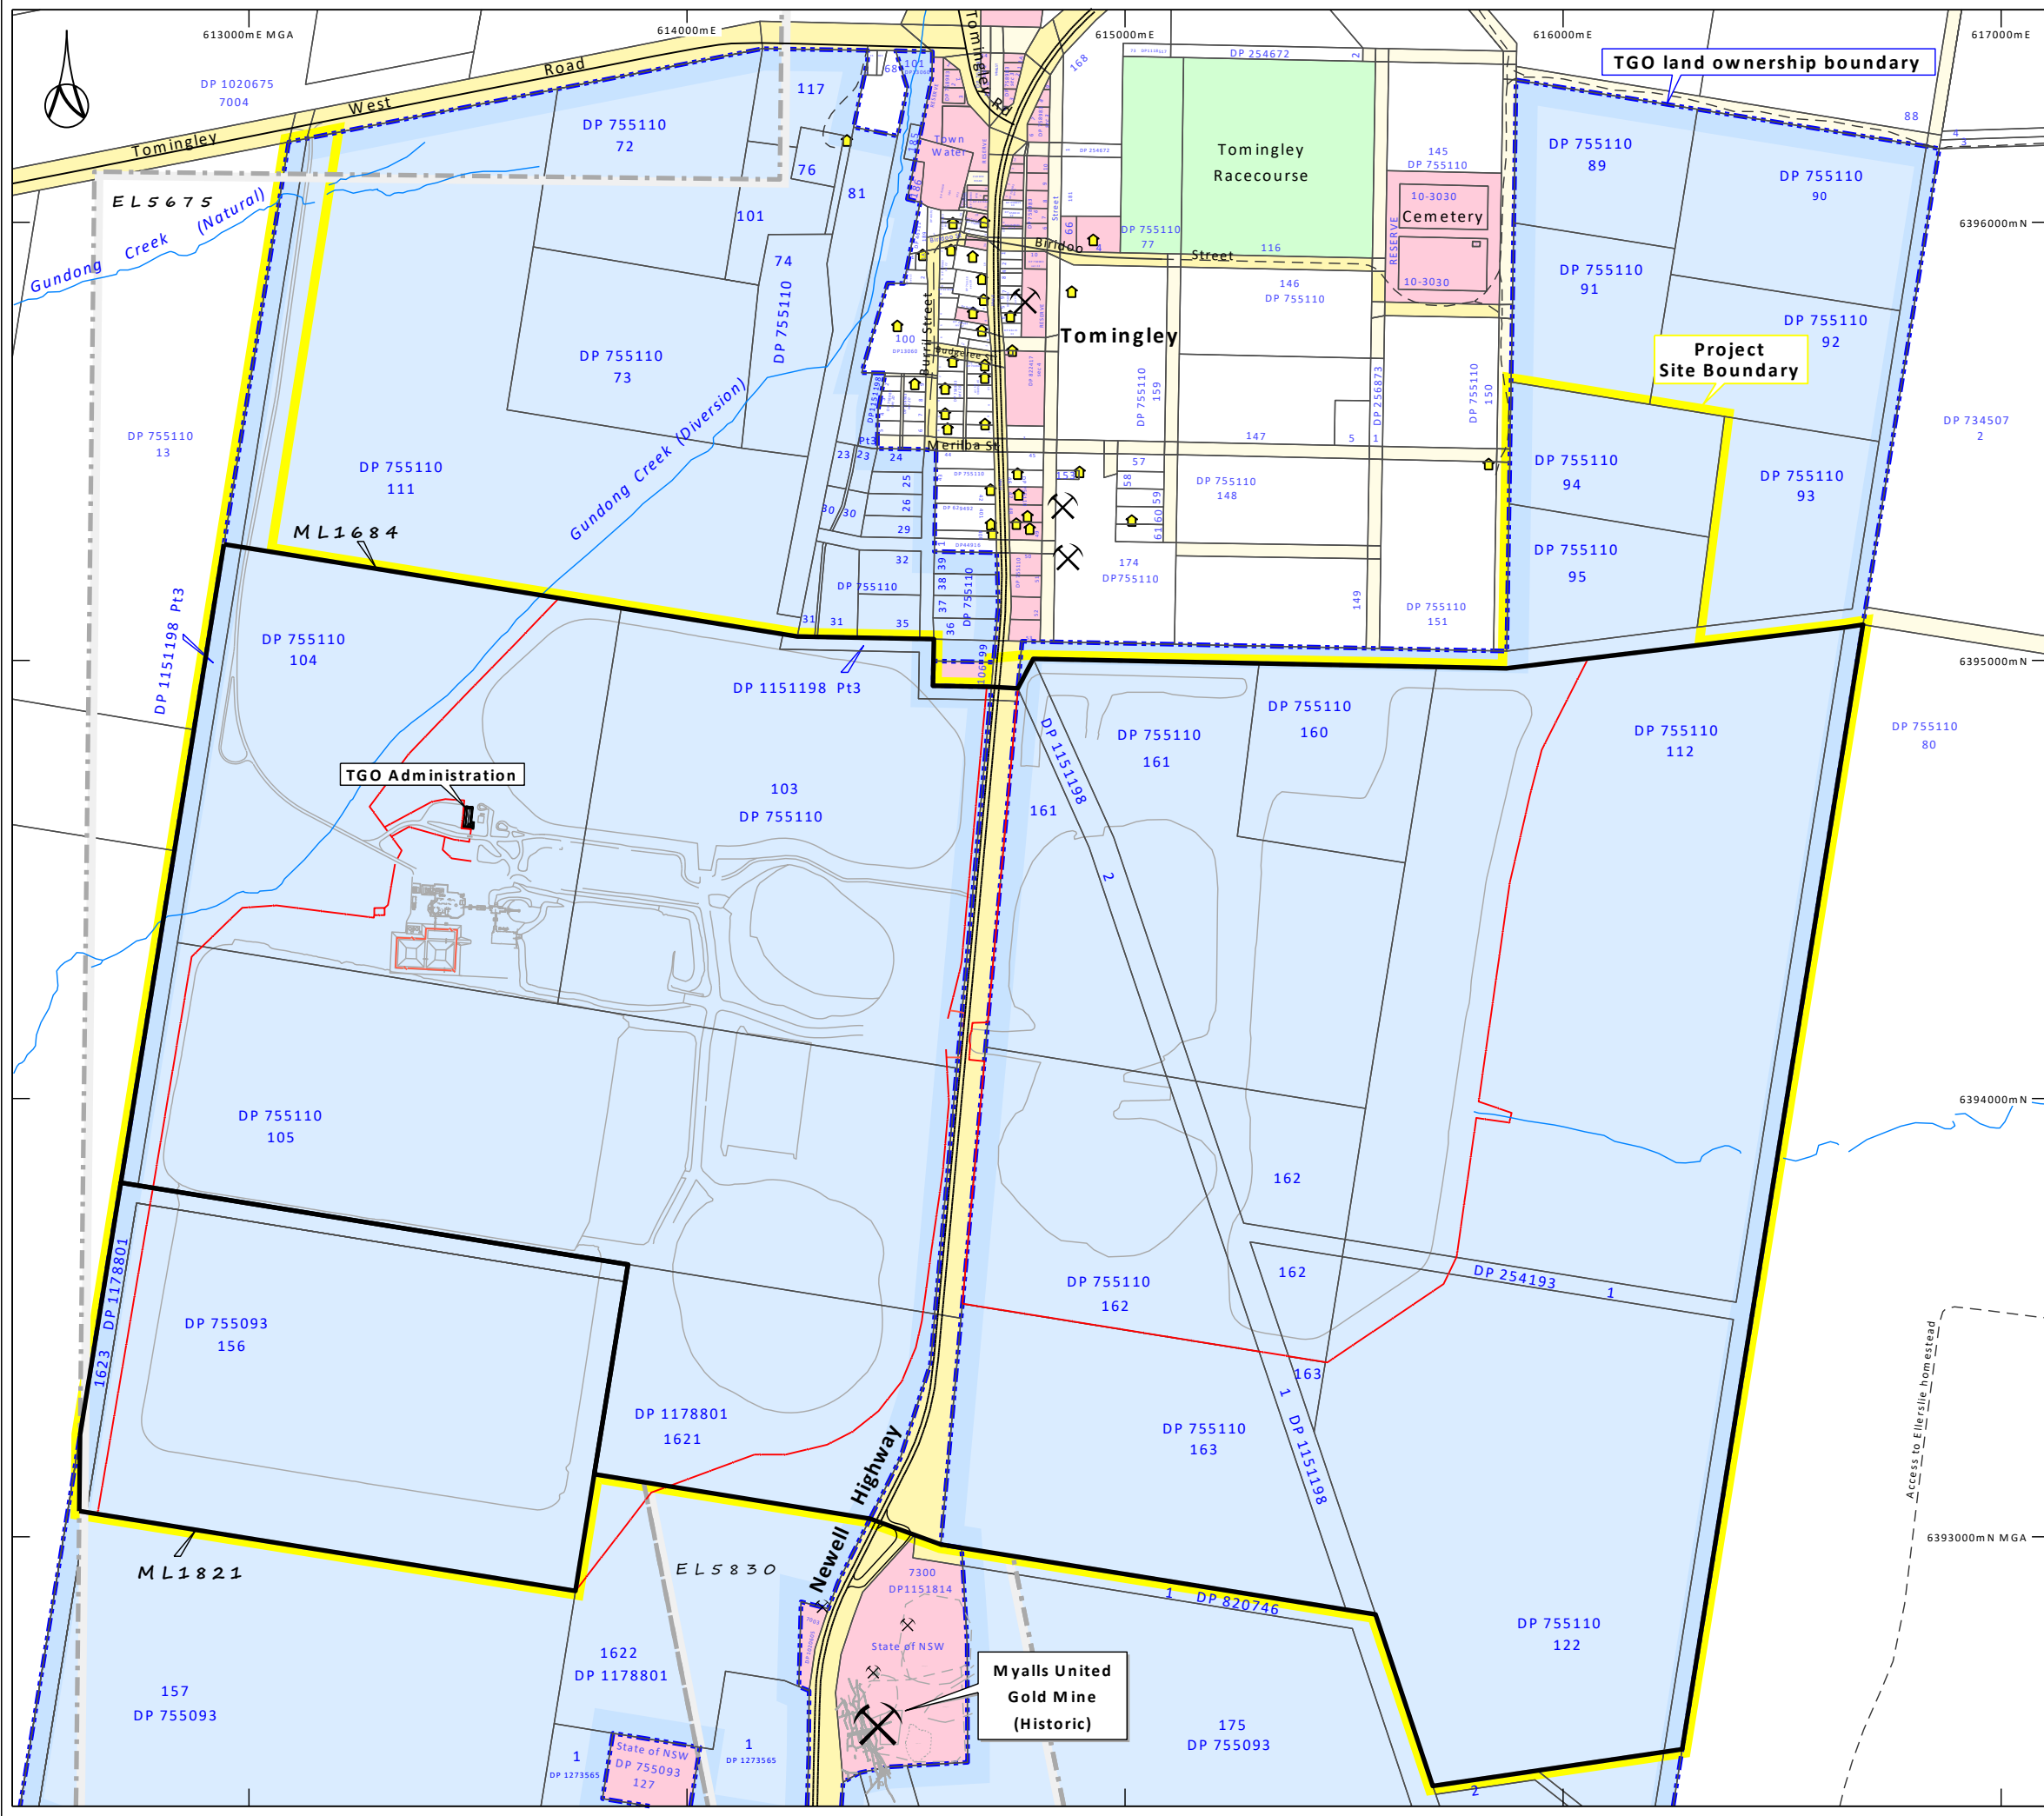
**Land Ownership and Surrounding Residences**  
(RMP 2022 - Figure 4)

**Table 2** provides an overview of the land tenure of lots within and adjacent to the TGO Mine Site and **Figure 4** presents the land tenure of lots within and in the vicinity of the TGO Mine Site. In addition, the road reserve of the Newell Highway intersects the TGO Mine Site. An unnamed Crown Parcel is located adjacent to and immediately north of the TGO Mine Site, intersecting Lot 31 DP 755110.

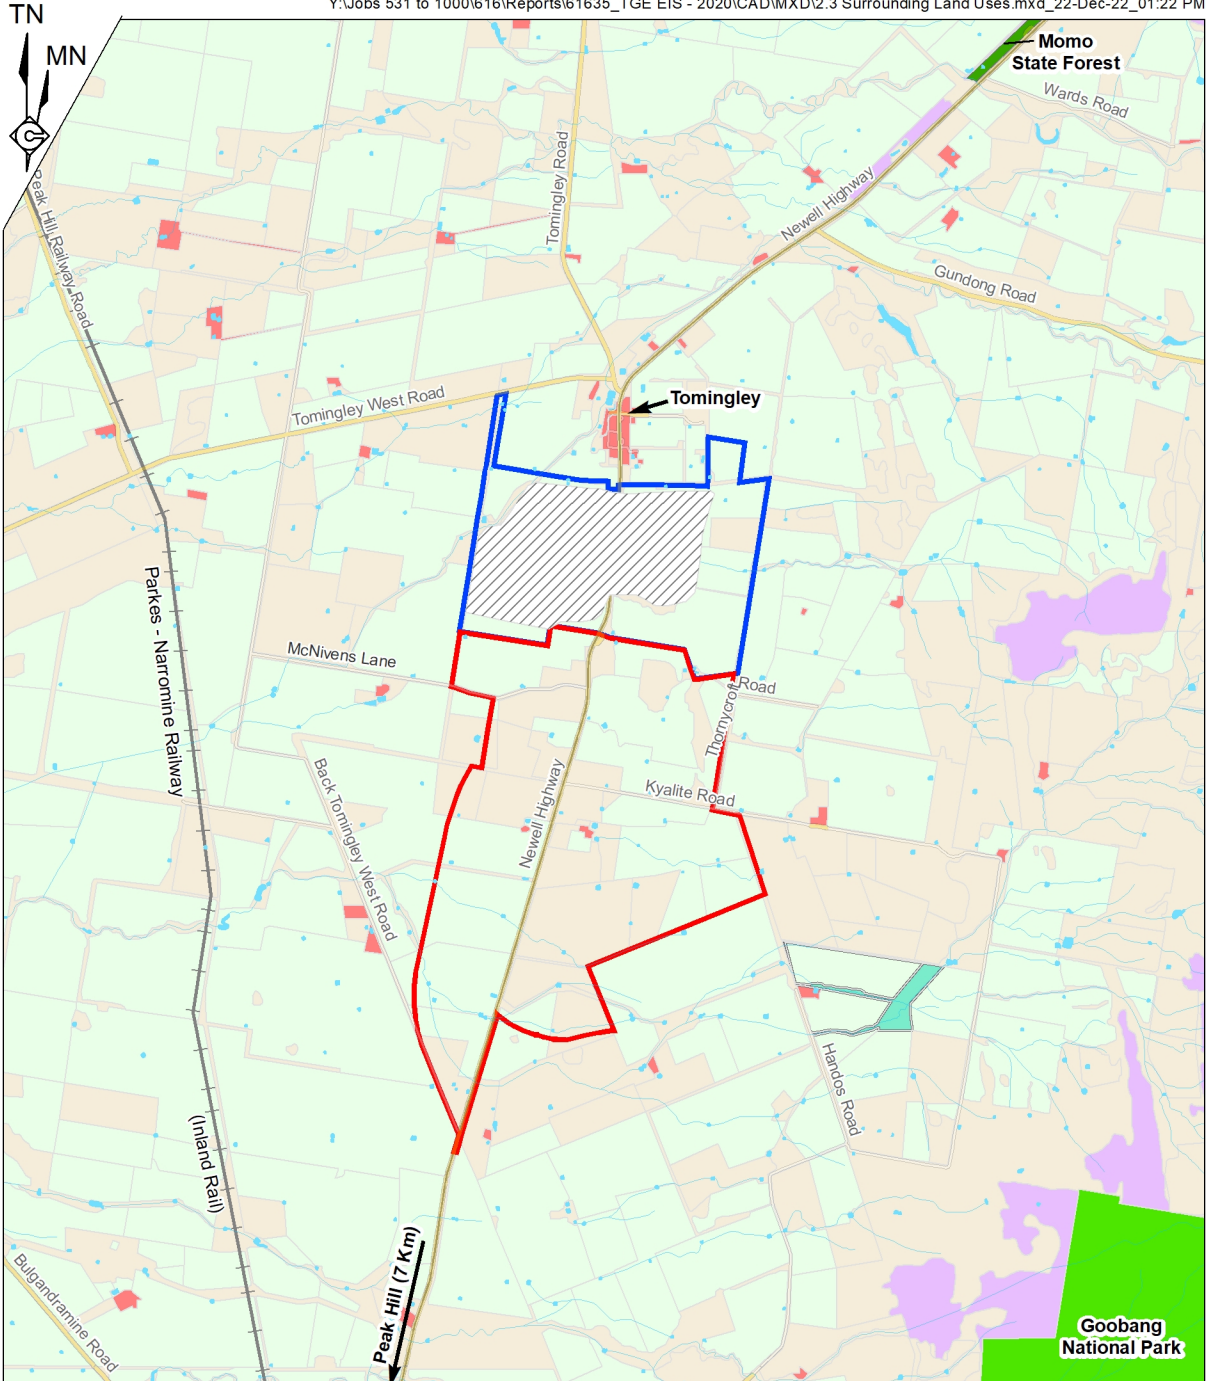
**Figure 5  
SURROUNDING LAND USES**

The dominant surrounding land uses generally comprise of dryland cropping and grazing with associated rural homesteads, and Tomingley Village (**Figure 5**). Other land uses include the following.

- Road transportation associated with the Newell Highway and surrounding local roads.
- Rail transportation associated with the Inland Rail.
- Village residential associated with the village of Tomingley.
- Nature conservation and “other minimal use” associated with areas of native vegetation.

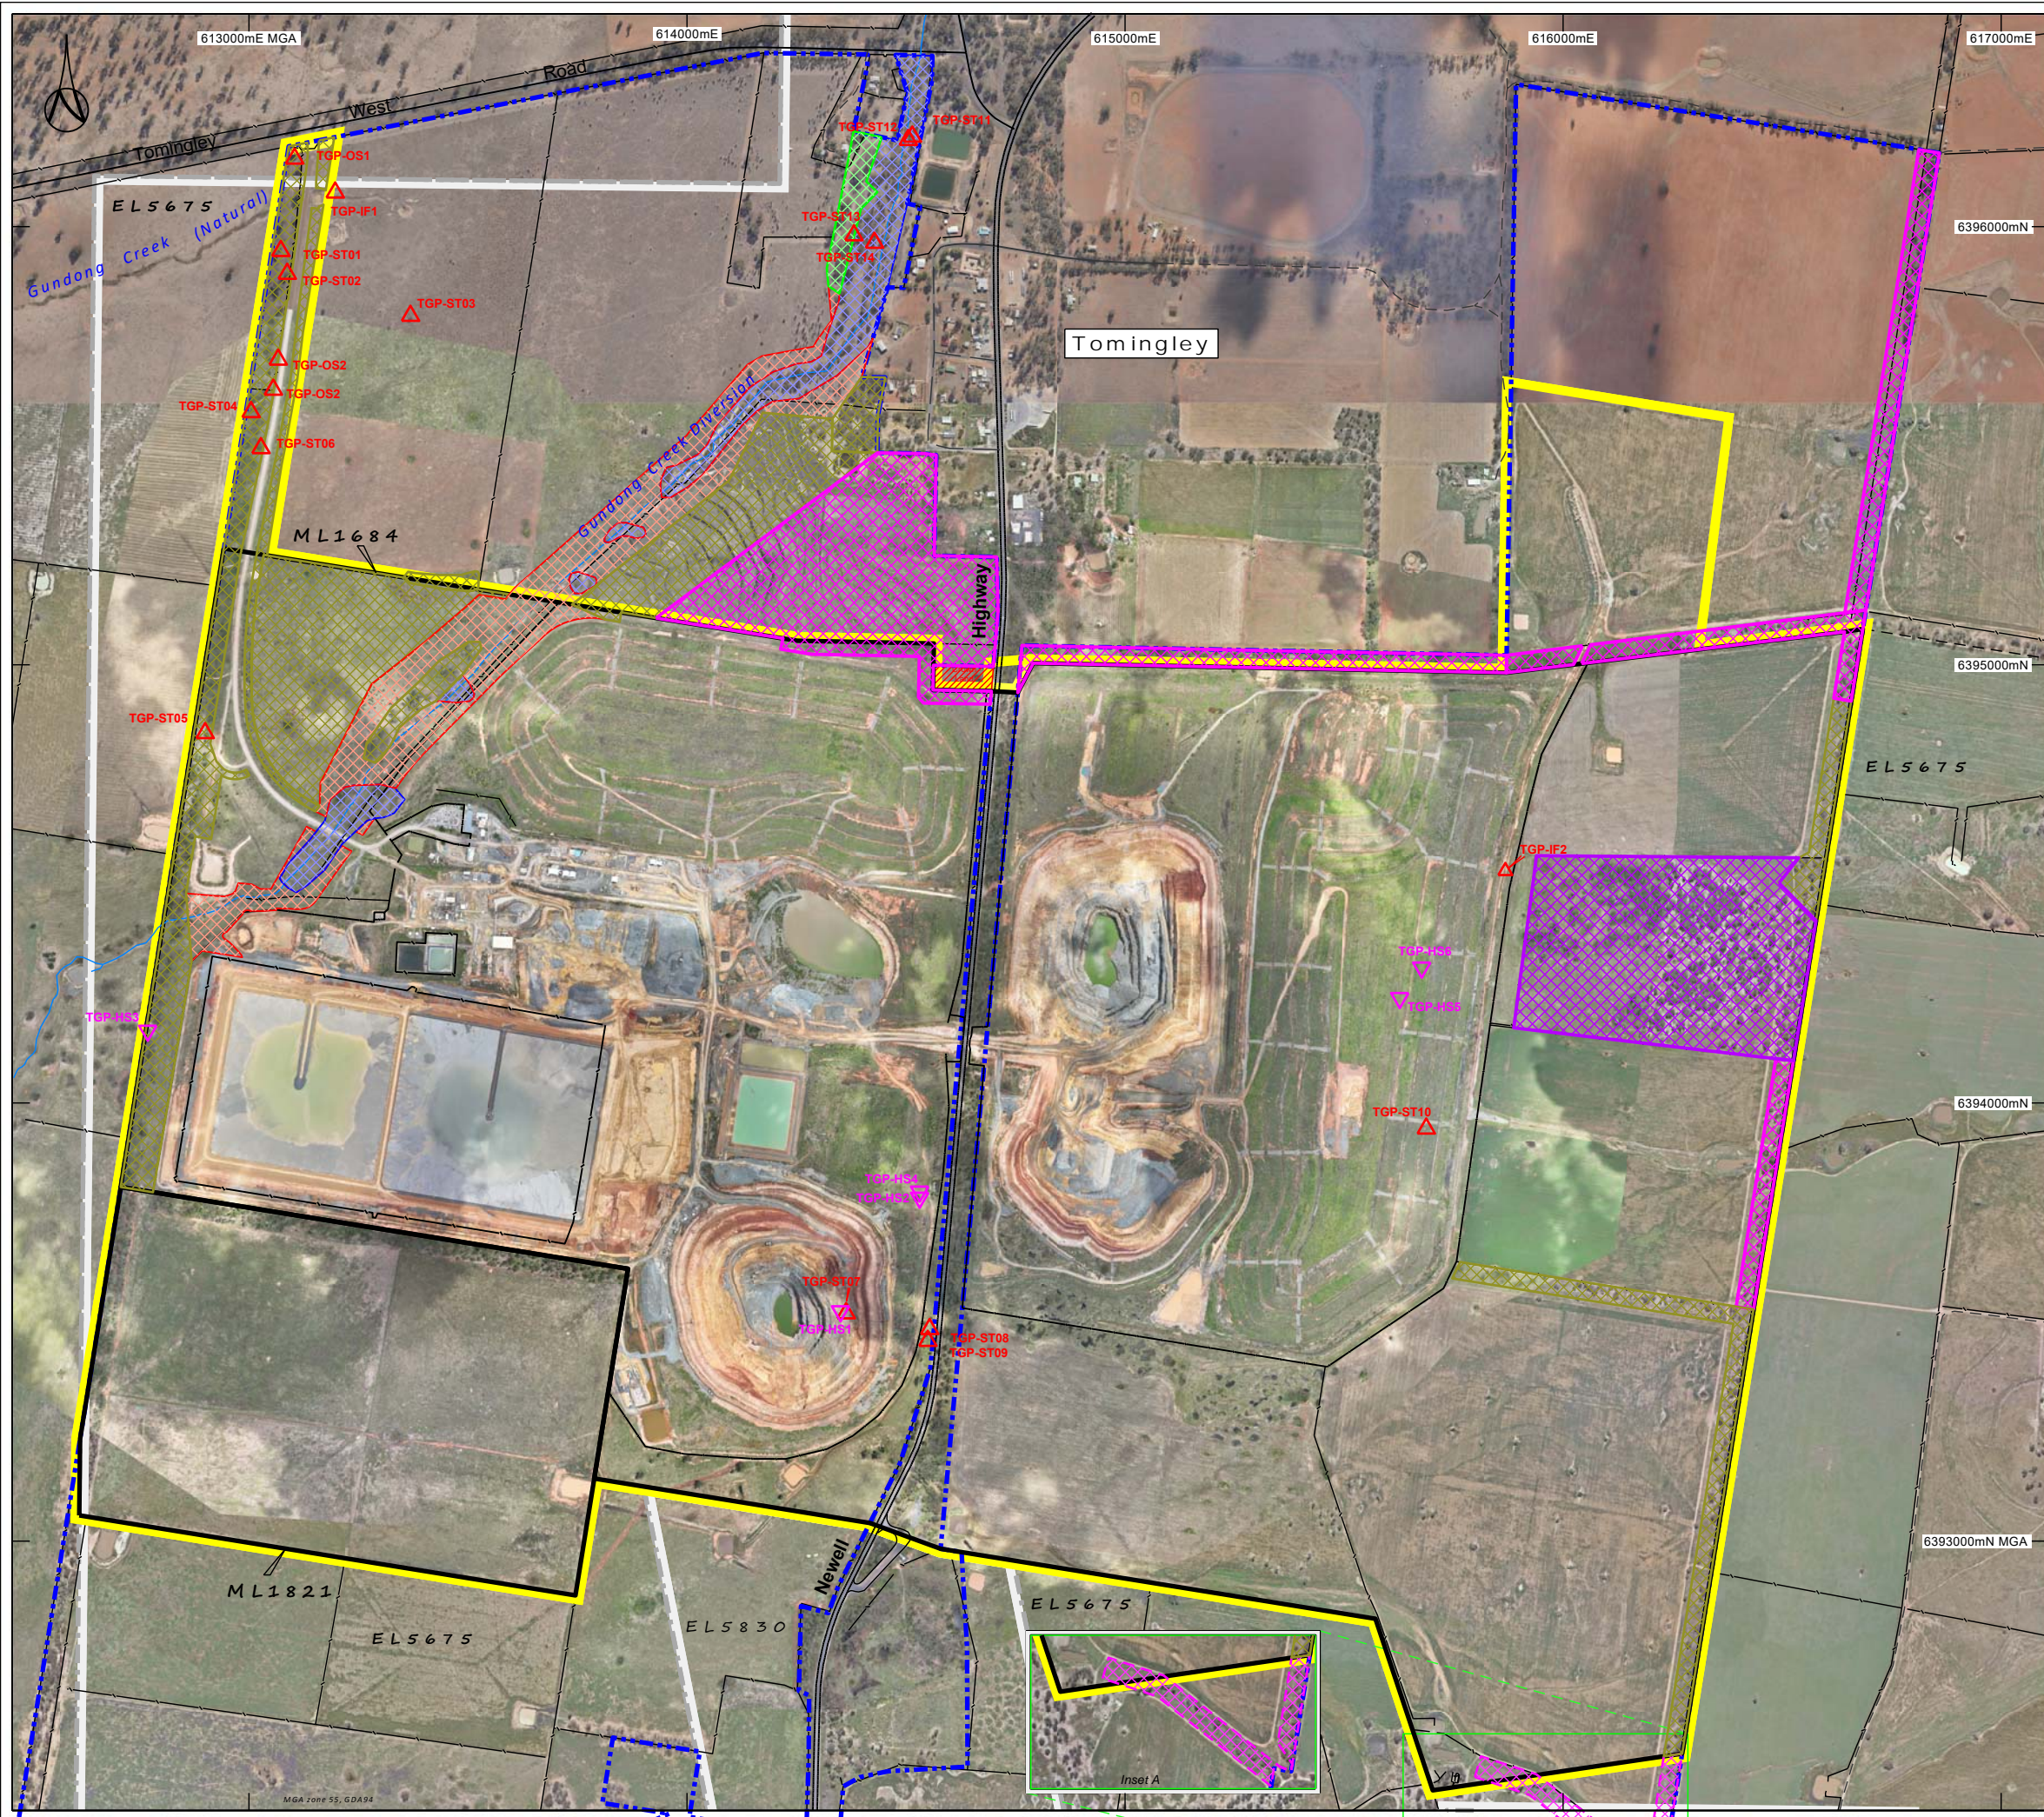
**Biodiversity Offset Strategy  
Vegetation Communities**

Vegetation Communities to be managed or established  
(Total area 157ha)

The Company maintains approximately 157ha of Biodiversity Offset Area within and in the vicinity of the TGO Mine Site in accordance with Conditions 33, 34, and 34A of MP 09\_0155 and as shown on **Figure 6**. Further information is provided in Sections 2.4.1 and 2.4.2 in regard to those areas of the Biodiversity Offset Area within the Mining Leases of the TGO Mine Site.

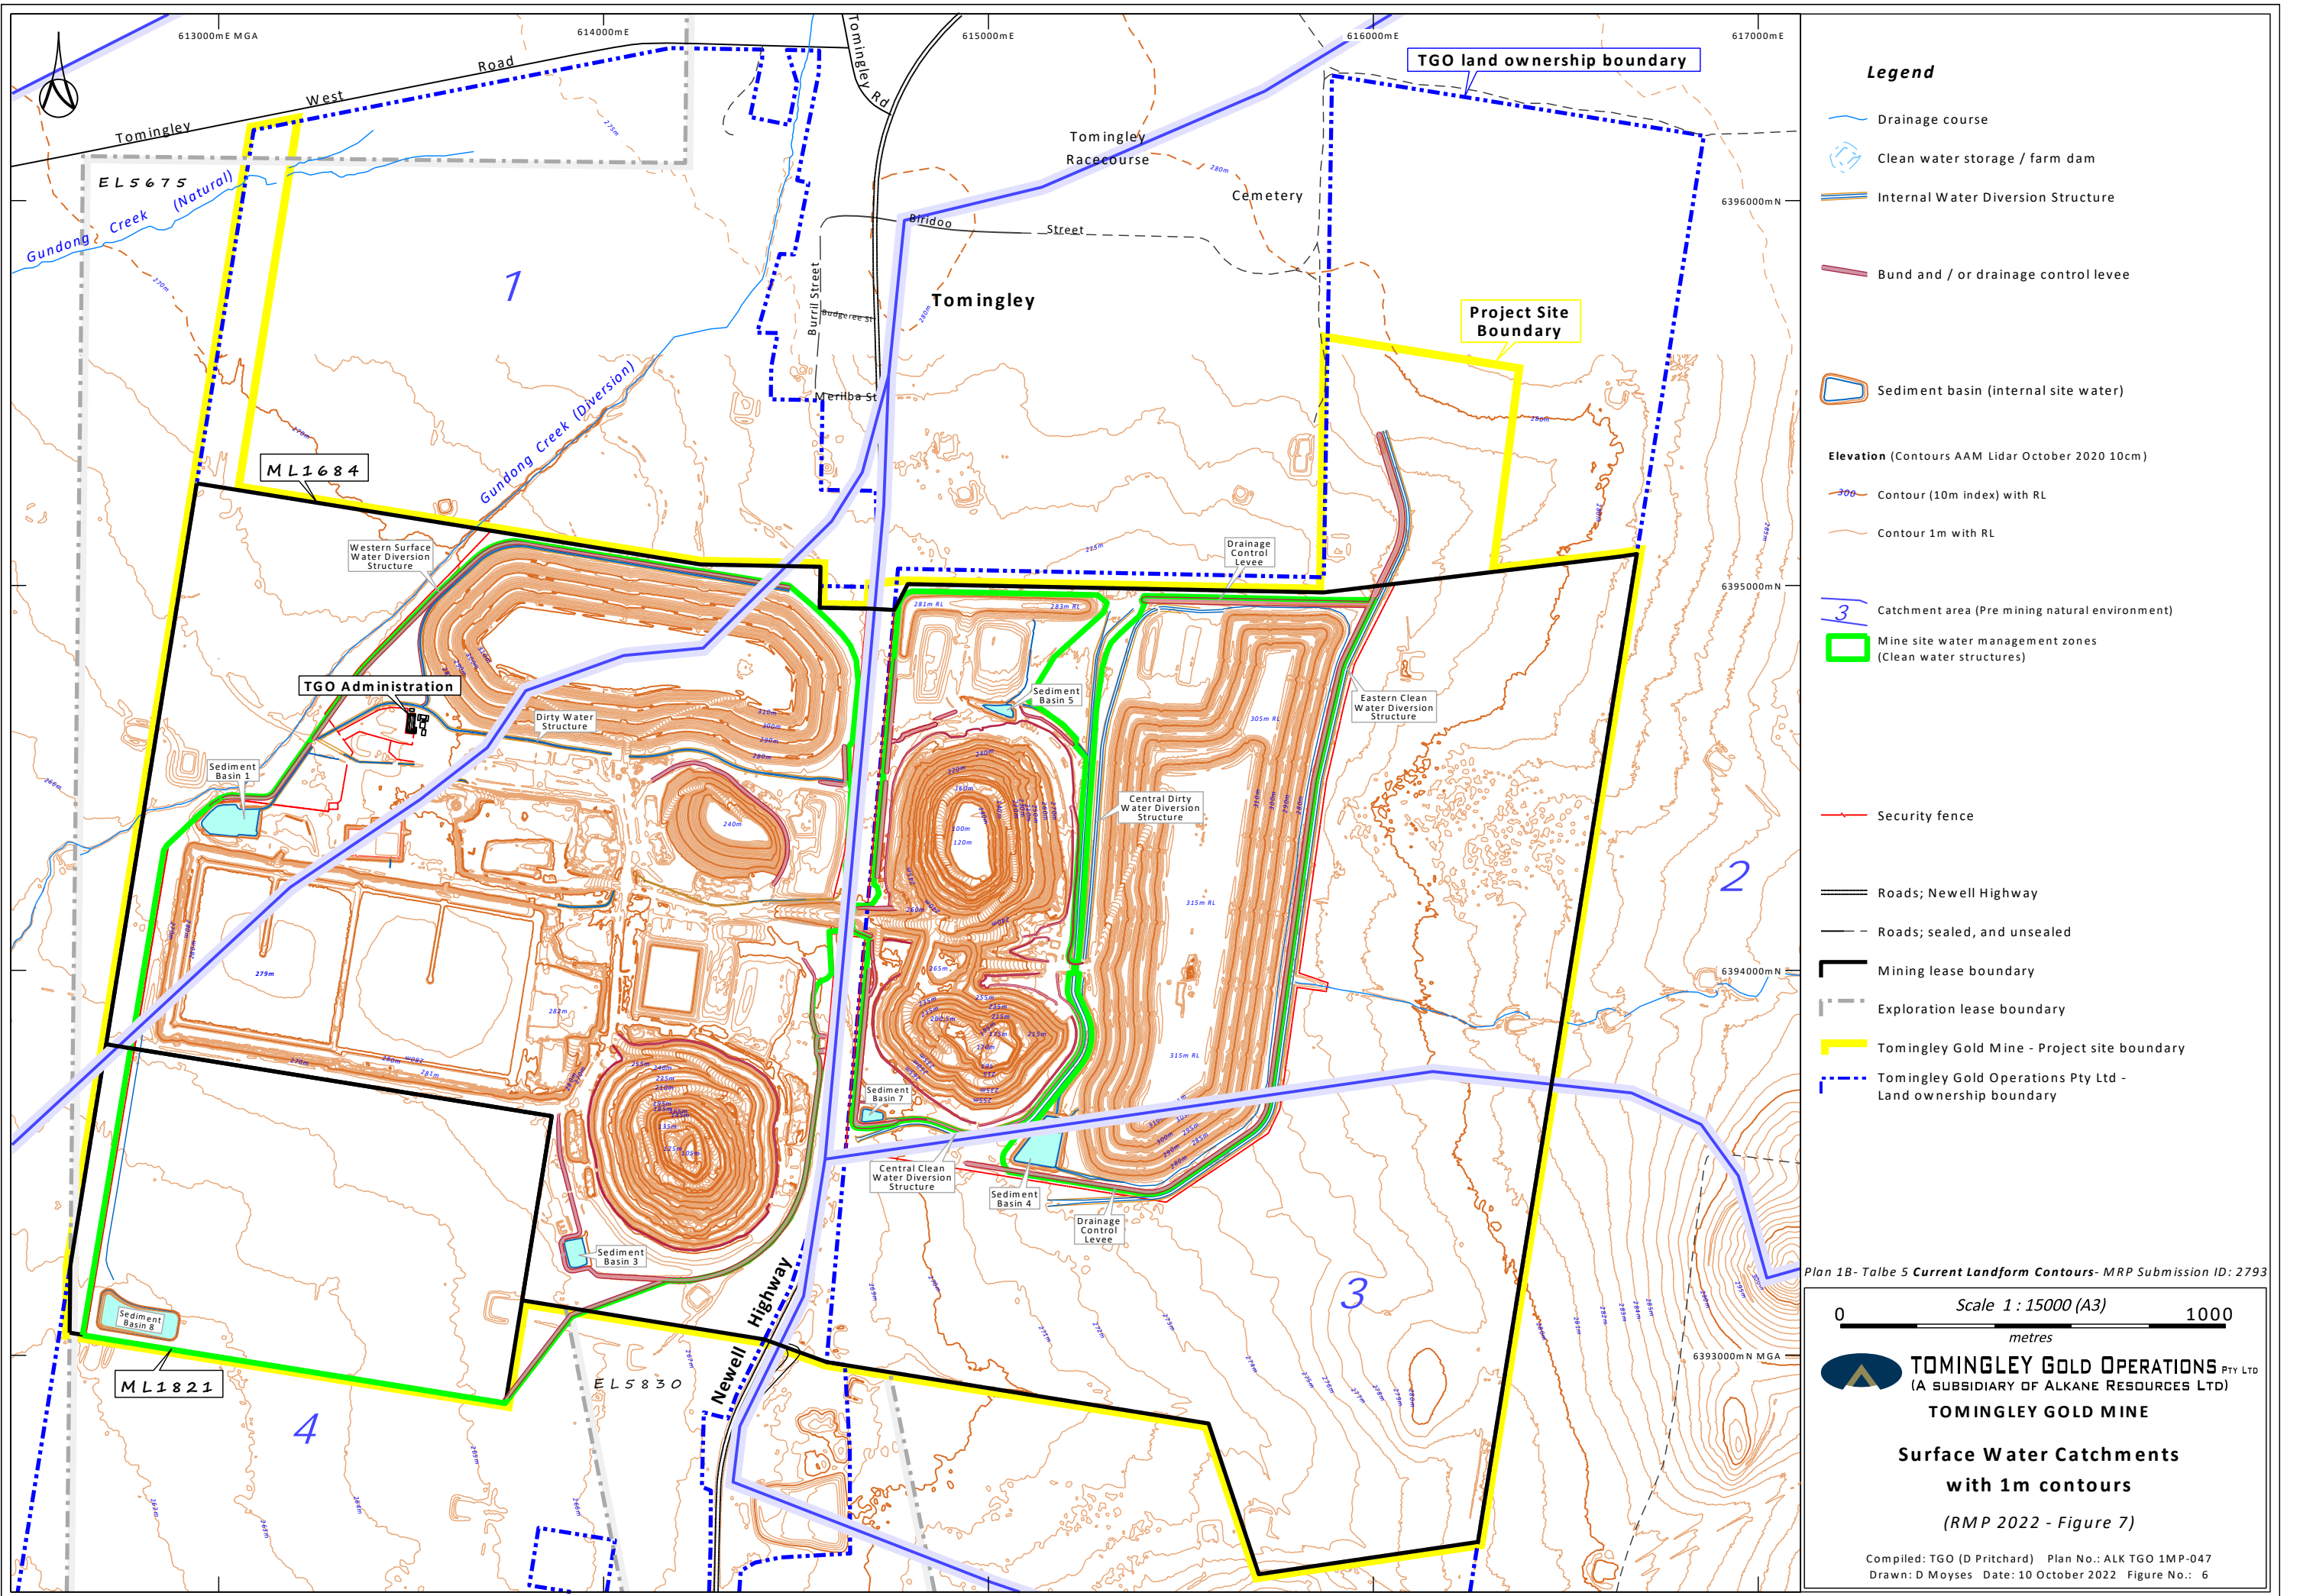
**Surface Water Catchments  
 with 1m contours**  
 (RMP 2022 - Figure 7)

- Drainage course
- Clean water storage / farm dam
- Internal Water Diversion Structure
- Bund and / or drainage control levee
- Sediment basin (internal site water)
- Elevation (Contours AAM Lidar October 2020 10cm)**
- Contour (10m index) with RL
- Contour 1m with RL
- Catchment area (Pre mining natural environment)
- Mine site water management zones (Clean water structures)
- Security fence
- Roads; Newell Highway
- Roads; sealed, and unsealed
- Mining lease boundary
- Exploration lease boundary
- Tomingley Gold Mine - Project site boundary
- Tomingley Gold Operations Pty Ltd - Land ownership boundary

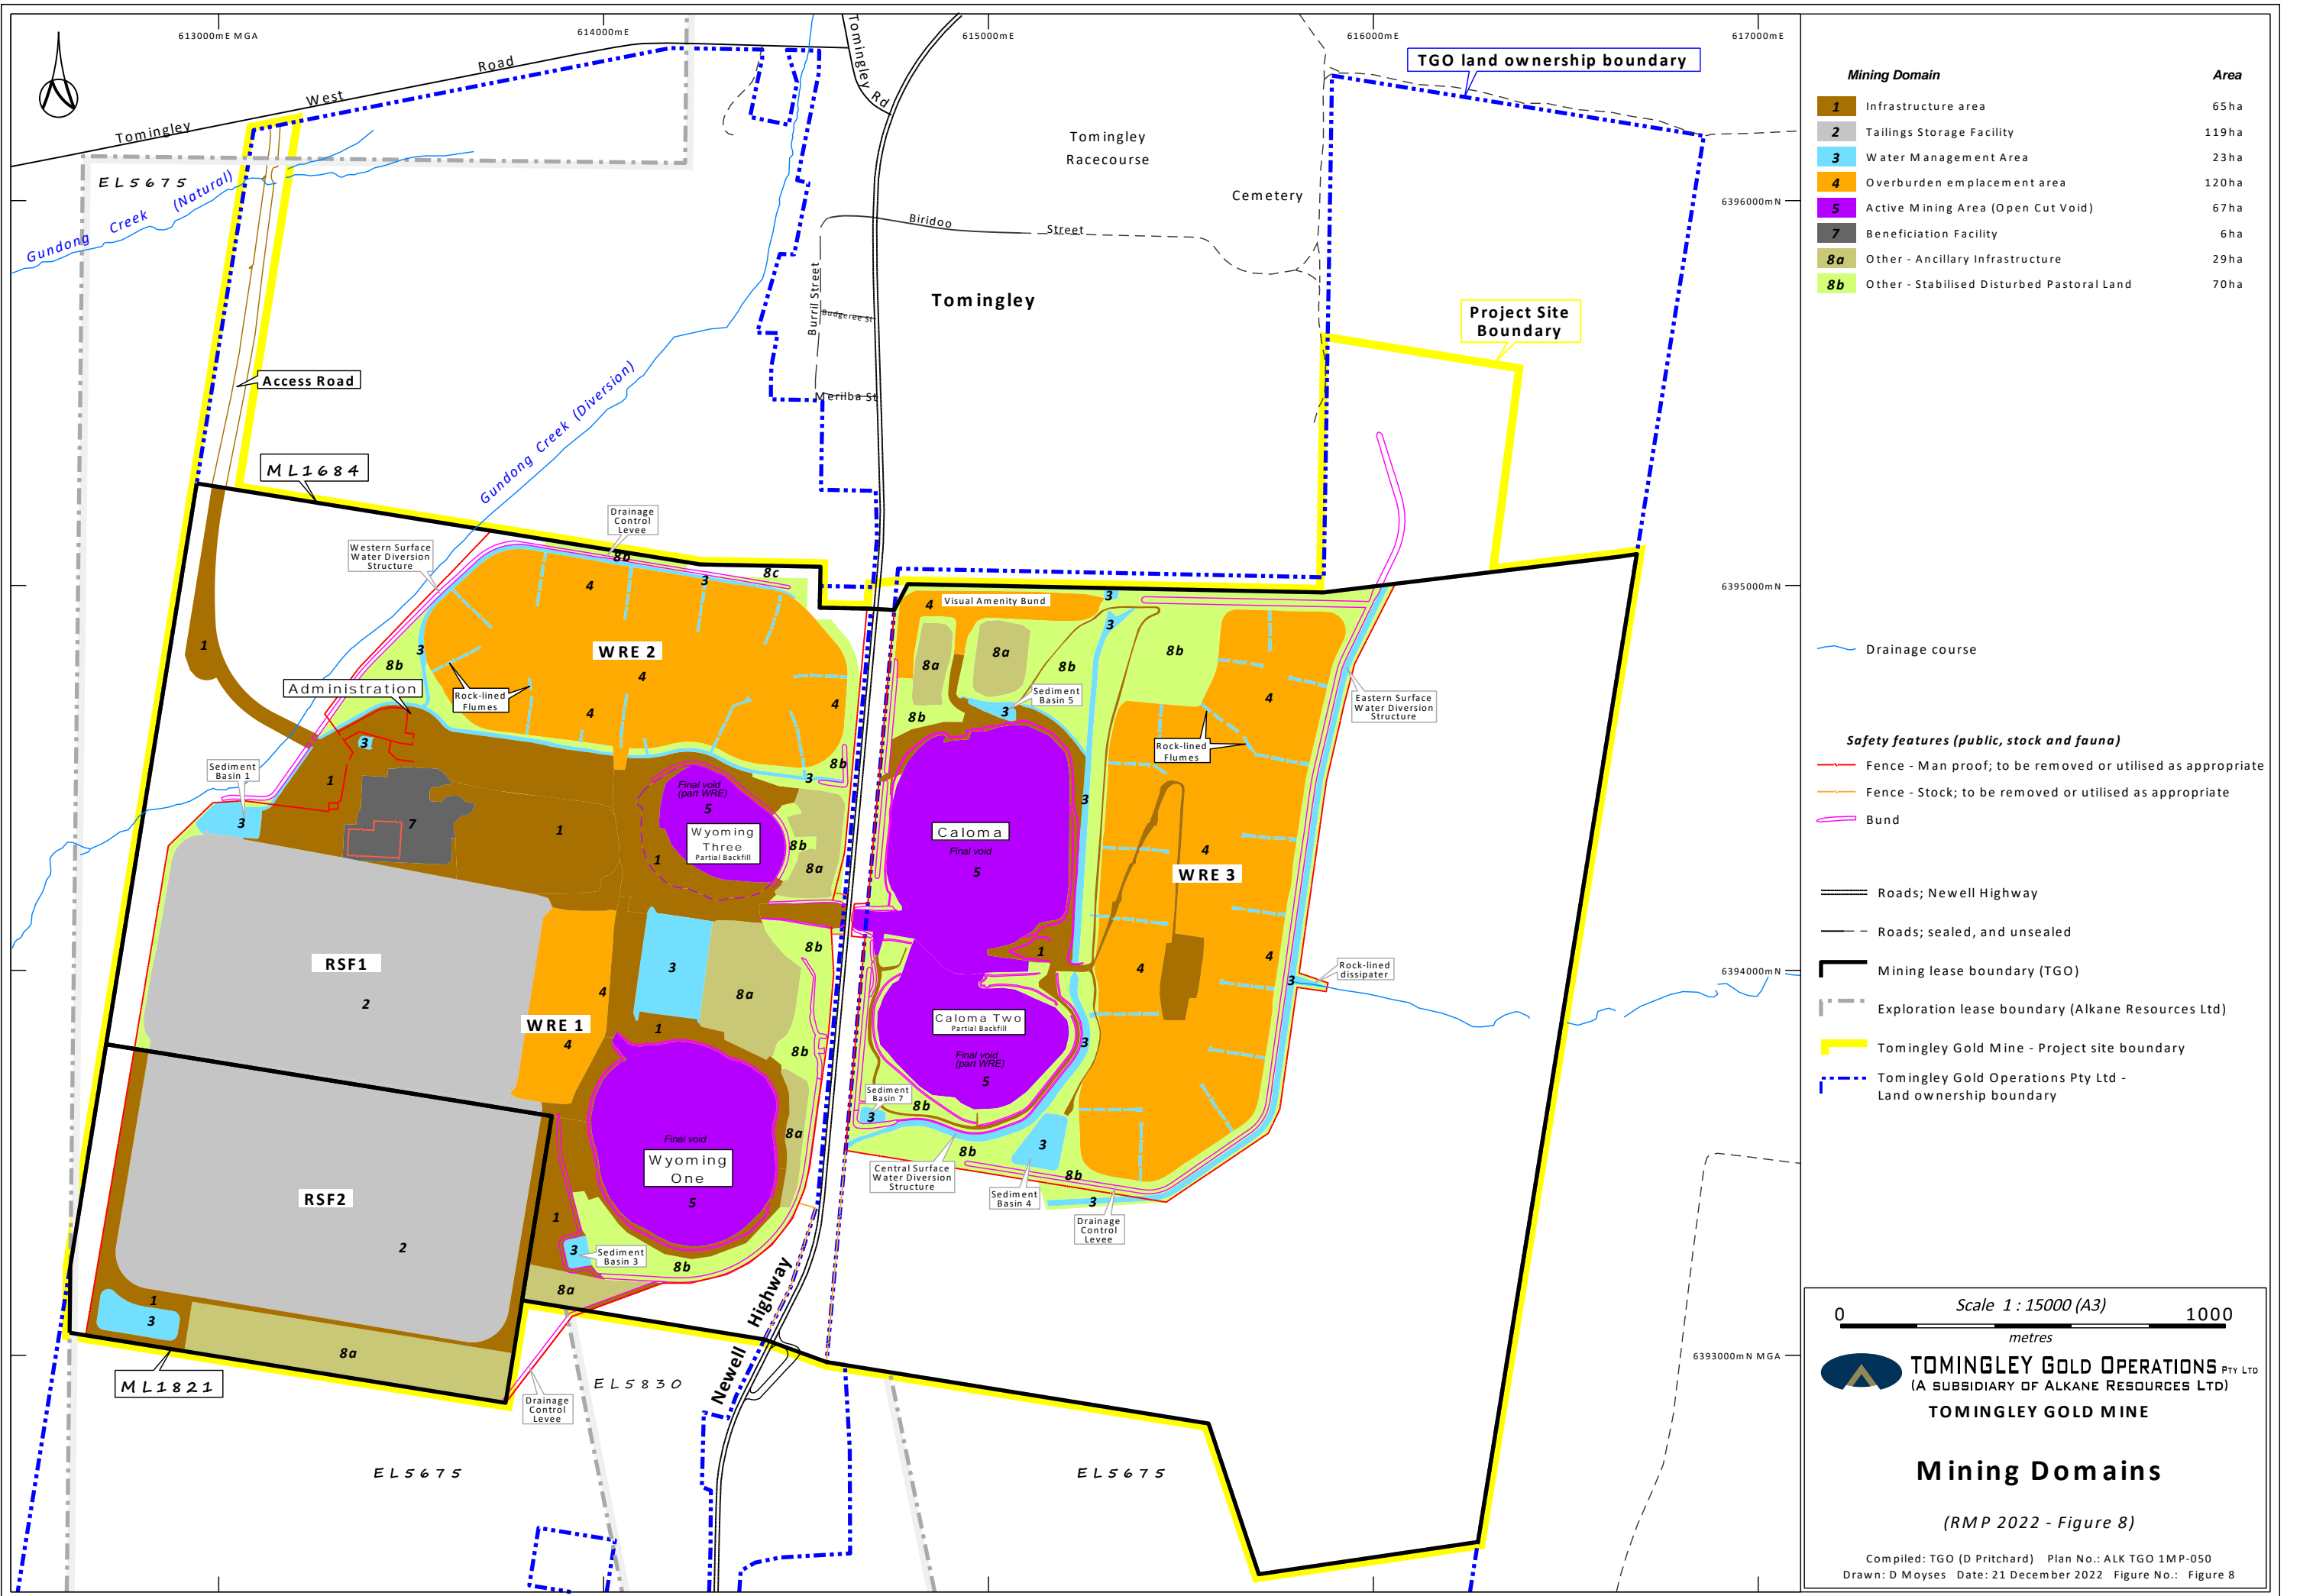
This section describes the mining domains for all operational/ disturbance areas within the ML 1684 and ML 1821 of the TGO Mine Site as shown on **Figure 8**. It is noted that minor areas of infrastructure, surface water diversions, and Biodiversity Offset Areas are located outside of the MLs. Notwithstanding the above, these areas/land forms are approved to be retained as part of the final land use (with the potential for the Site Access Road to be reduced in width, depending final land use requirements) and as such, are not included in this Plan.

This domain is limited to water management structures, including diversion structures and sediment basins, used to permit management of dirty or sediment-laden water or ensuring that clean water, namely water from undisturbed sections of the TGO Mine Site and surrounds, does not flow onto disturbed areas. The Wyoming Central Dams, which contain Mine and Process water storage, are also included. This domain does not include the water management structures of the Processing Plant (included as Domain 7) or Mine water storage within open cut voids (included as Domain 5).

This domain is limited to the operational footprints of Waste Rock Emplacement 1, 2, and 3 and the Caloma Amenity Bund. This domain does not include the in-pit waste rock emplacements within Wyoming 3 and Caloma 2 Open Cuts.

Note 1: See **Figures 2, 3 and 8**
