# Tomingley Gold Project Rehabilitation Management Plan

State Significant Development  
MP 09\_0155

**R.W. CORKERY & CO. PTY. LIMITED**

December 2022

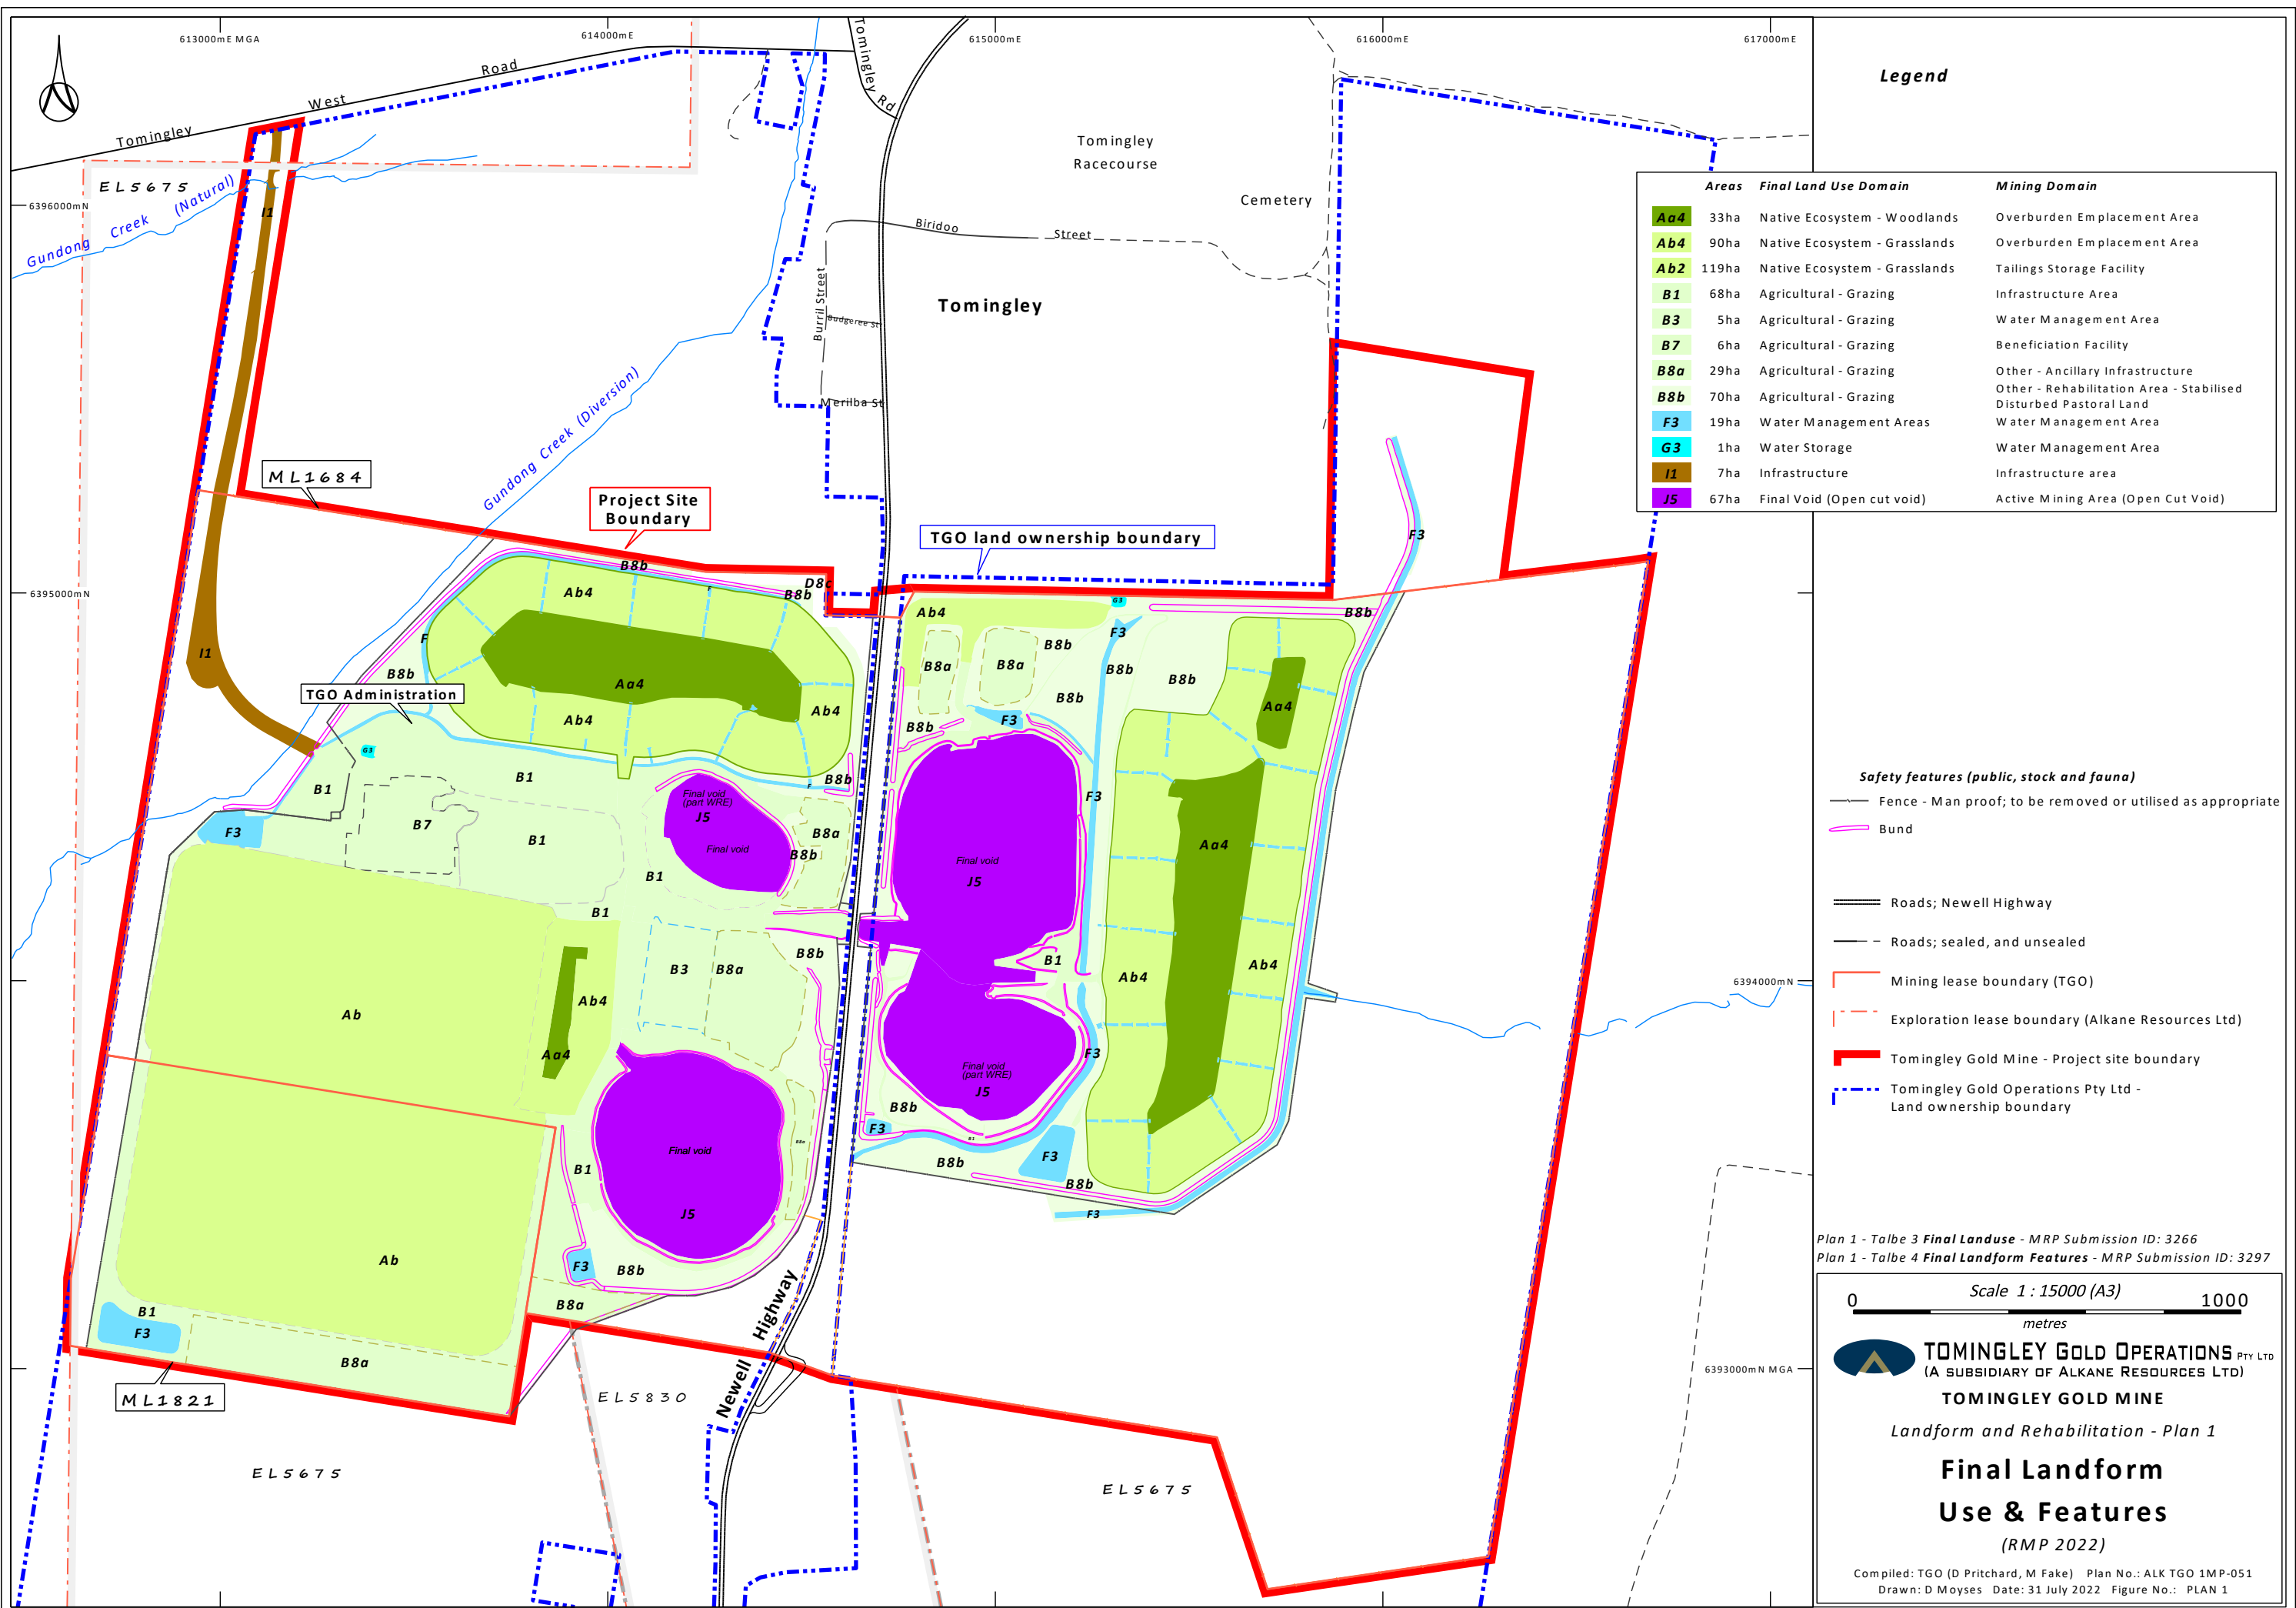
**TOMINGLEY GOLD OPERATIONS** PTY LTD  
 (A SUBSIDIARY OF ALKANE RESOURCES LTD)  
**TOMINGLEY GOLD MINE**  
 Landform and Rehabilitation - Plan 1  
**Final Landform Use & Features**  
 (RMP 2022)

**Plan 1** presents the final landform features for the TGO Mine Site and **Plan 2** presents the final landform contours for the TGO Mine Site.

Areas	Final Land Use Domain	Mining Domain
Aa4	33ha Native Ecosystem - Woodlands	Overburden Emplacement Area
Ab4	90ha Native Ecosystem - Grasslands	Overburden Emplacement Area
Ab2	119ha Native Ecosystem - Grasslands	Tailings Storage Facility
B1	68ha Agricultural - Grazing	Infrastructure Area
B3	5ha Agricultural - Grazing	Water Management Area
B7	6ha Agricultural - Grazing	Beneficiation Facility
B8a	29ha Agricultural - Grazing	Other - Ancillary Infrastructure
B8b	70ha Agricultural - Grazing	Other - Rehabilitation Area - Stabilised Disturbed Pastoral Land
F3	19ha Water Management Areas	Water Management Area
G3	1ha Water Storage	Water Management Area
I1	7ha Infrastructure	Infrastructure area
J5	67ha Final Void (Open cut void)	Active Mining Area (Open Cut Void)

It is noted that rehabilitation progress through the planned rehabilitation phases will not occur at the same rate across all mining and final land use domains identified in **Figure 5** and **Plan 1**. Therefore the quality assurance records of rehabilitation for each domain will be recorded as appropriate to the respective phase of rehabilitation for that domain. In some instances, validation and monitoring records that apply to all/multiple domains may occur following completion of the relevant phase for all domains.

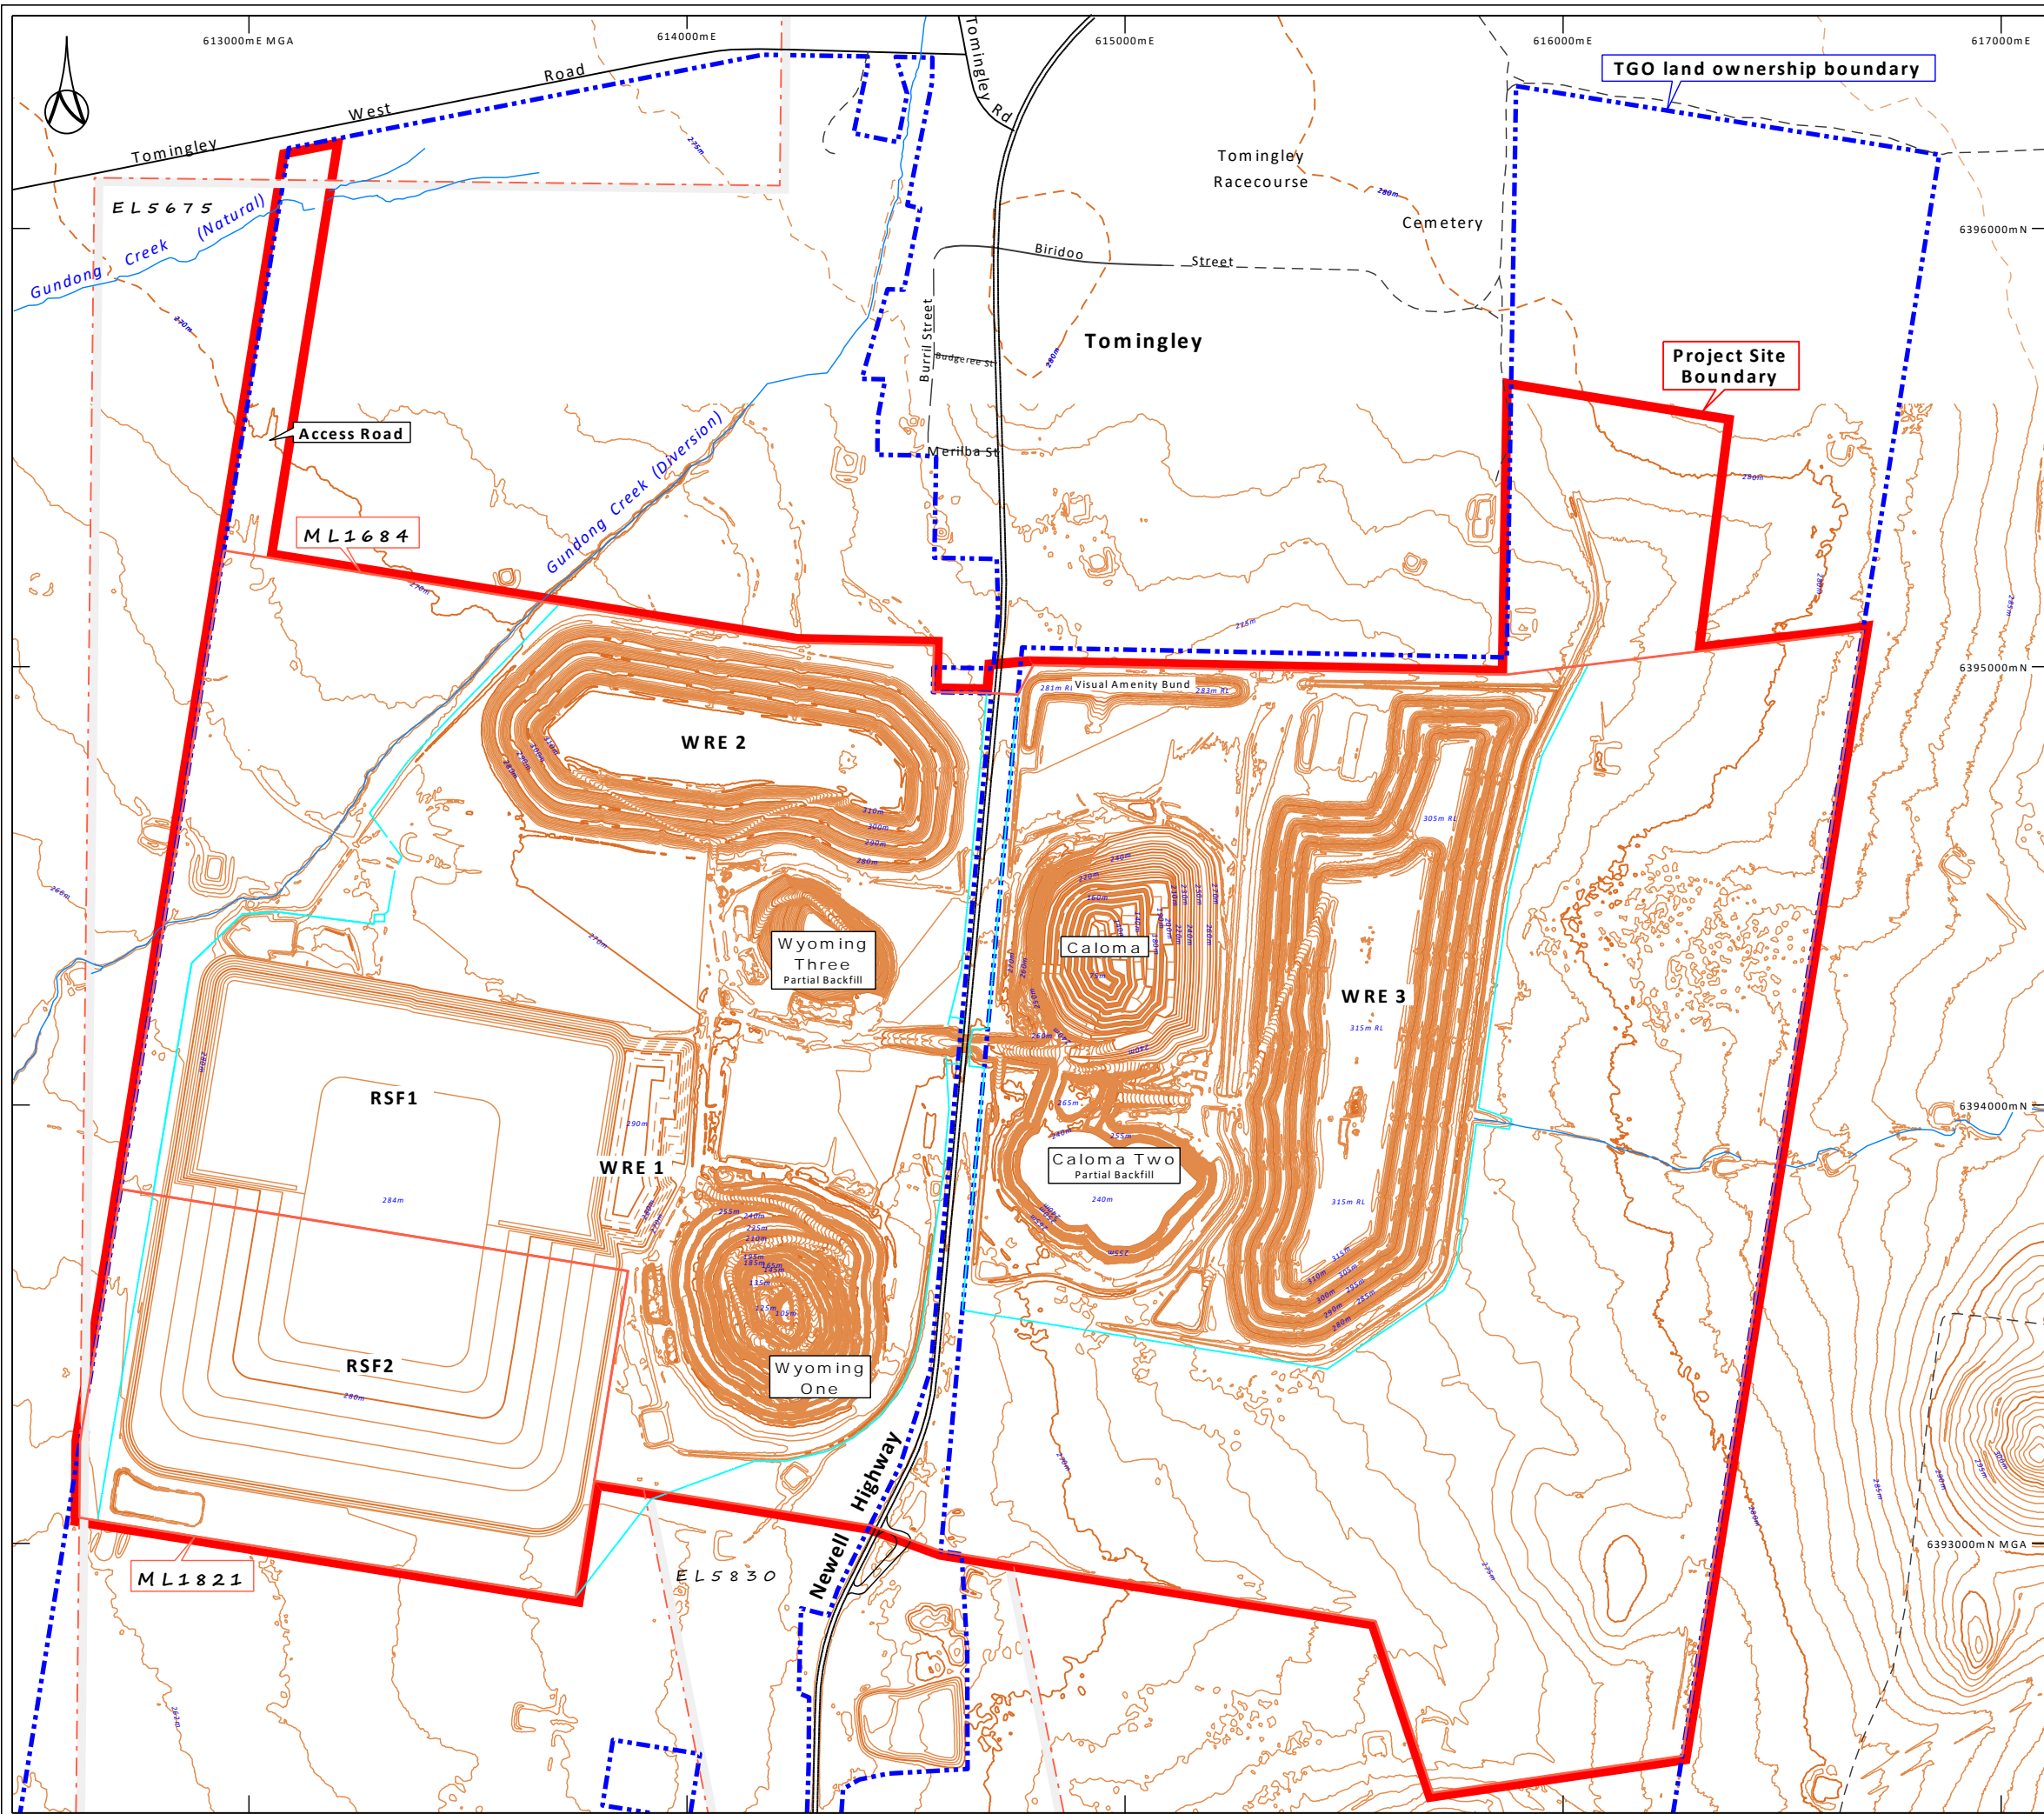
- Relief**
- Contour (10m index) with RL
  - Contour 1m with RL
- Note: All contours are indicative of final landform, not absolute*
- Fence - Man proof; to be removed or utilised as appropriate
  - Roads; Newell Highway
  - Roads; sealed, and unsealed
  - Tomingley Gold Operations Pty Ltd - Land ownership boundary
  - Mining lease boundary (TGO)
  - Exploration lease boundary (Alkane Resources Ltd)
  - Tomingley Gold Mine - Project site boundary  
Project approval 09\_0155  
(MOD 1 - 24 July 2012)  
(MOD 2 - 13 May 2015)  
(MOD 3 - 5 July 2016)  
(MOD 4 - 25 May 2020)  
(MOD 5 - April 2021)

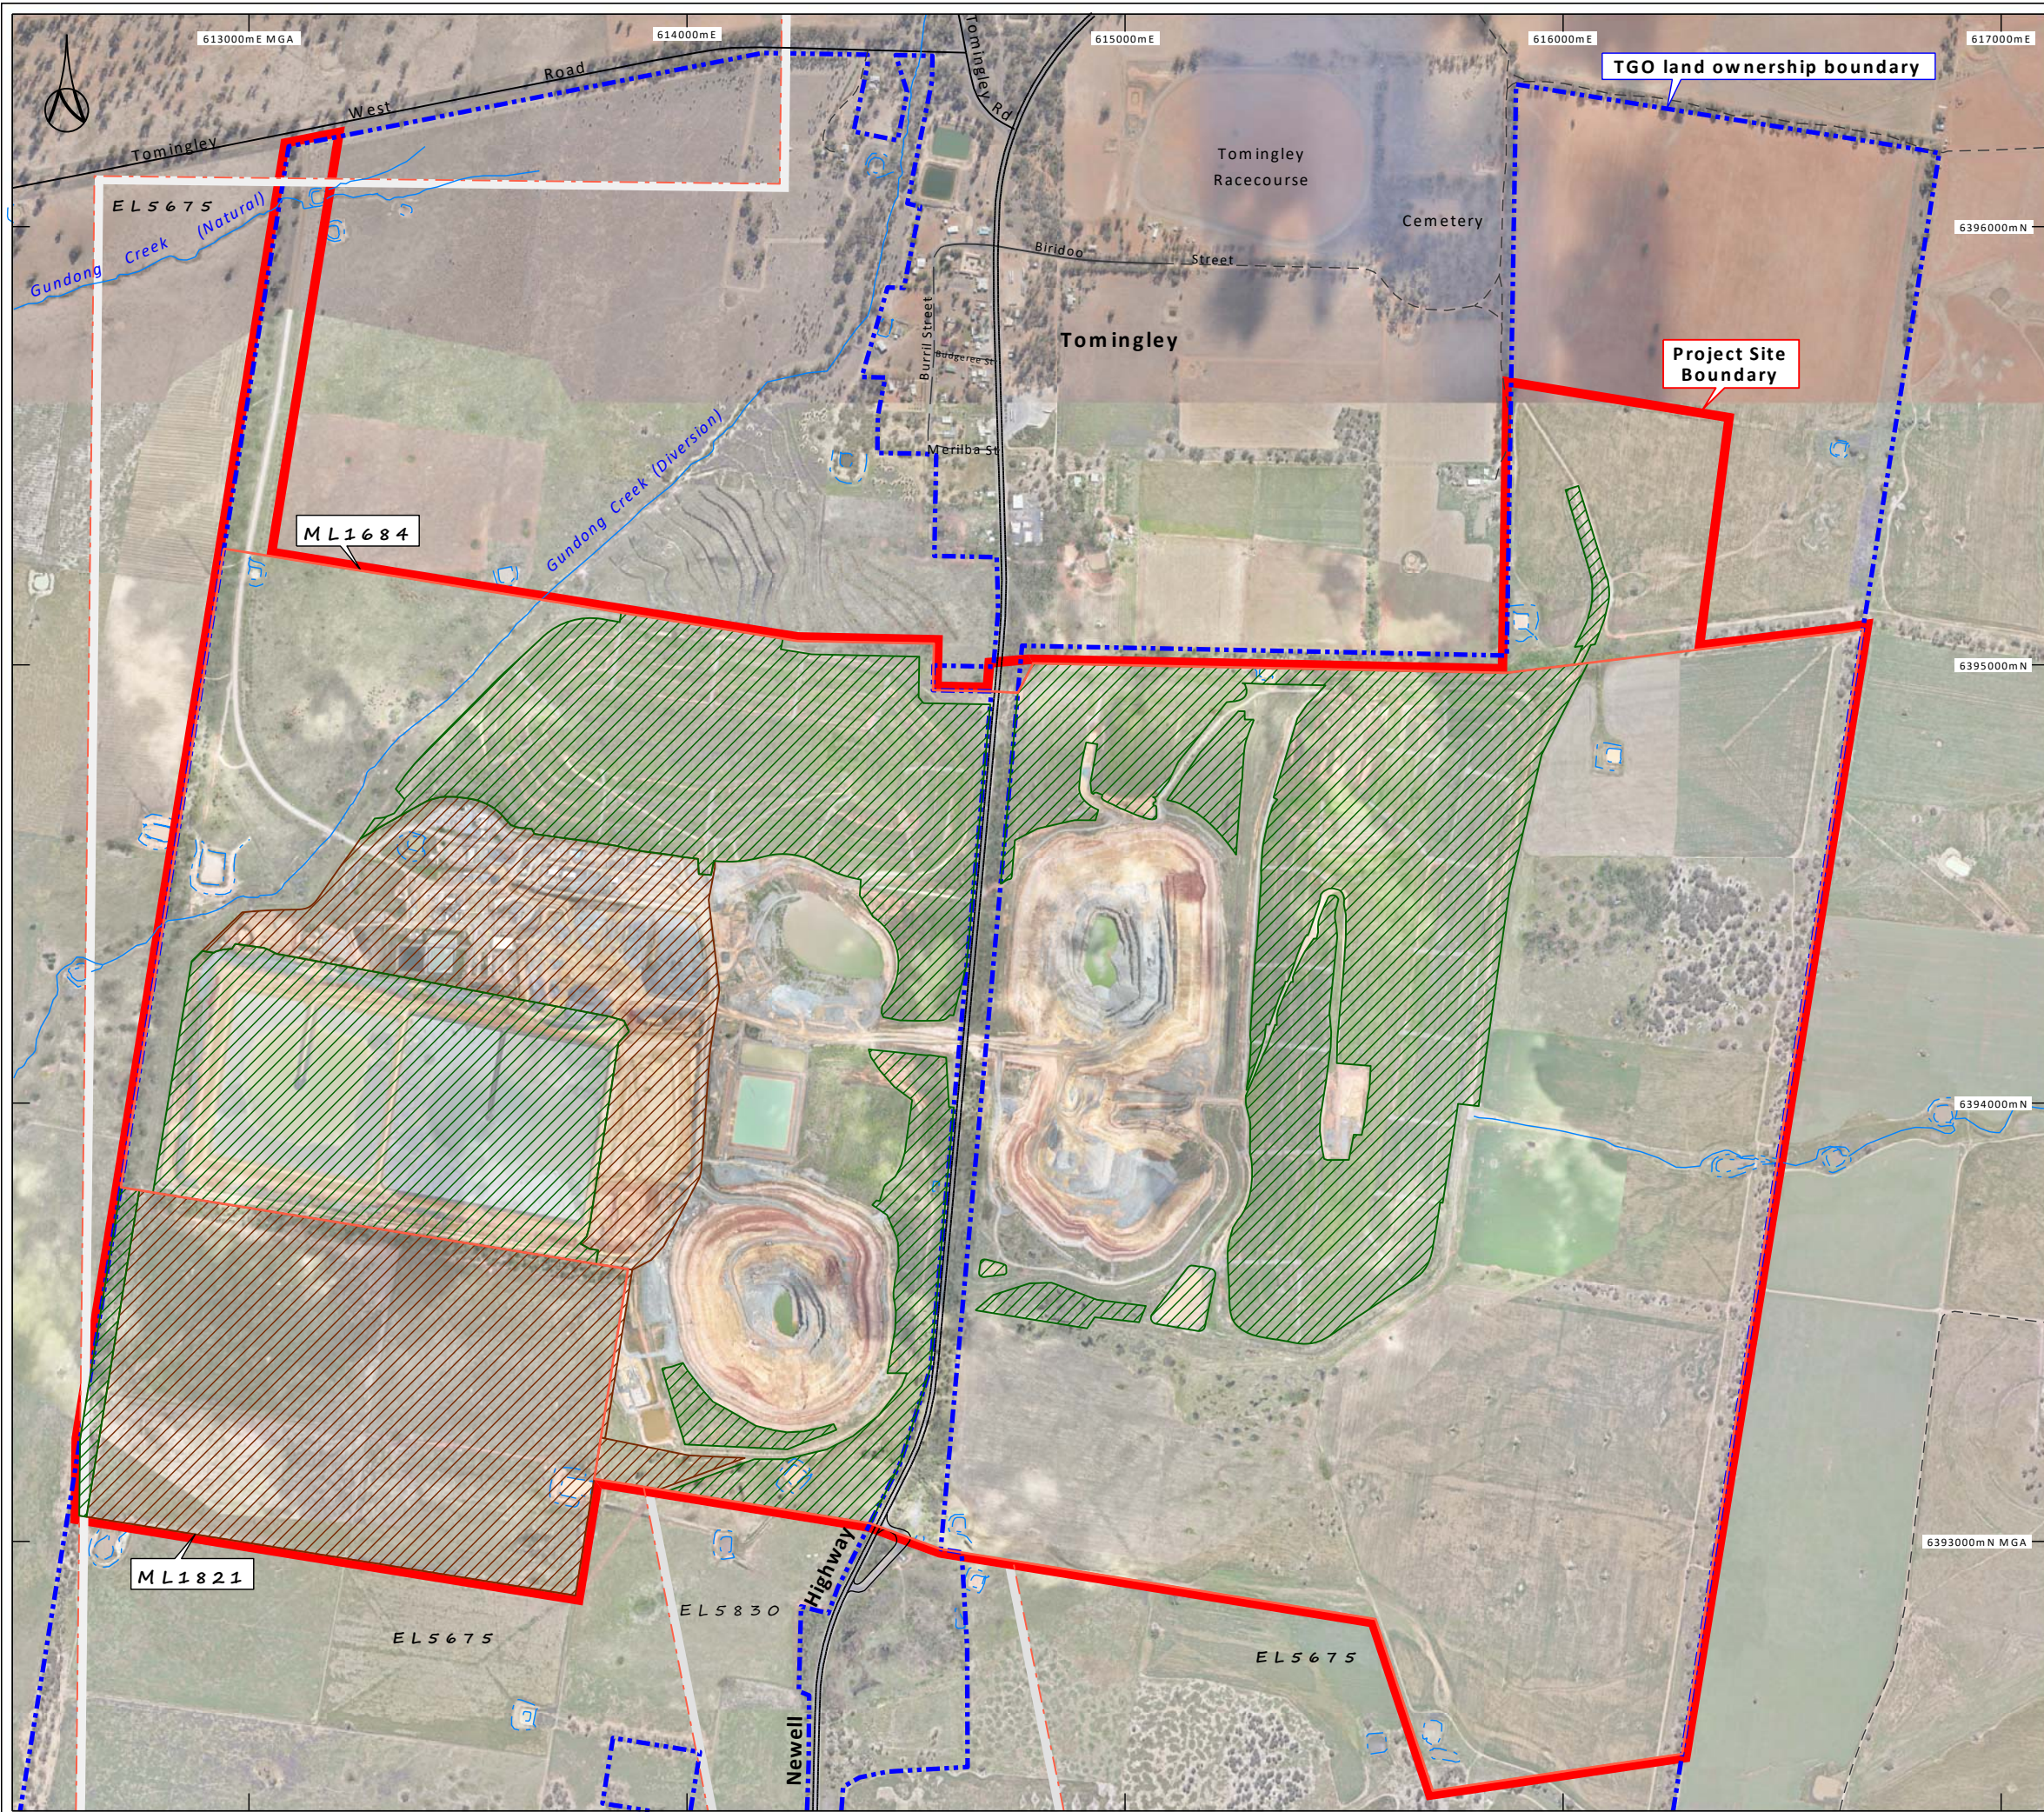
**TOMINGLEY GOLD OPERATIONS** PTY LTD  
 (A SUBSIDIARY OF ALKANE RESOURCES LTD)  
**TOMINGLEY GOLD MINE**  
**Rehabilitation Progress**  
**(2022-2025)**  
 (RMP 2022 - PLAN 3)

Compiled: TGO (D Pritchard, M Fake) Plan No.: ALK TGO 1MP-053  
 Drawn: D Moyses Date: 15 December 2022 Figure No.: PLAN 3

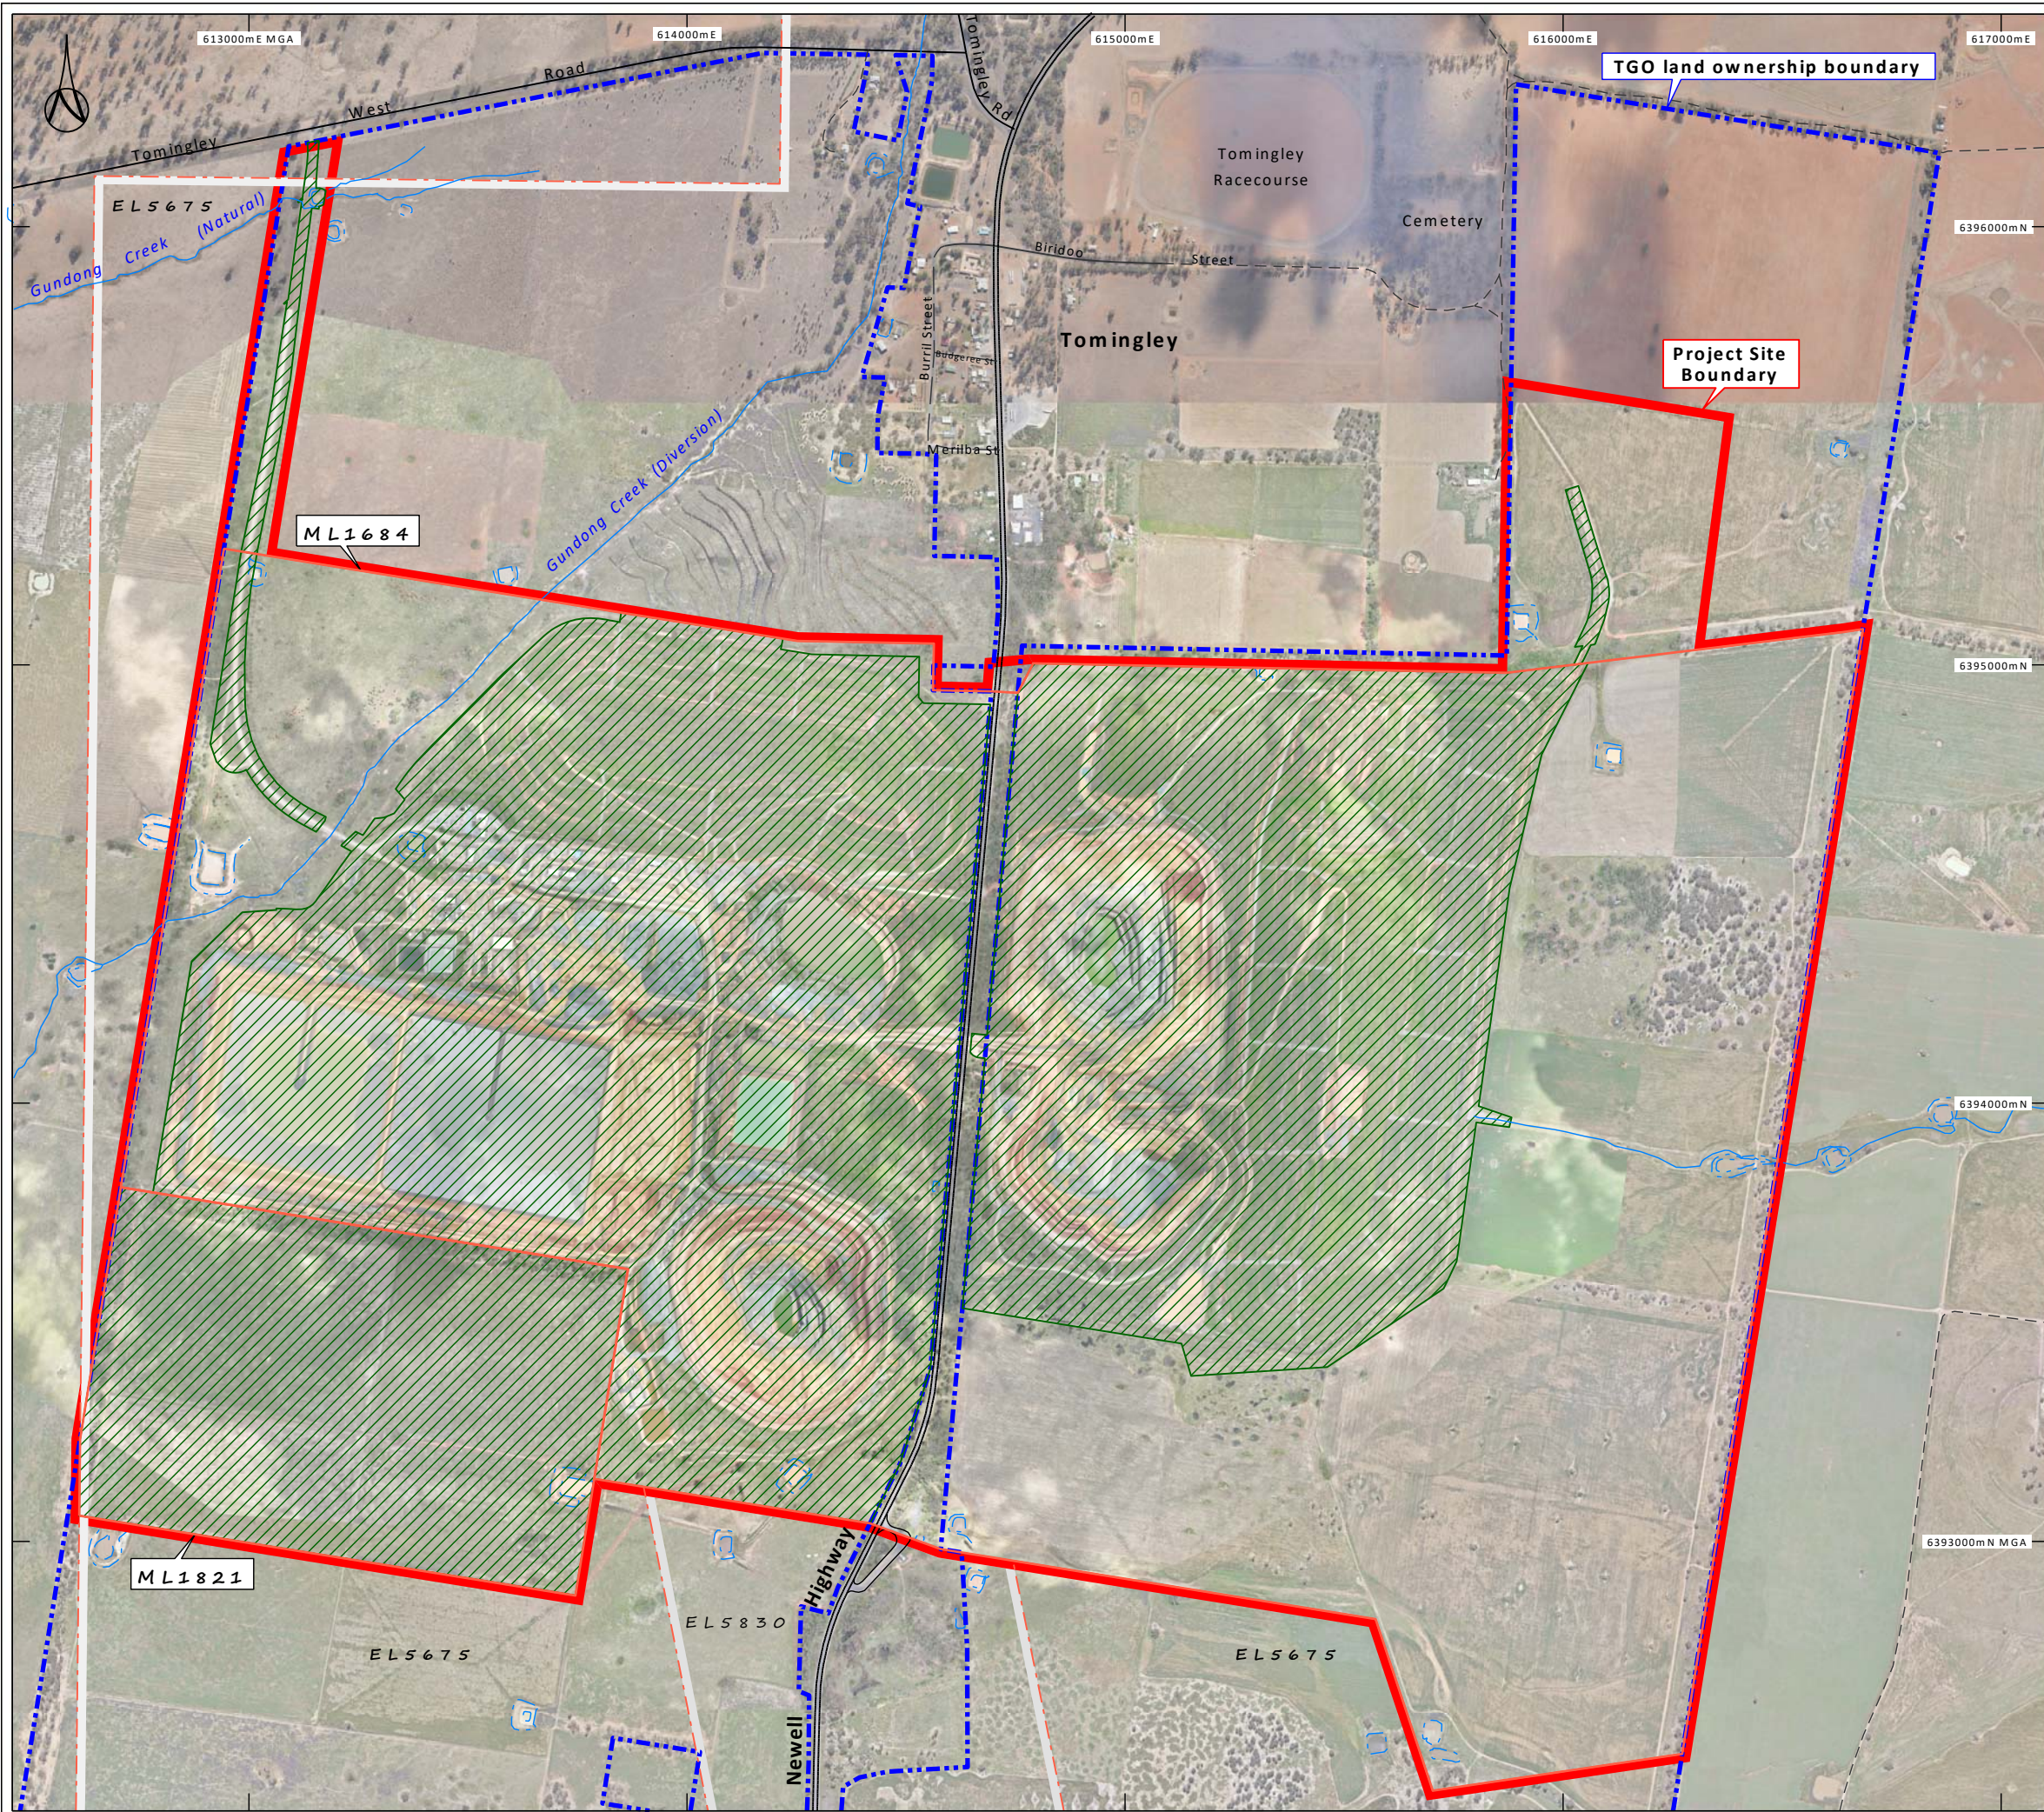
**TOMINGLEY GOLD OPERATIONS** PTY LTD  
 (A SUBSIDIARY OF ALKANE RESOURCES LTD)  
**TOMINGLEY GOLD MINE**  
**Rehabilitation Progress**  
**(2026-2030)**  
 (RMP 2022 - PLAN 4)

Compiled: TGO (D Pritchard, M Fake) Plan No.: ALK TGO 1MP-054  
 Drawn: D Moyses Date: 16 December 2022 Figure No.: PLAN 4

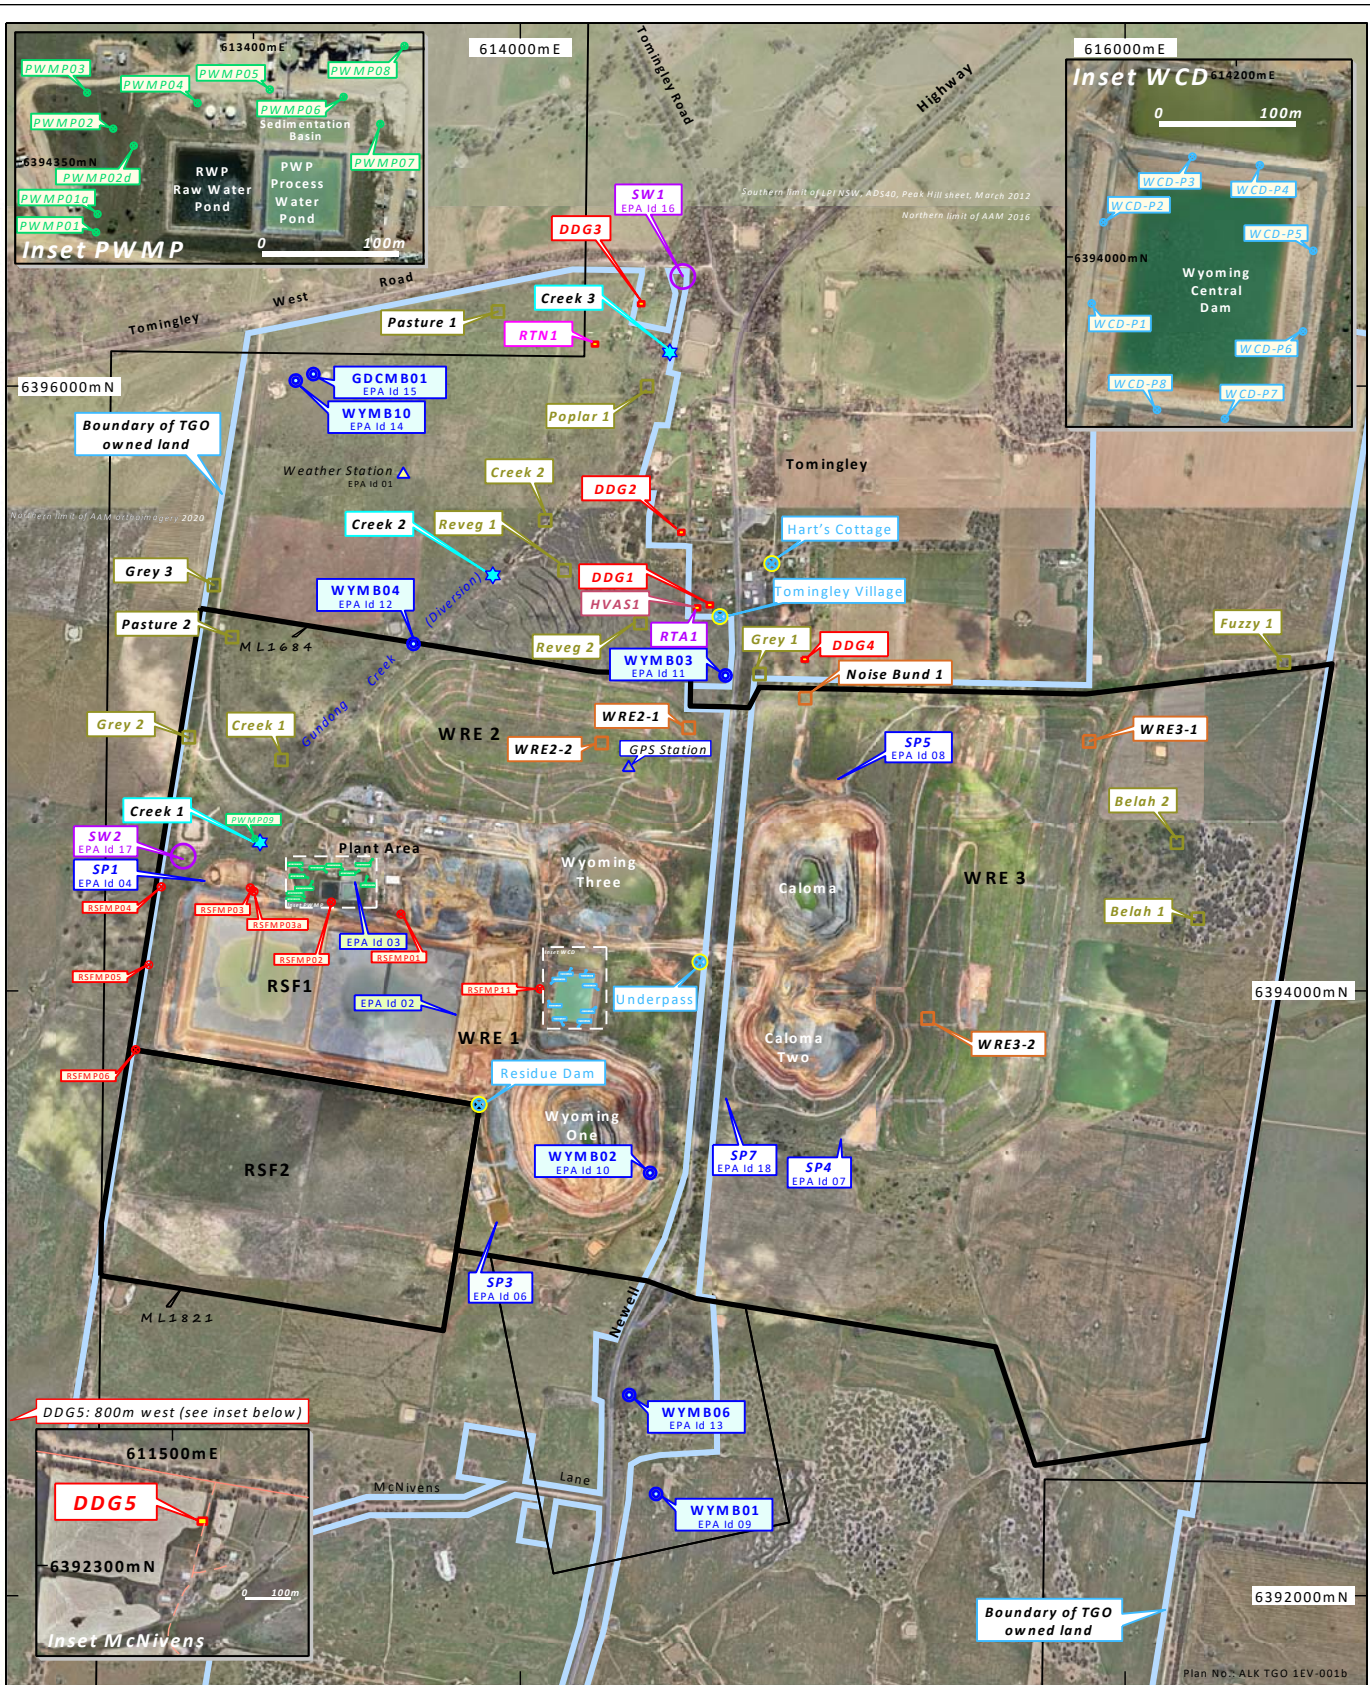
- **SP** Sediment pond discharge location
- **DDG** Dust deposition gauge location
- **HVAS** High volume air sampler location
- **RTA** Real time air quality monitoring station
- **RTN** Real time noise monitoring station
- **SW2** Surface water
- **Hart's** Blast monitoring station
- **RSEMP01** Piezometer (RSF monitoring)
- **PWMP01** Piezometer (PWP monitoring)
- **WYMB06** Groundwater bore
- **Creek 2** Gundong Creek Diversion monitor / photo point
- **Belah 2** Vegetation monitoring site
- **Pasture 2** Rehabilitation vegetation monitoring site
- Additional EPA ID Locations**
- **EPA Id 02** Discharge of tailings to the RSF moves around the circumference.
- **EPA Id 03** Discharge between the Process Sediment Pond and the Process Water Pond
