Monthly Noise Monitoring Assessment

Tomingley Gold Mine, April 2022

Prepared for: Tomingley Gold Operations Pty Limited
May 2022
MAC160270-2022RP04

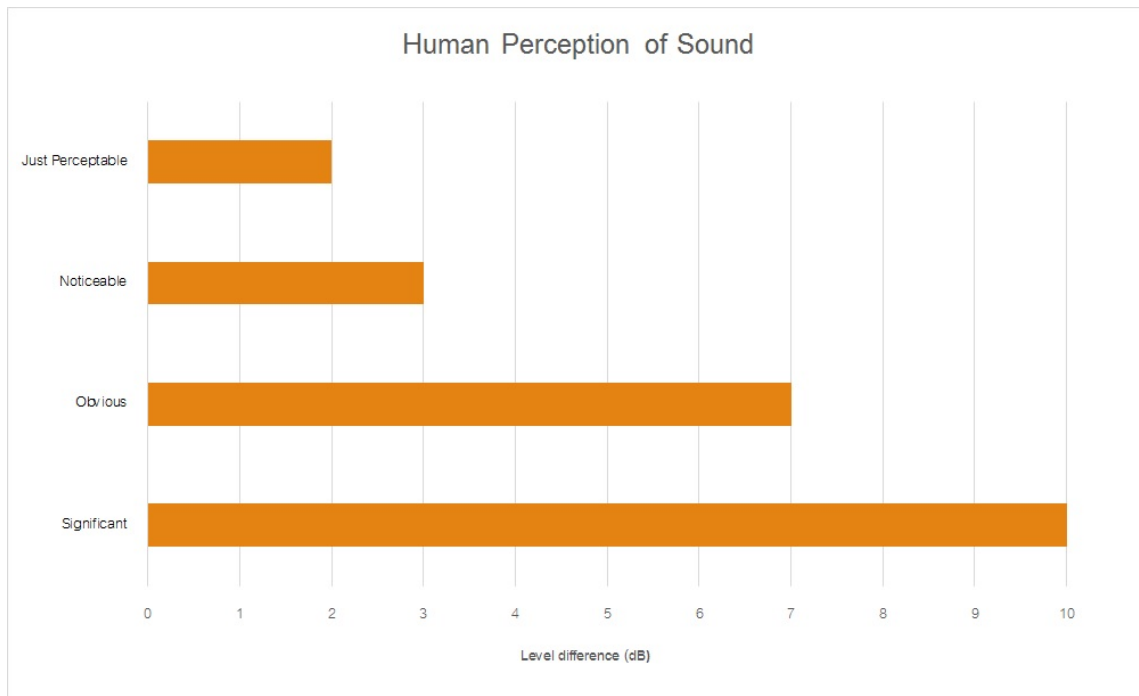
Figure A1 – Human Perception of Sound

Table A2 provides a list of common noise sources and their typical sound level.
